**APPENDIX B**

## Scoudouc River

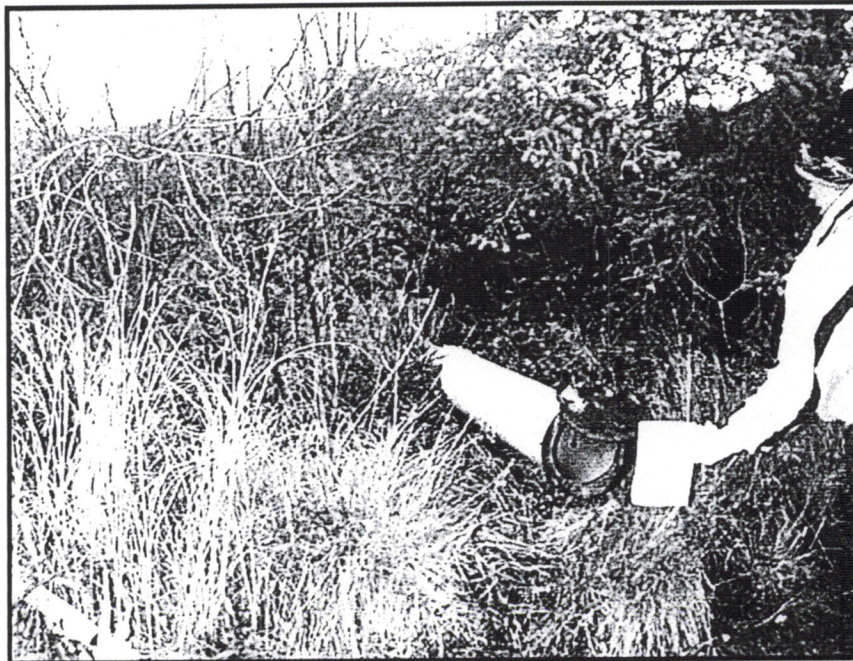
**Figure 1.** Plastic storm drainage pipe (with metal lid) originating from house at site 3.

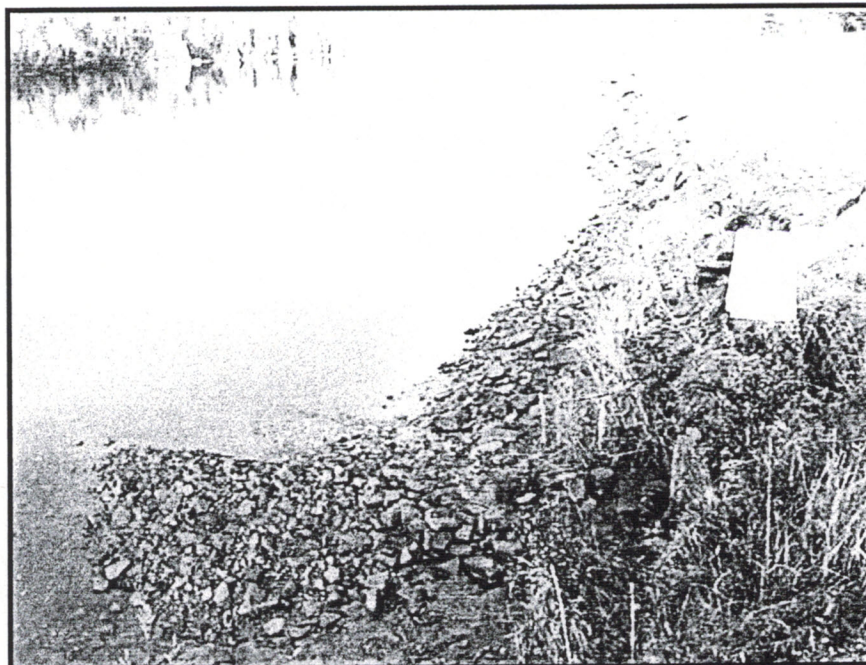
**Figure 2.** Serious erosion problems near culvert crossing dirt road at site 5.

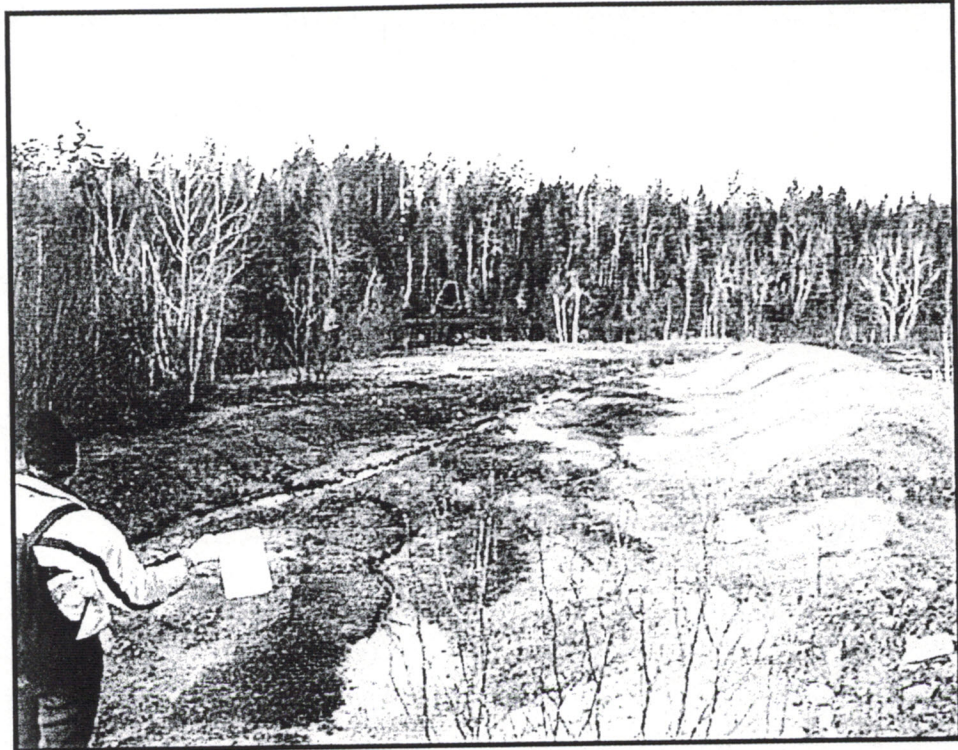
**Figure 3.** Small erosion ditch originating from abandoned pit at site 6.

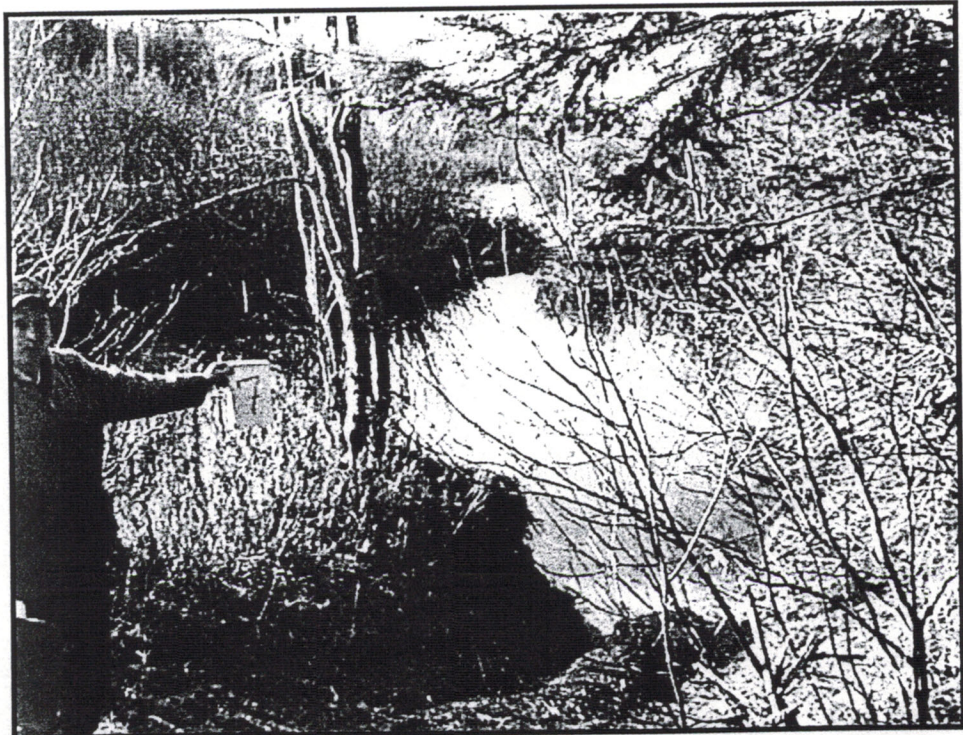
**Figure 4.** An all-terrain vehicle crossing the Scoudouc river at site 7.

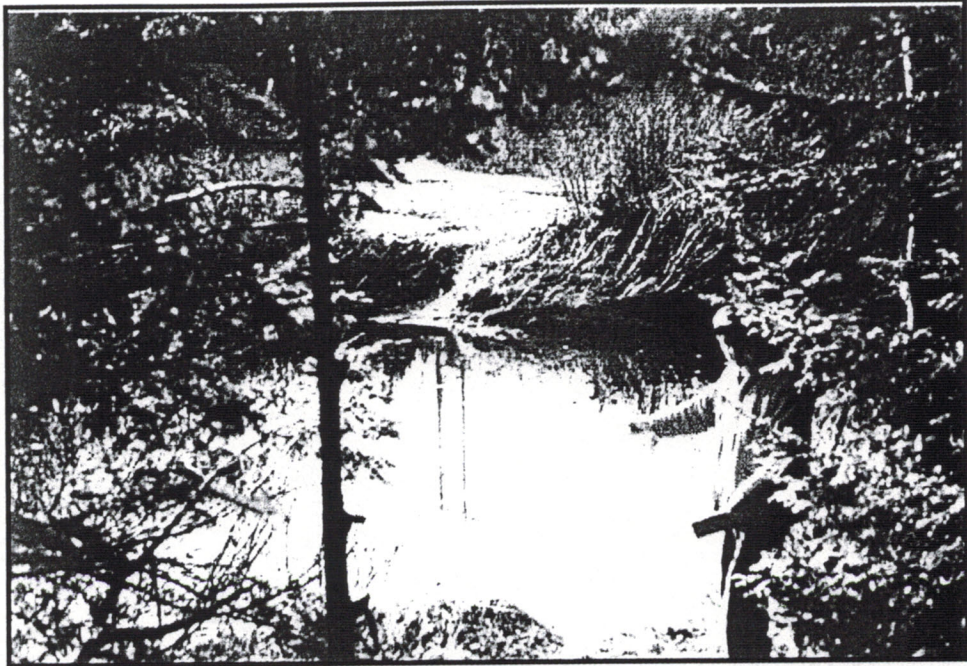
**Figure 5.** An all-terrain vehicle crossing the Scoudouc river at site 8.

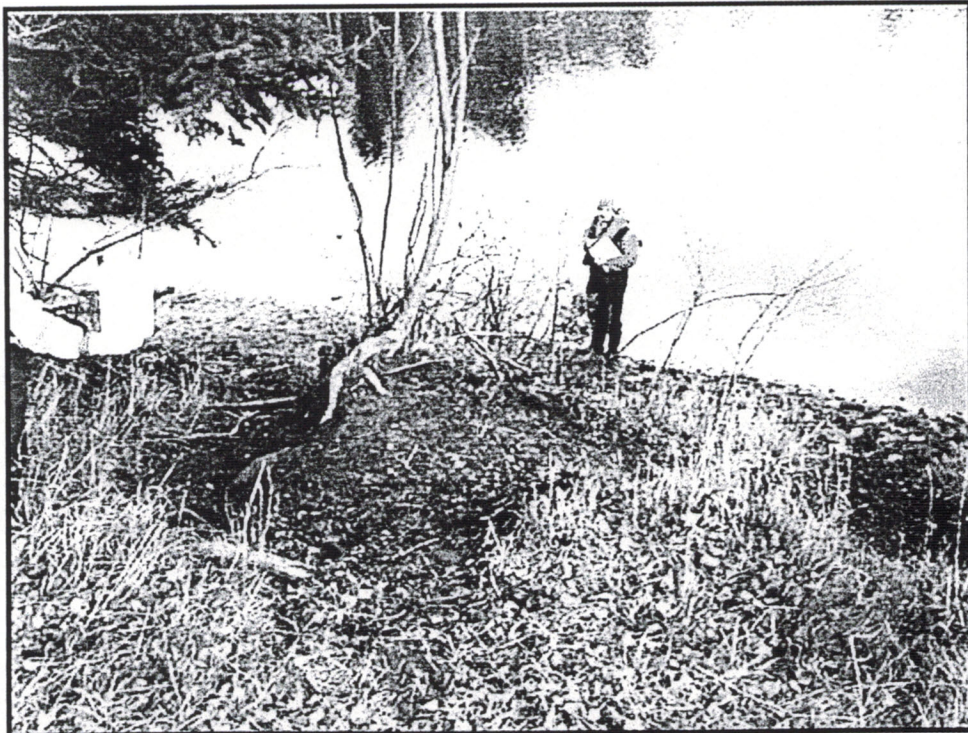
**Figure 6.** Cattle access to river at site 9.

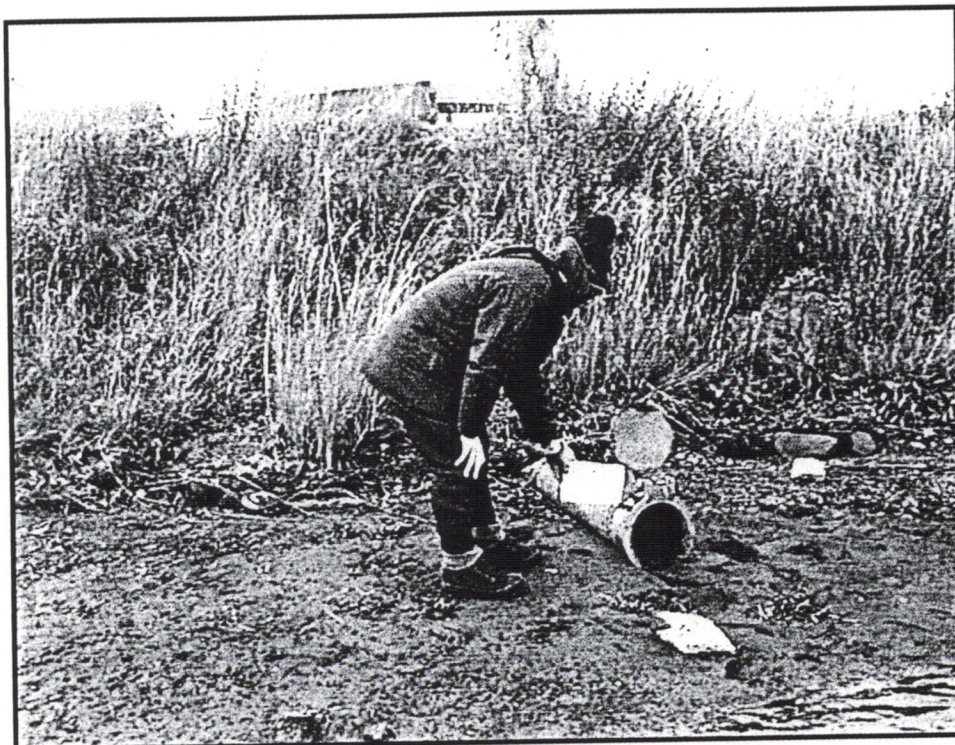
**Figure 7.** Metal storm drainage pipe originating from tourist center at site 10.

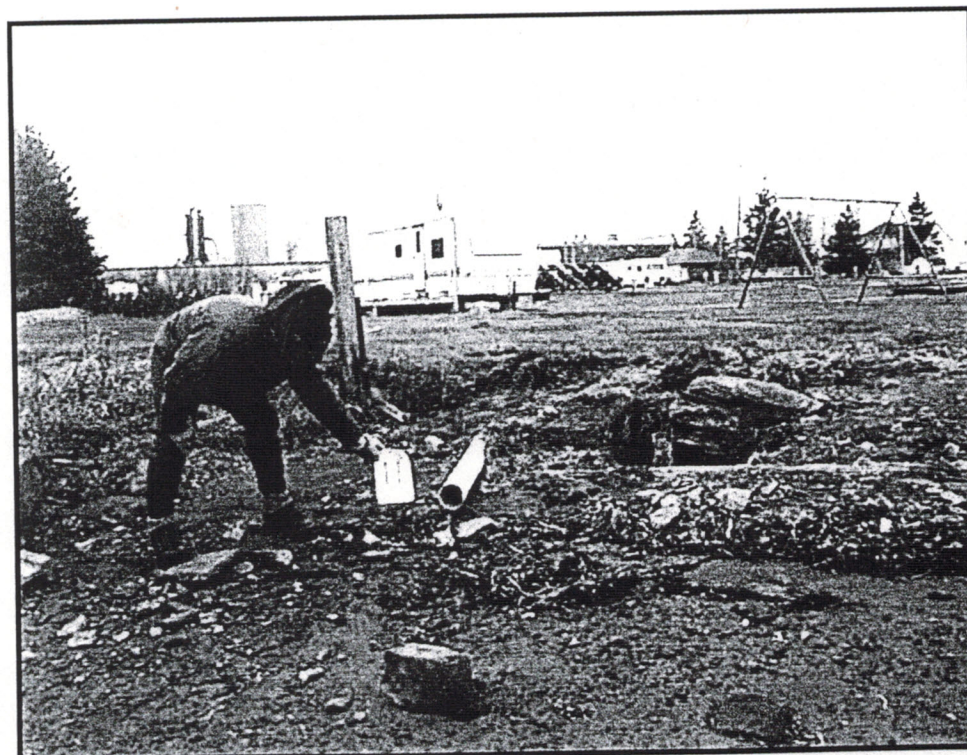
**Figure 8.** Plastic drainage pipe originating from trailer camp ground at site 11.

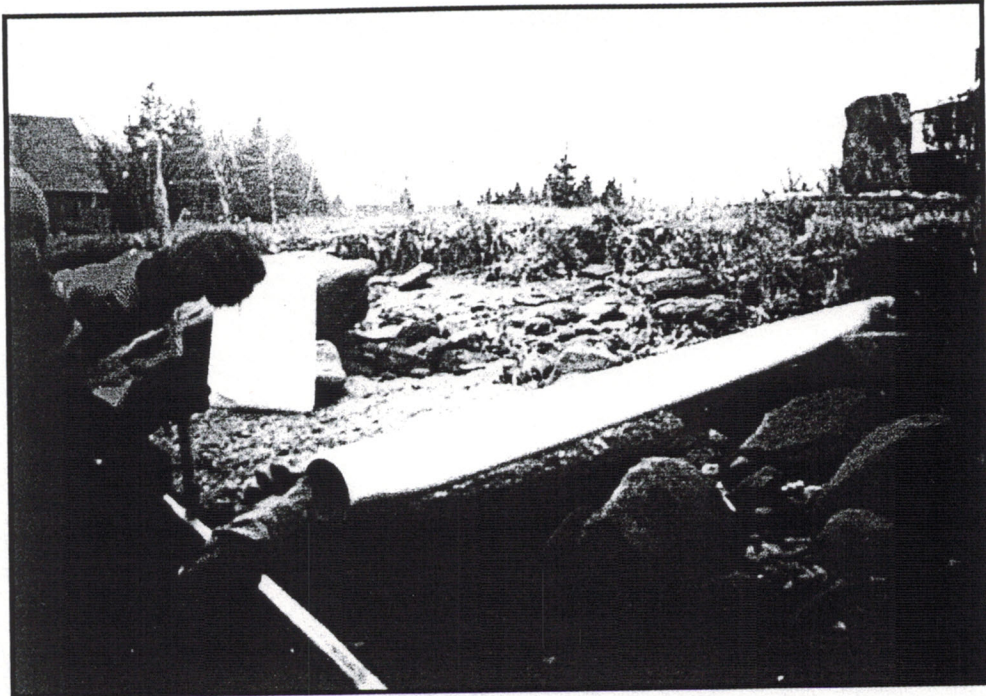
**Figure 9.** Plastic pipe originating from white house at site 12.

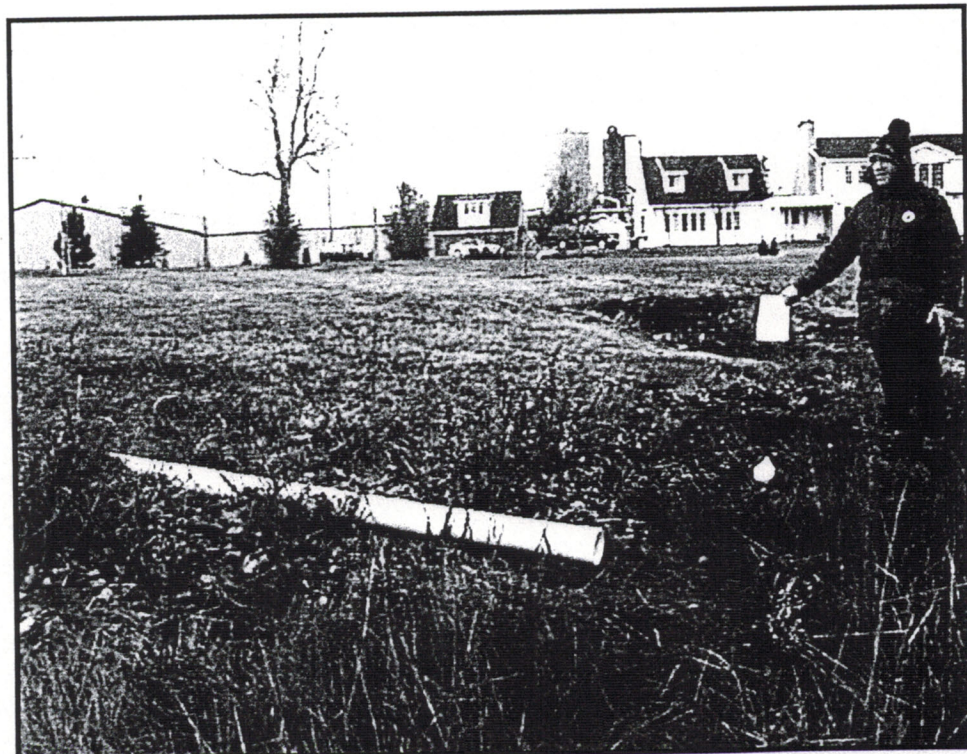
**Figure 10.** Plastic pipe originating from grey house at site 13.

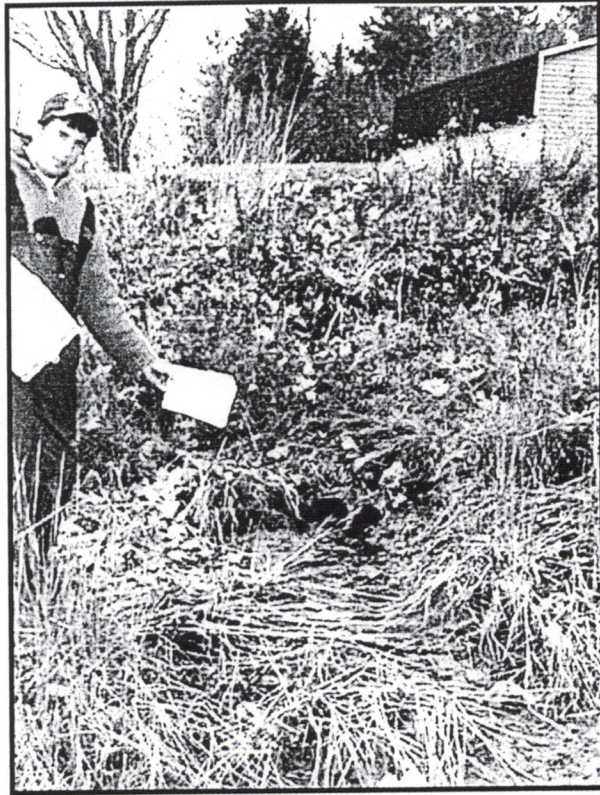
**Figure 11.** Metal culvert originating from white house at site 13.

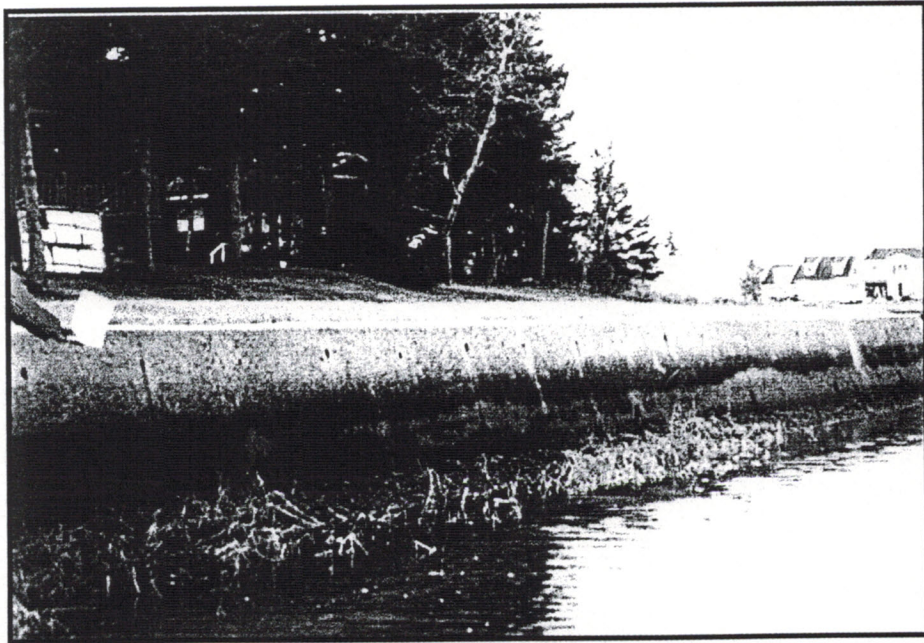
**Figure 12.** Concrete bank stabilizer at site 15. Small drainage pipes are built-in the concrete at every 6-8 feet.

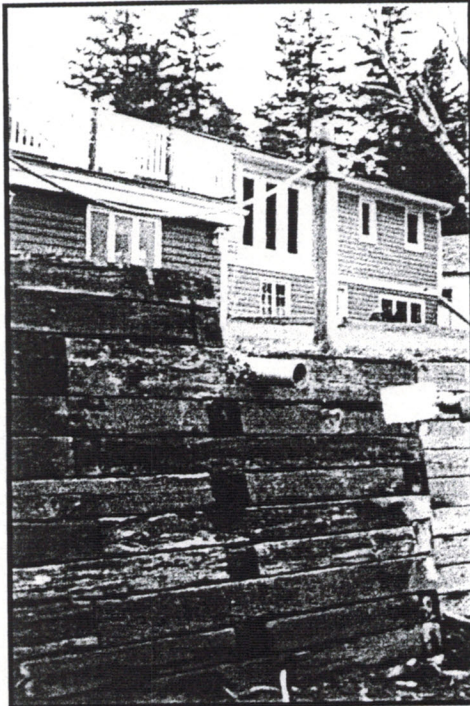
**Figure 13.** Plastic drainage pipe originating from blue house at site 17.

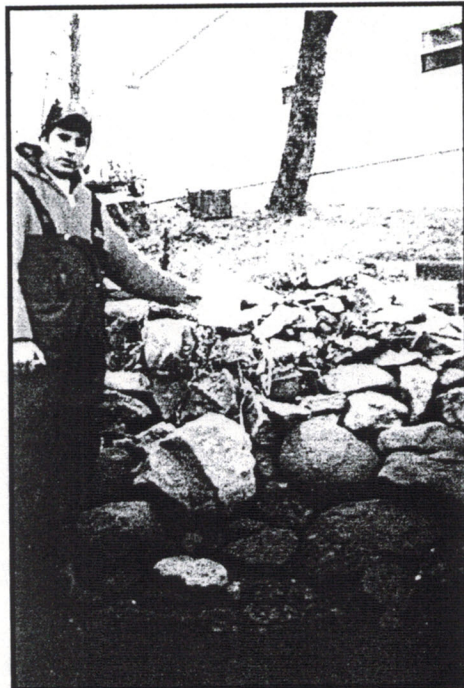
**Figure 14.** Plastic drainage pipe originating from white house at site 18.

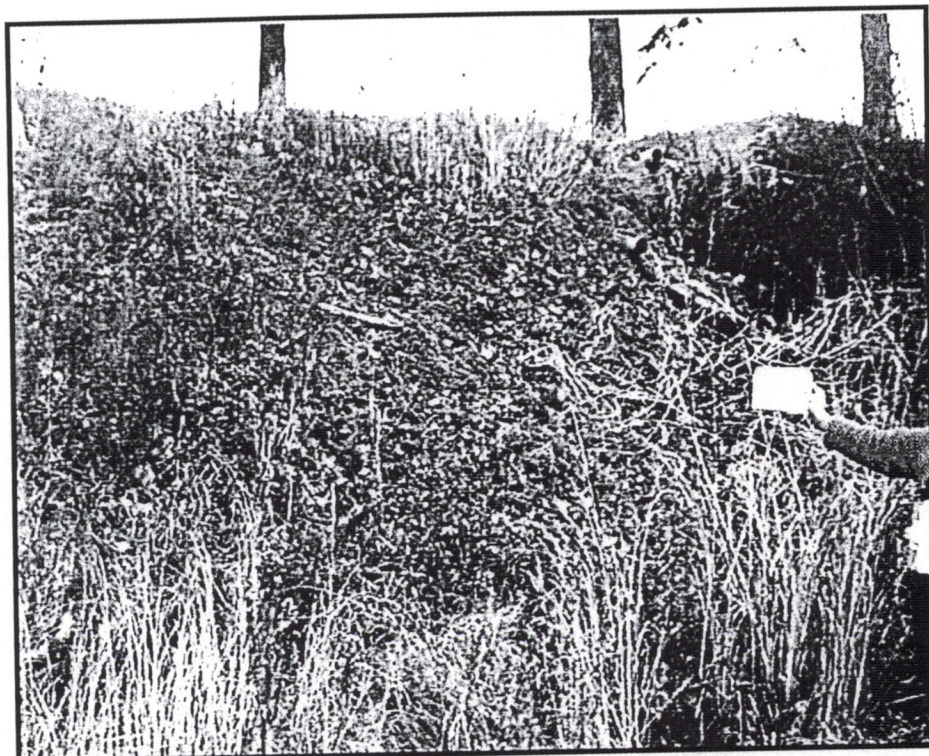
**Figure 15.** Plastic culvert in road at site 19.

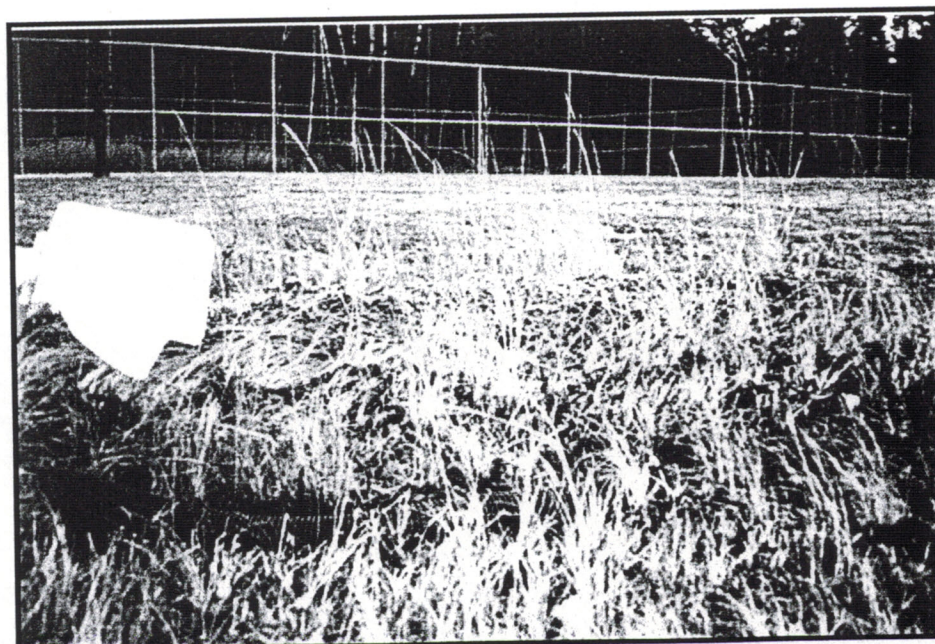
**Figure 16.** Plastic storm drainage pipe originating from white house at site 20.

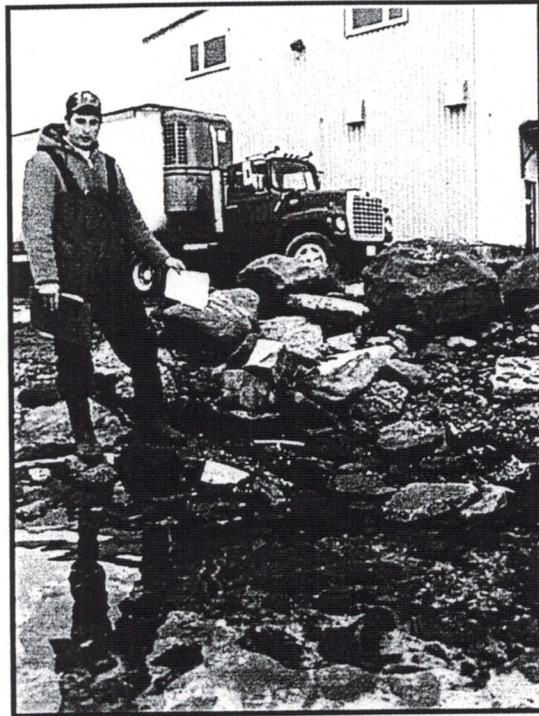
**Figure 17.** Small plastic pipe originating from Shediac Lobster Shop at site 22. .

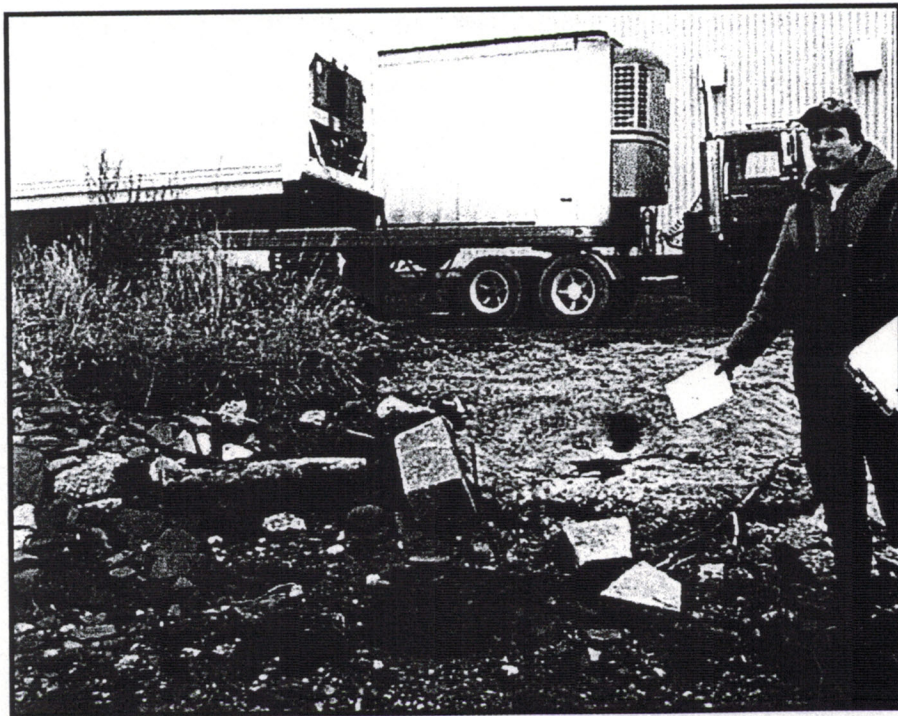
**Figure 18.** Large plastic pipe originating from Shediac Lobster Shop at site 22. Lobster waste flowing from pipe.

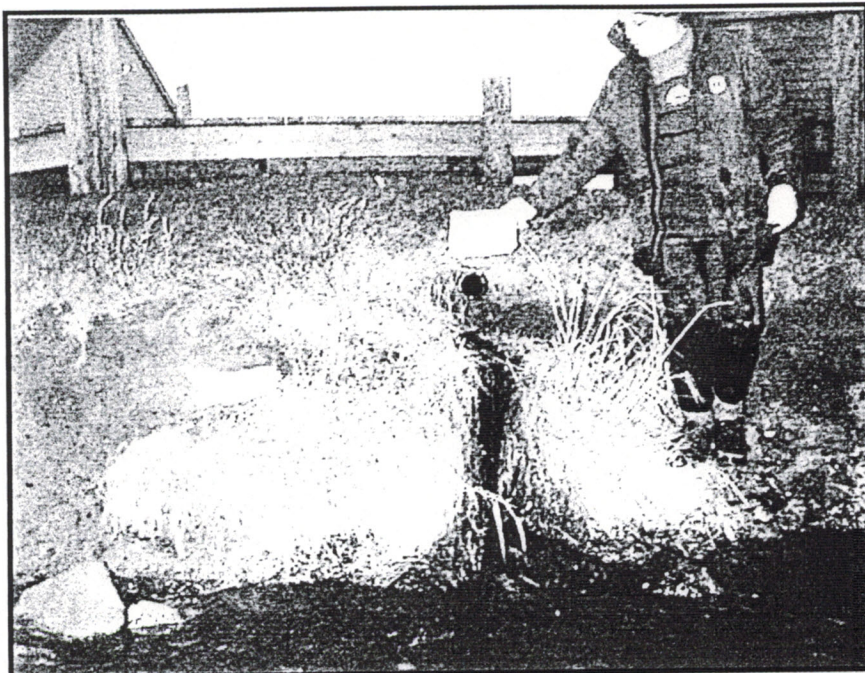
**Figure 19.** Plastic pipe originating from behind tourist center in Shediac (site 23).

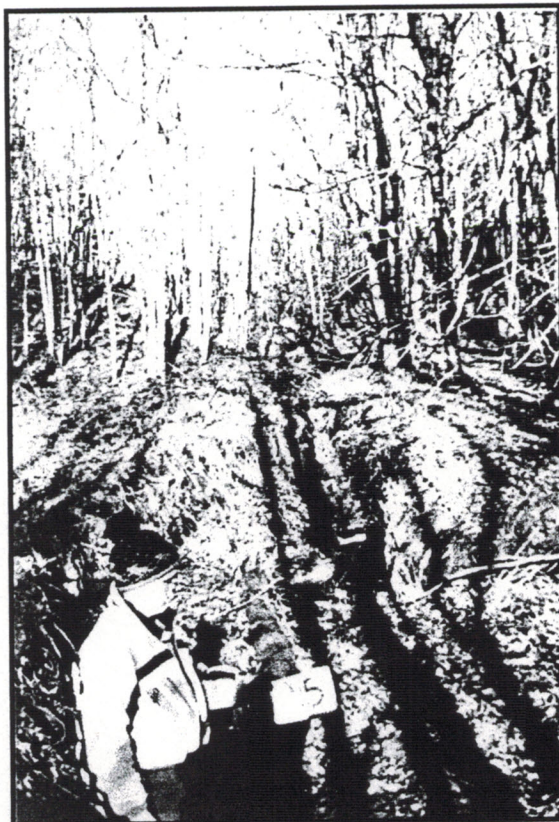
**Figure 20.** Erosion ditch along a slightly sloped bank at site 25.

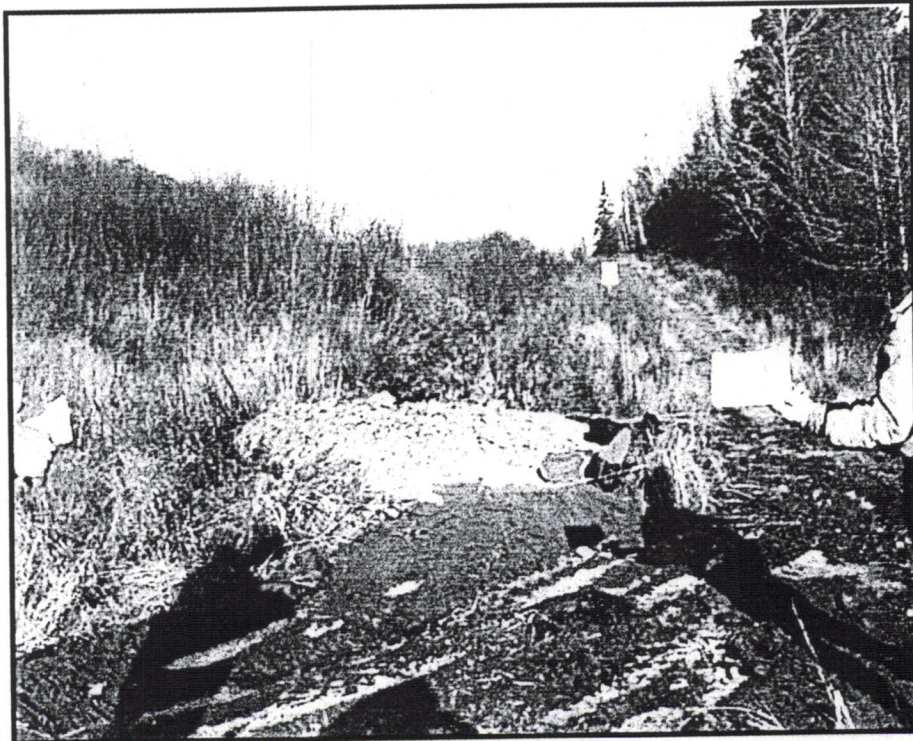
**Figure 21.** Erosion ditch along right side of Scoudouc river that is probably caused by power lines trail (site 26).

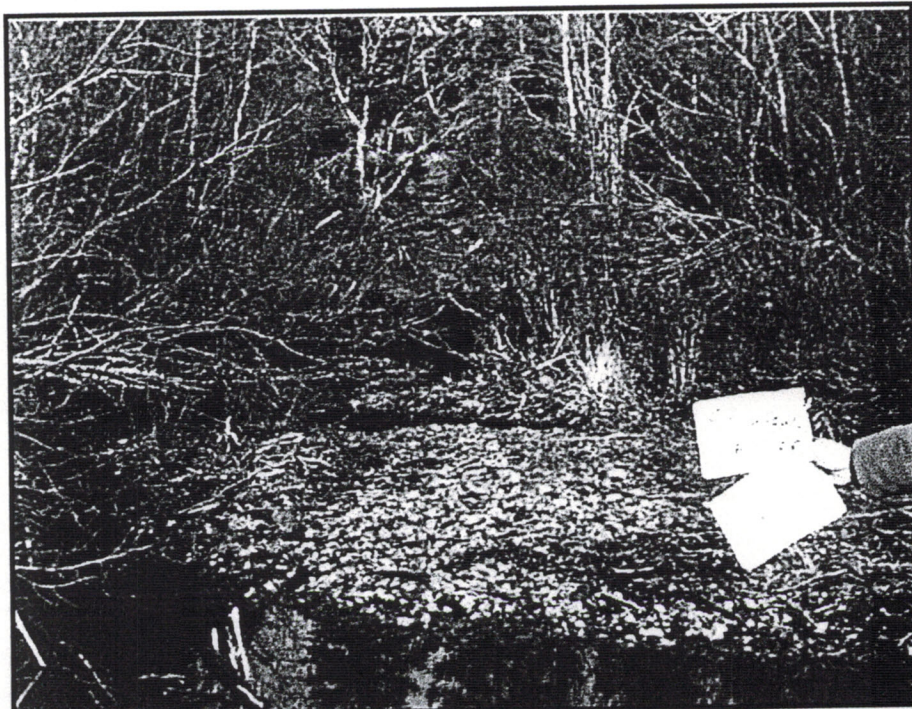
**Figure 22.** Moderate erosion caused by access road at site 28.

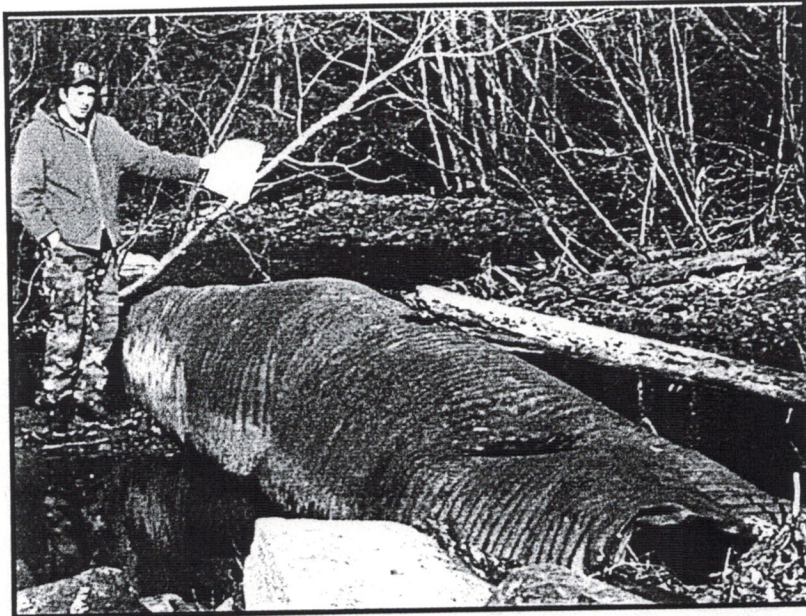
**Figure 23.** Rusting culvert pipe (abandoned) lying across a portion of the river at site 28.

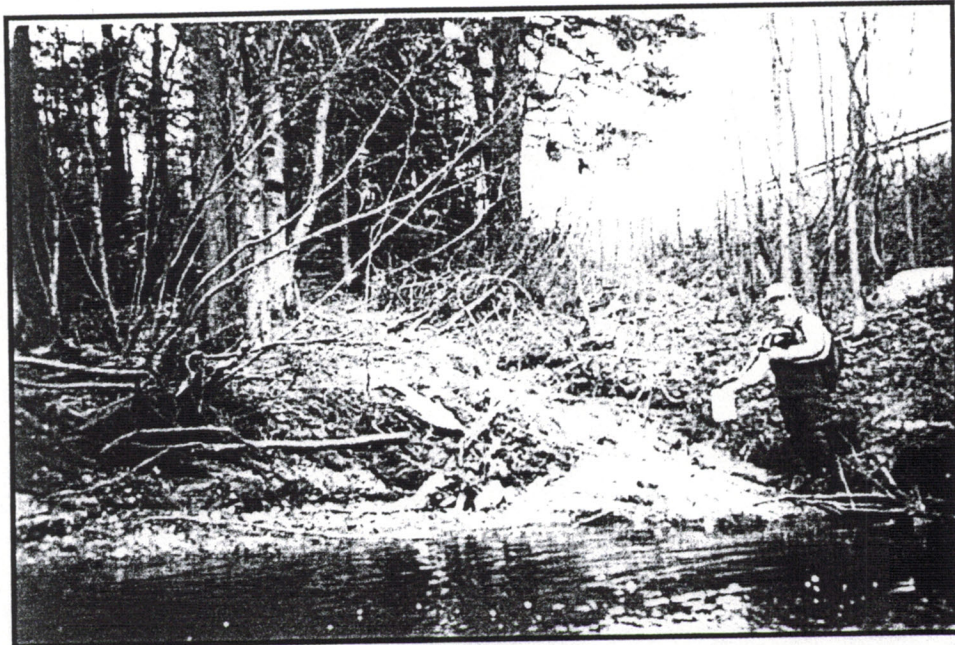
**Figure 1.** Minor erosion originating from lawn of nearby house at site 1.

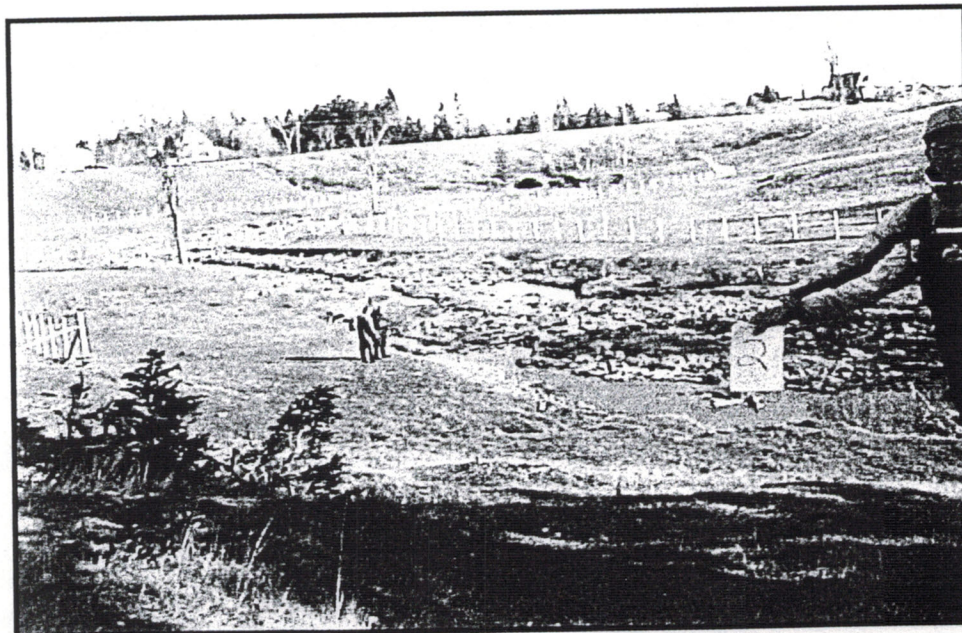
**Figure 2.** Serious erosion caused by cattle near farm in Irishtown (site 3).

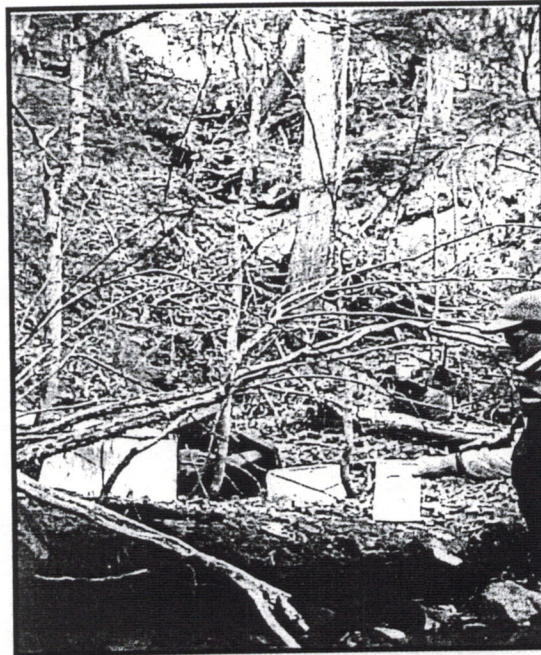
**Figure 3.** Piles of garbage including fridges, car parts, metals segments and tires were situated on the left side of the watercourse at site 5.

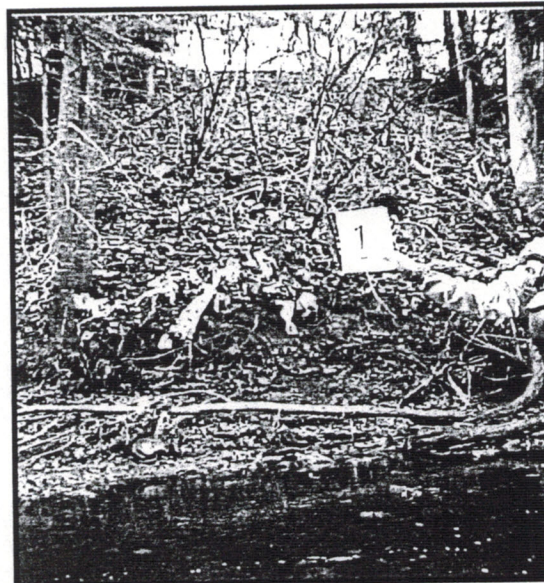
**Figure 4.** Presence of garbage on the right side of the stream at site 7. Included are metal segments, plastics and glass. Another pile of garbage is located 100 meters downstream, on the right side of the watercourse.

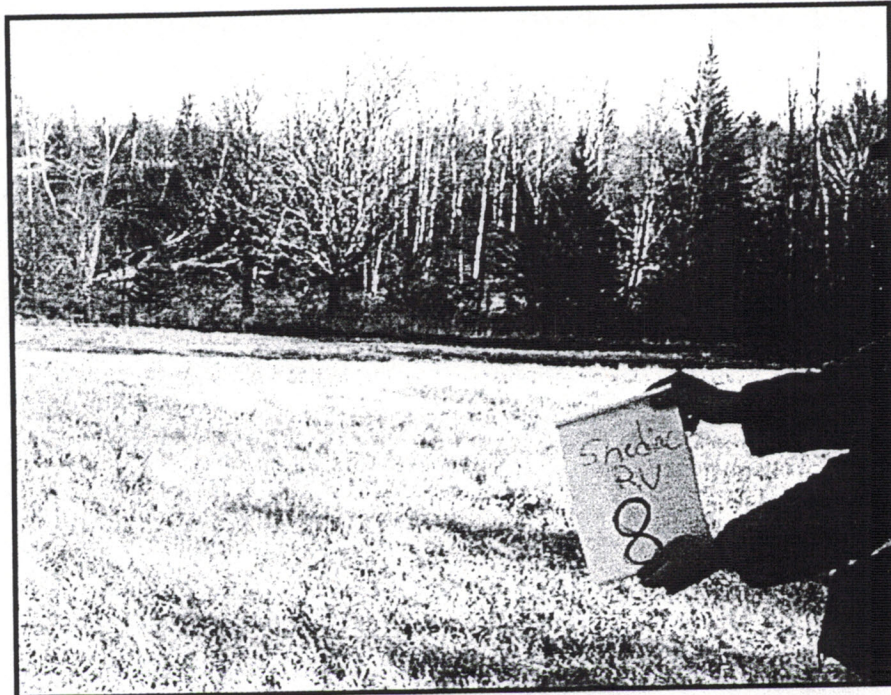
**Figure 5.** Hayfield located 5-10 meters from stream at site 8. No erosion problems observed.

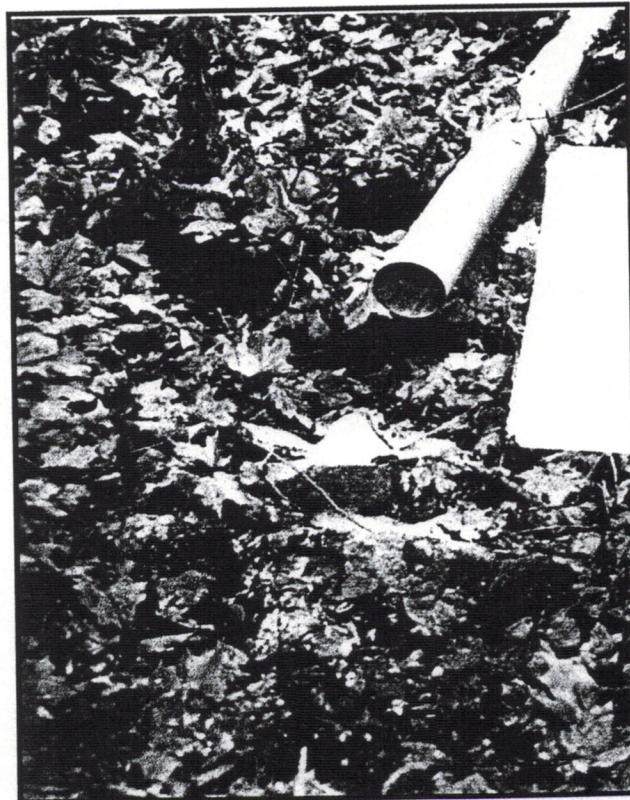
**Figure 6.** Plastic drainage pipe originating from a house at site 9.

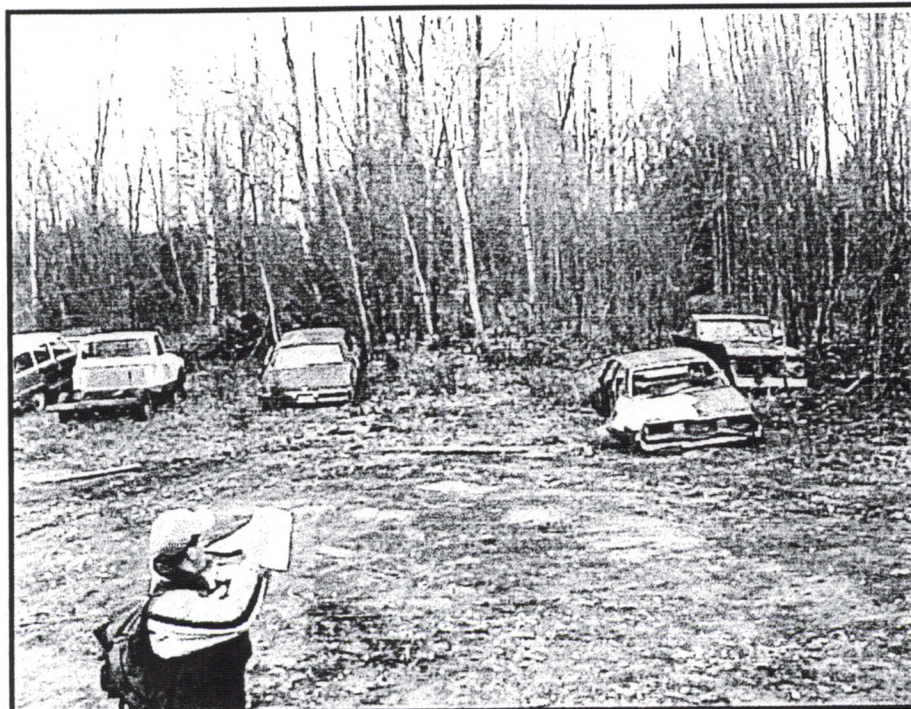
**Figure 7.** A car junk yard located 15 meters from stream at site 10.

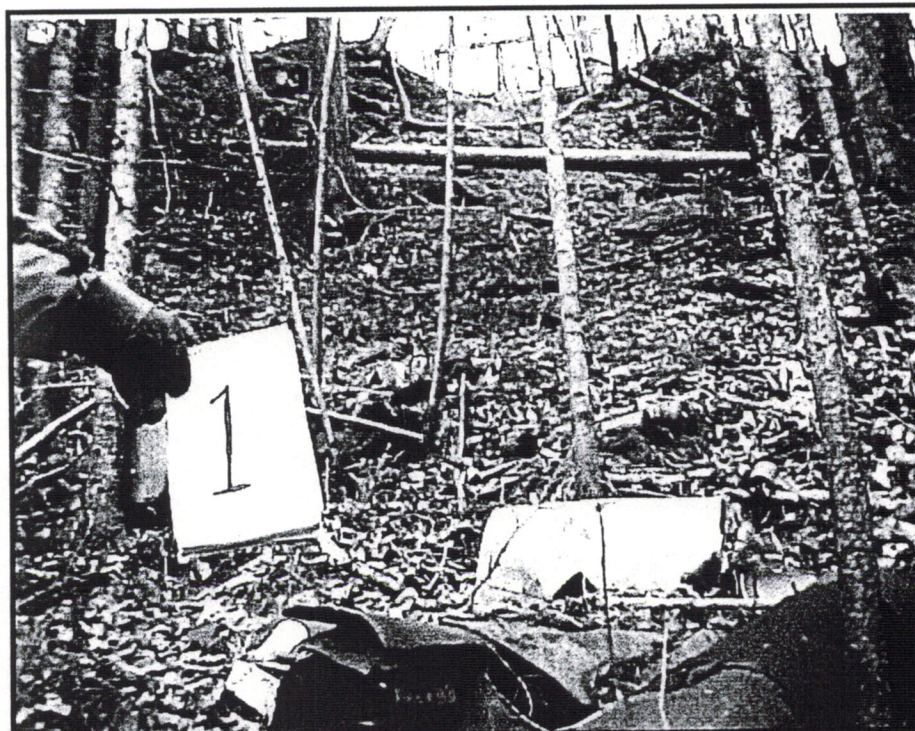
**Figure 8.** Plastic pipe originating from 2 houses at site 11. Beside this pipe exists a small quantity of garbage on the bank. Included in this garbage are metals, plastic s and glass.

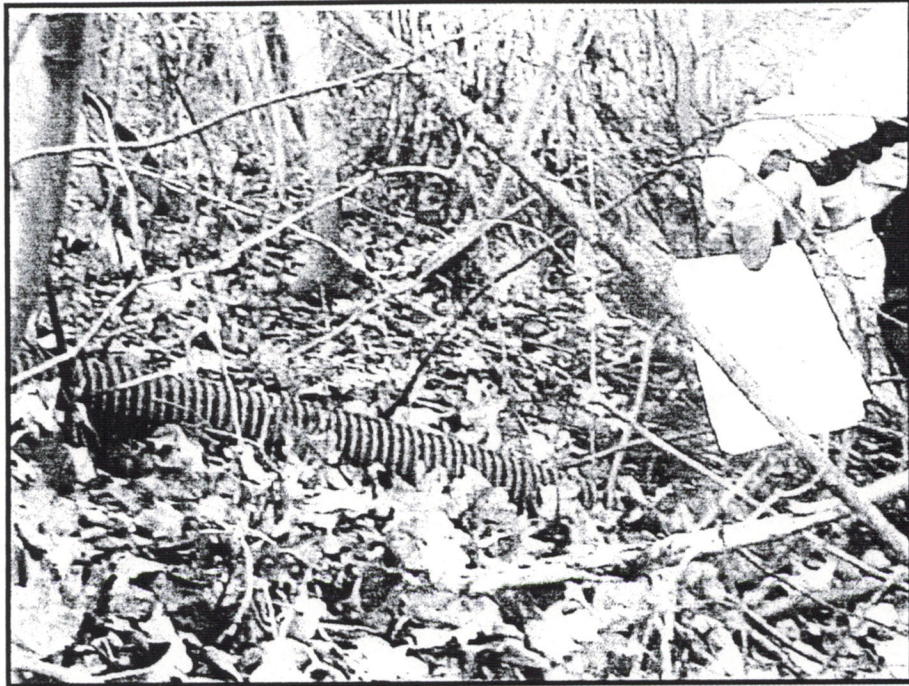
Figure 9. Small plastic pipe originating from two houses at site 11.

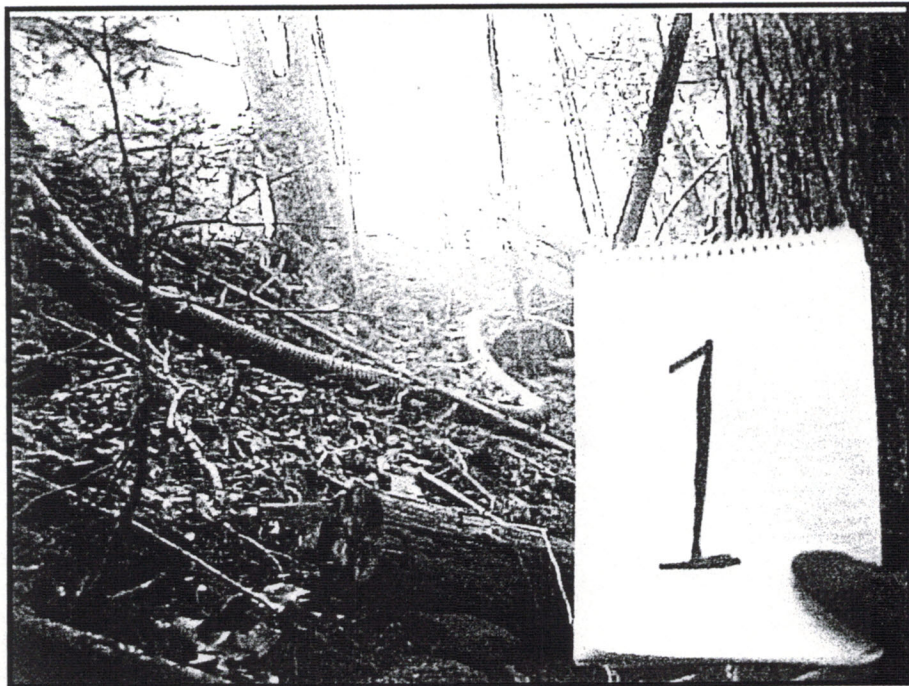
Figure 10. Small plastic pipe originating from three houses at site 12.

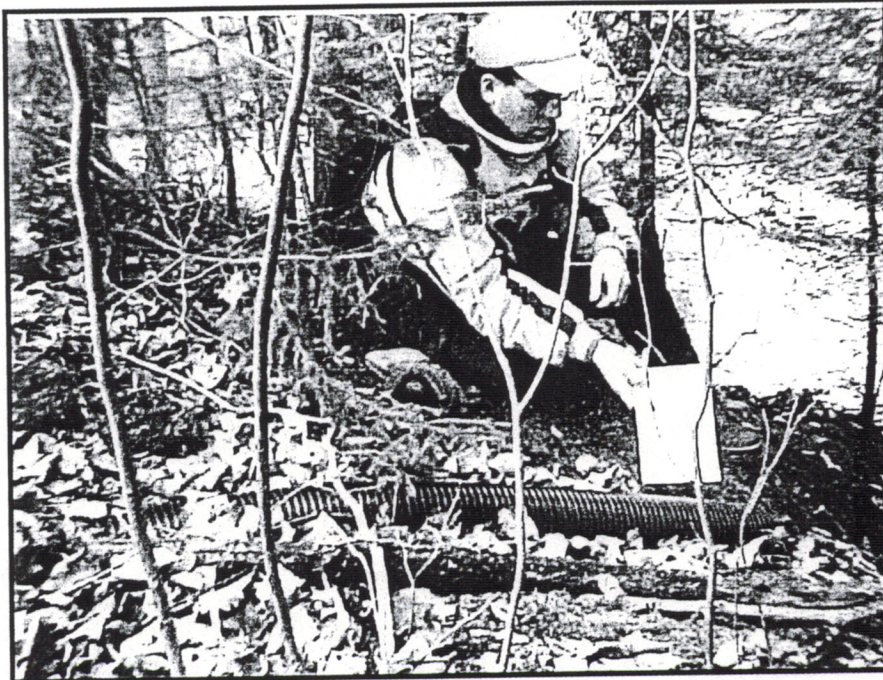
**Figure 11.** Plastic pipe originating from nearby house at site 14.

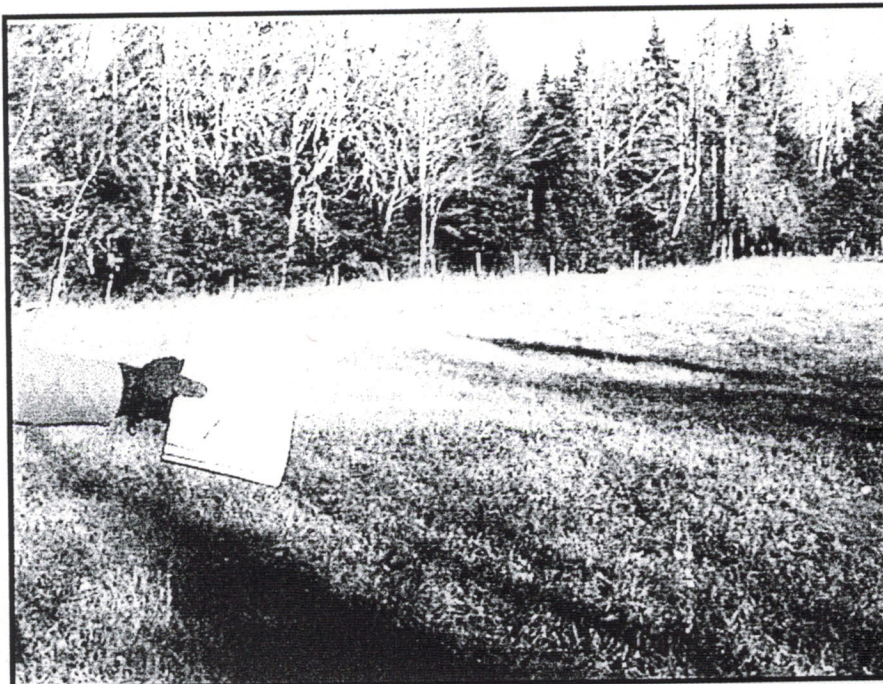
**Figure 12.** Fenced off cattle farm approximately 12 m from the watercourse at site 15.

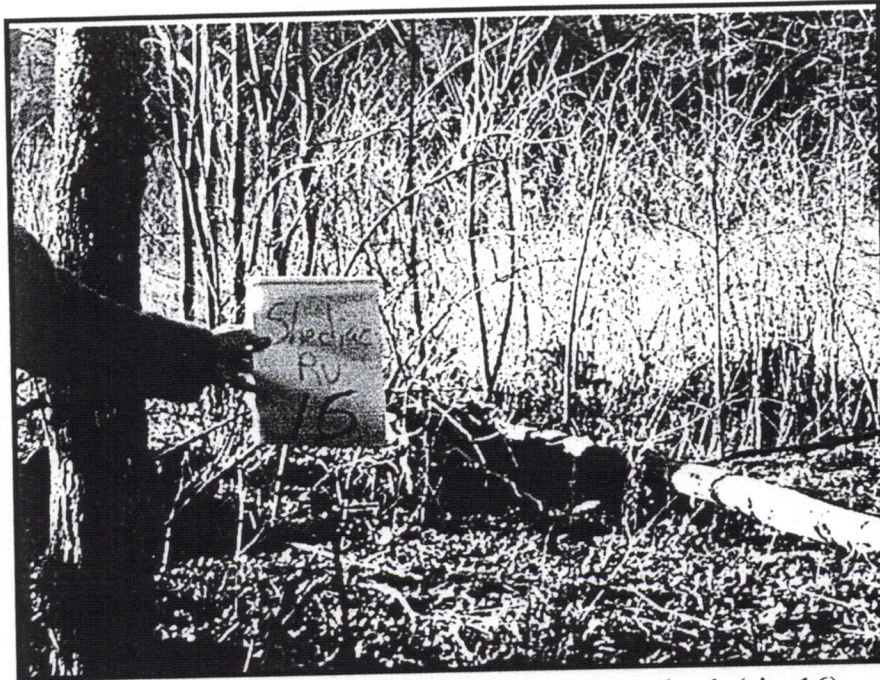
**Figure 13.** A clearcut at 10-15 m from the stream bank (site 16).  
No erosion observed.

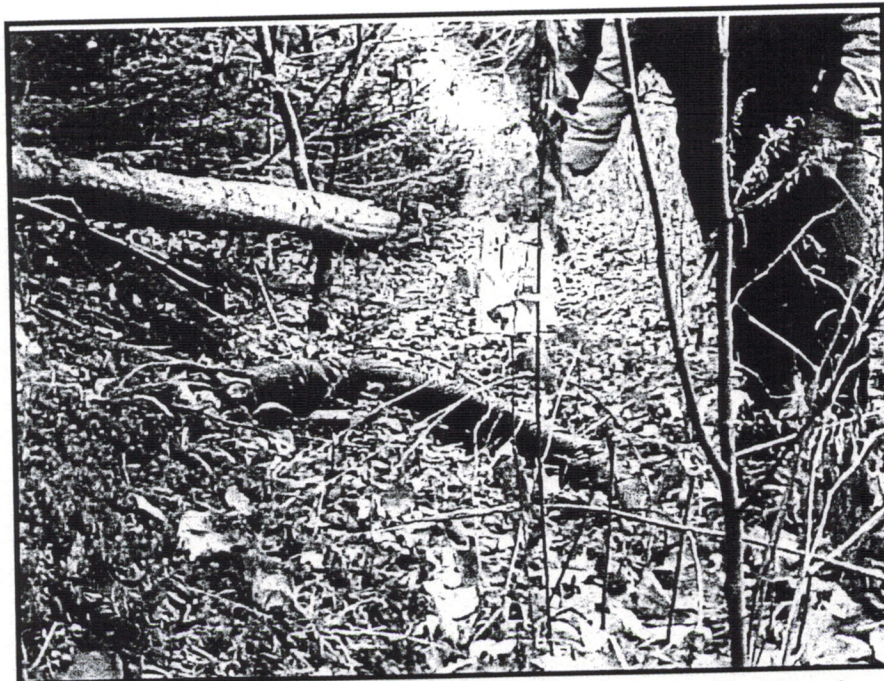
**Figure 14.** Plastic pipe originating from an abandoned field at site 17.

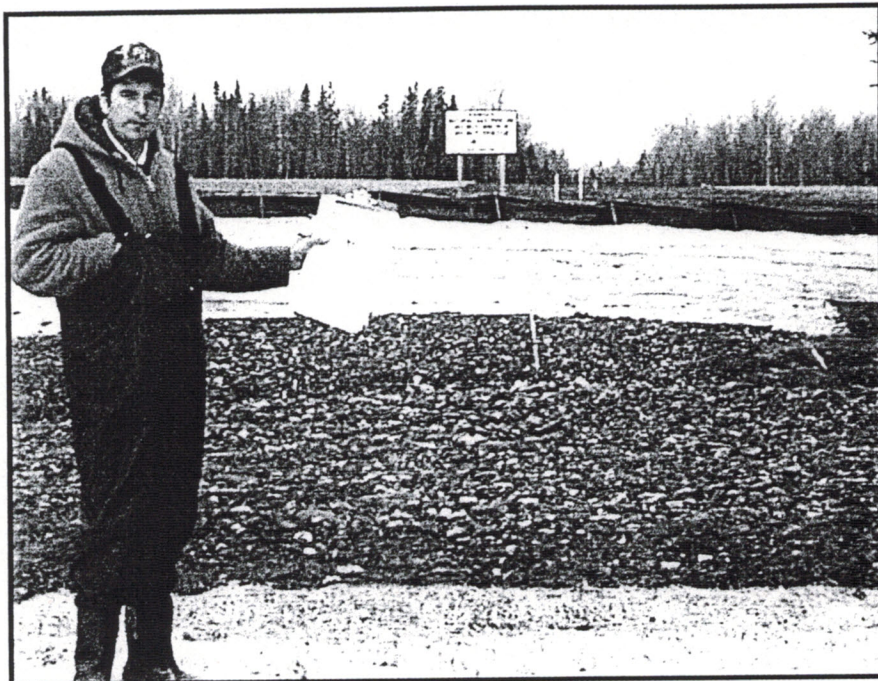
**Figure 15.** Pipeline construction at site 17.1 is leaving portion of land with no vegetation.
