**APPENDIX B**

## Scoudouc River

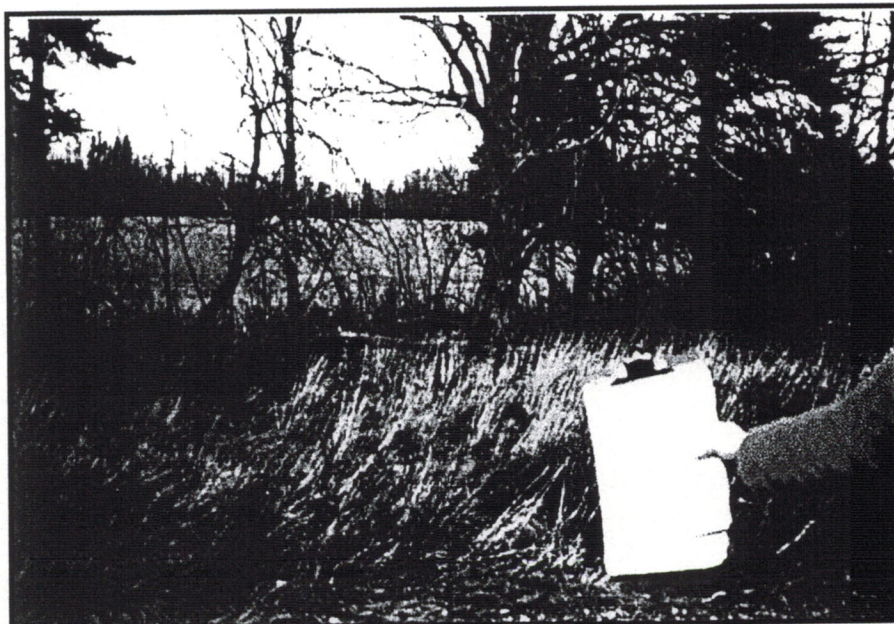
**Figure 16.** A farm field located 5-10 m from river at site 18.

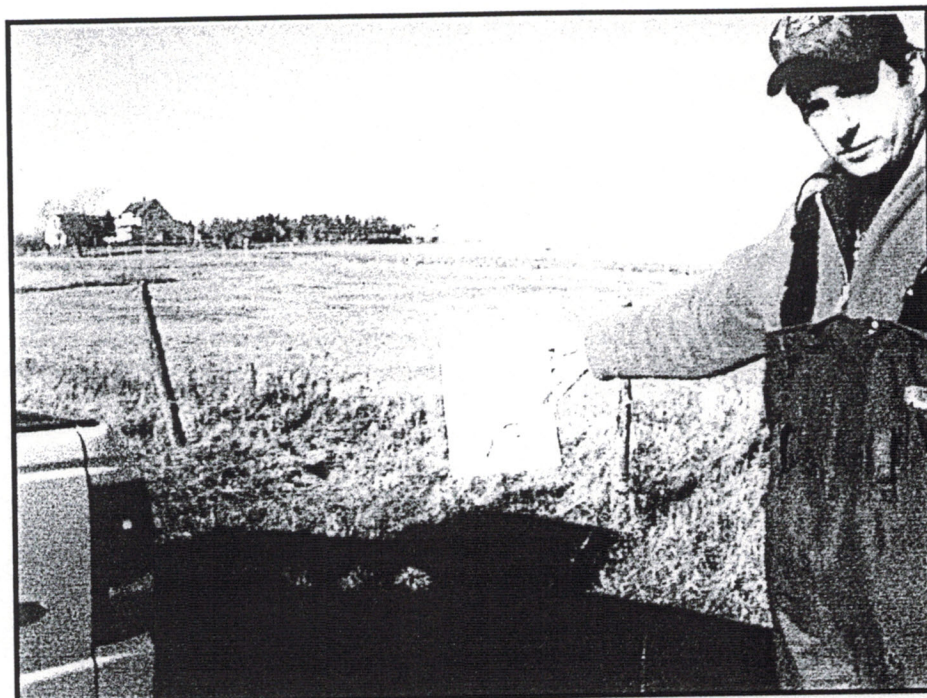
**Figure 17.** Cattle field fenced off at 3 meters from the watercourse at site 23. A small erosion ditch is flowing into river.

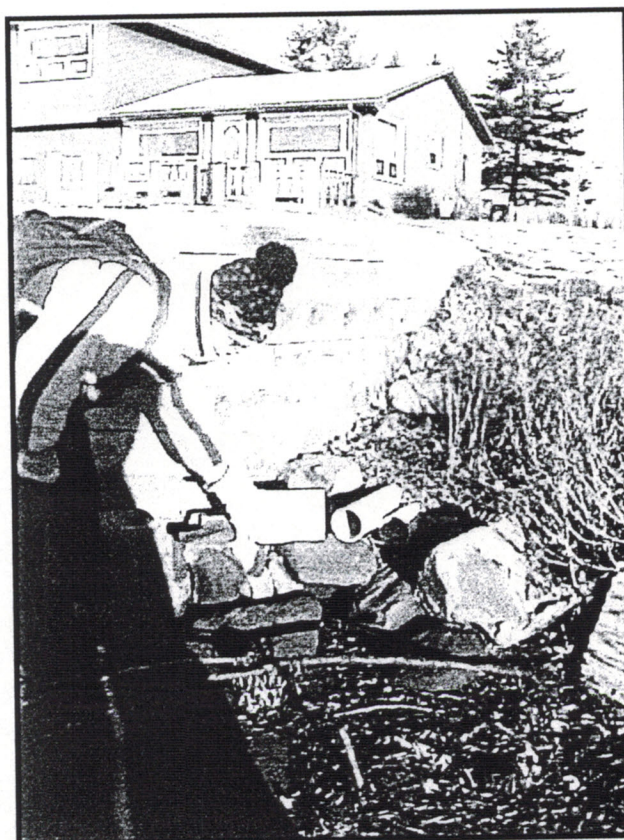
**Figure 18.** Two plastic pipes originating from a brown cottage at site 26.

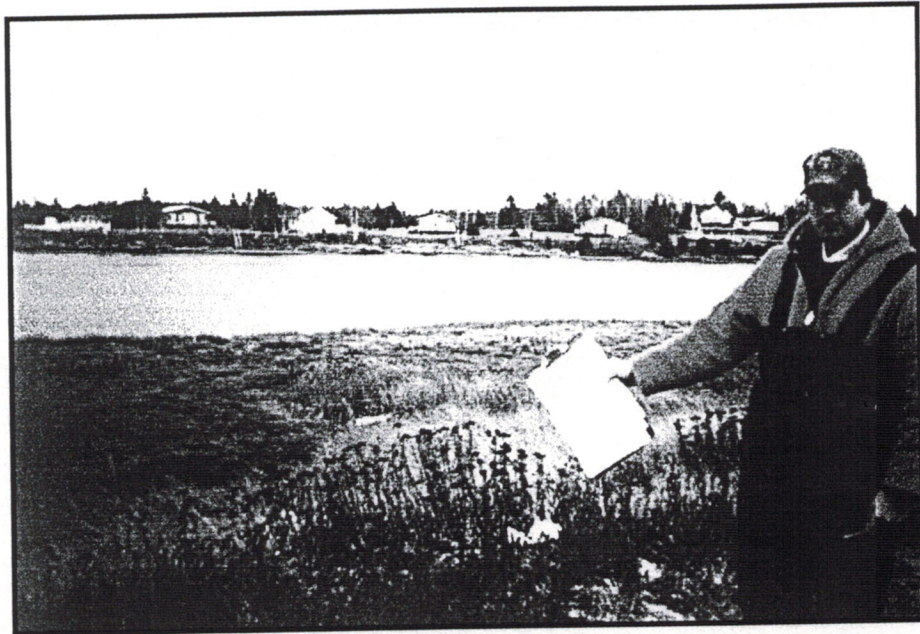
**Figure 19.** Several houses litter the bank of the Shediac river at site 27.

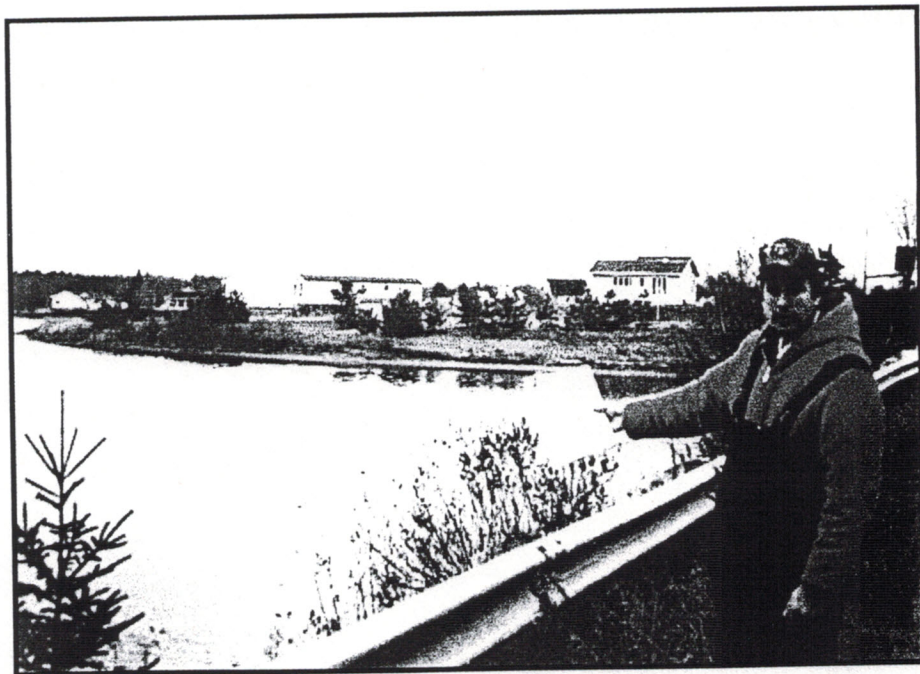
**Figure 20.** A stretch of houses and cottages close to the bank of the river at site 31.

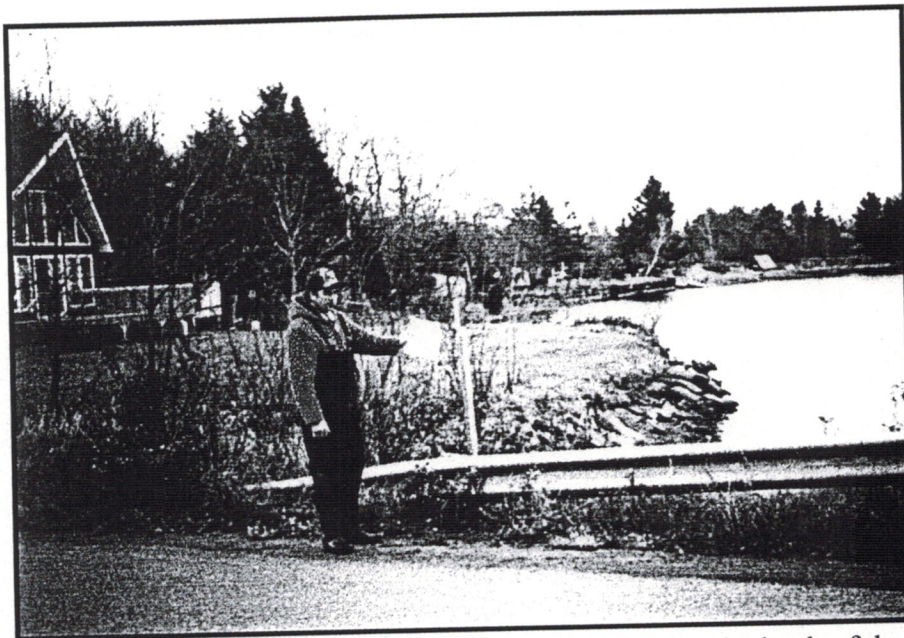
**Figure 21.** Several more houses and cottages close to the bank of the river at site 33.

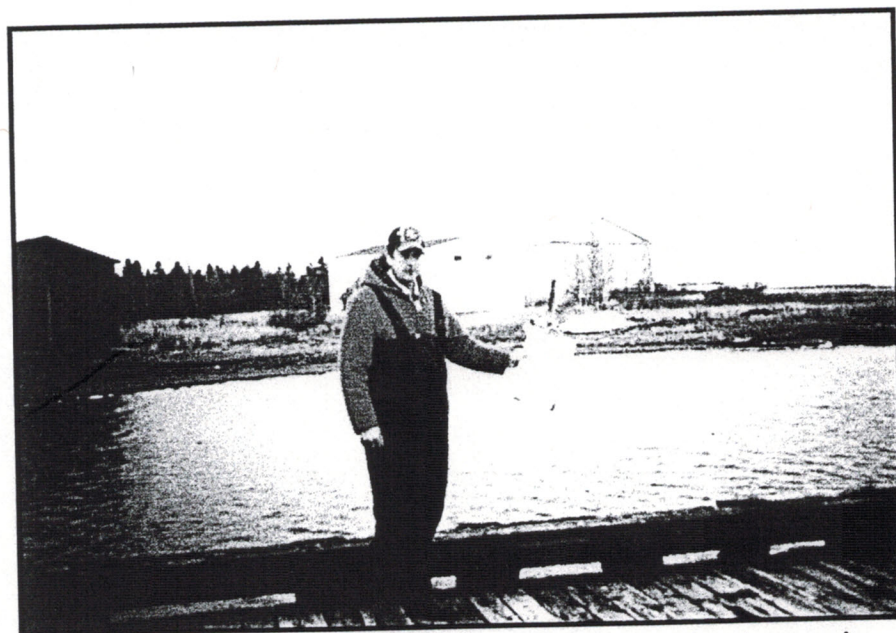
**Figure 22.** A wharf stretching 30 meters alongside the river at site 34.

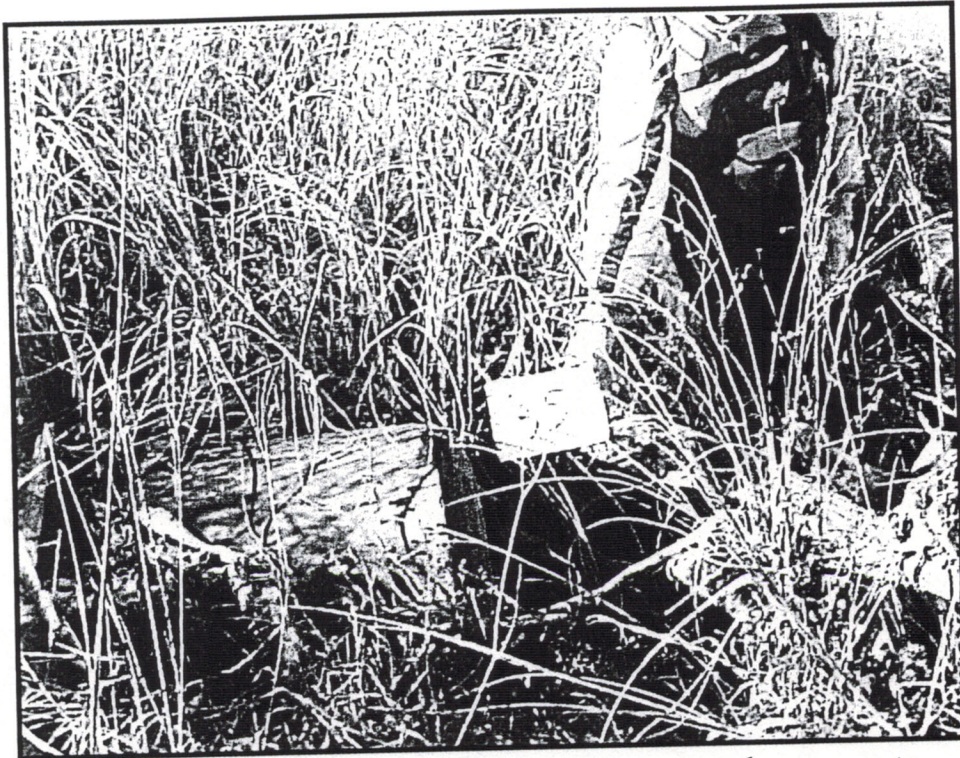
**Figure 23.** Bank stabilized with large boulders near a culvert on route 134 (site 35).

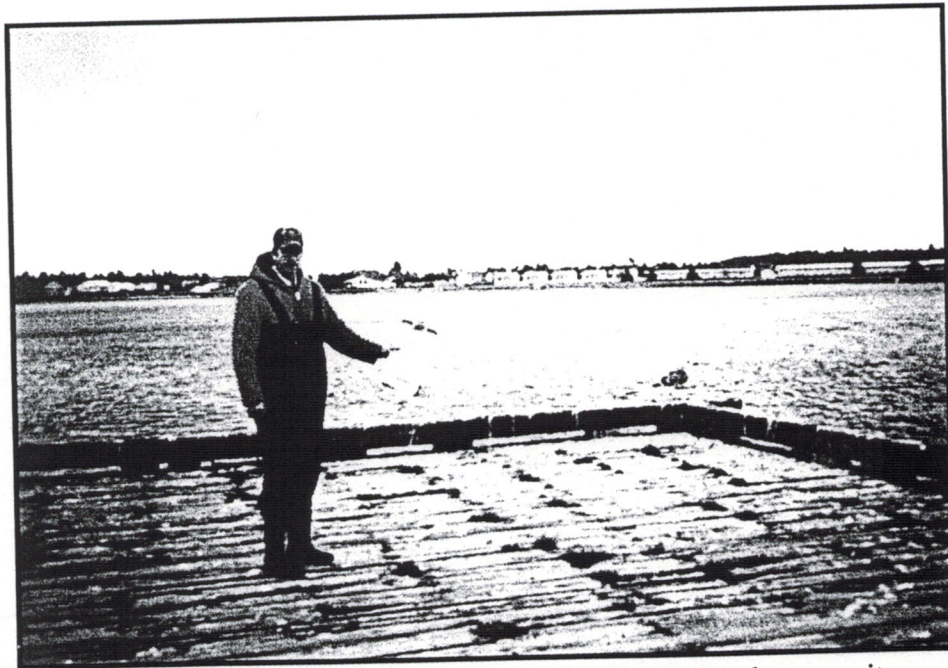
**Figure 24.** Houses and cottages litter the river bank (on the opposite side) at site 36. Banks are stabilized with cement blocks, rocks and wood for a distance of 100 m.

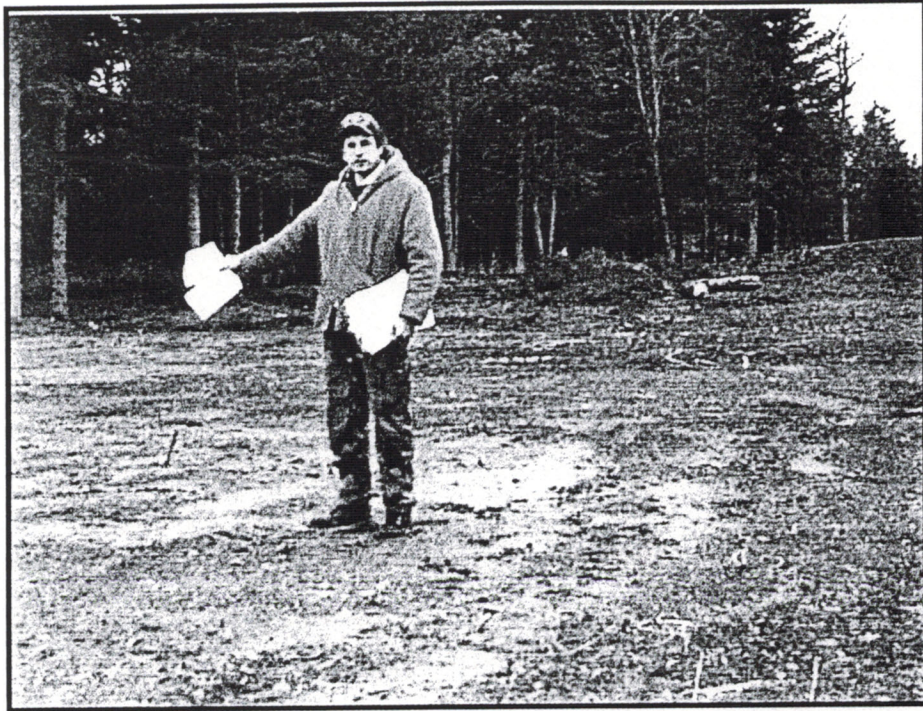
**Figure 25.** Small erosion ditches caused by bulldozing activities at site 39.

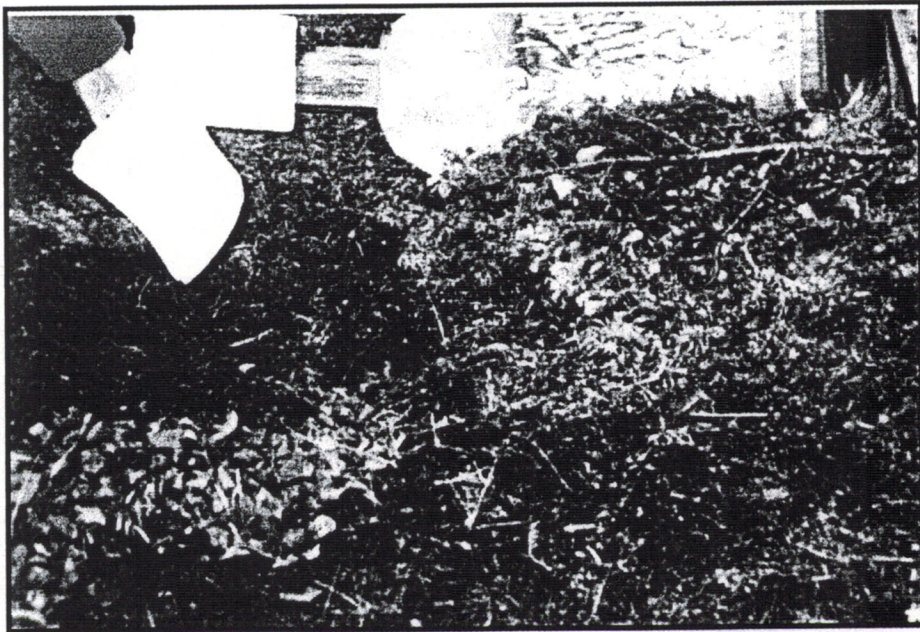
**Figure 26.** Small plastic pipe originating from red cottage at site 42. A portion of the pipe is covered with dirt.

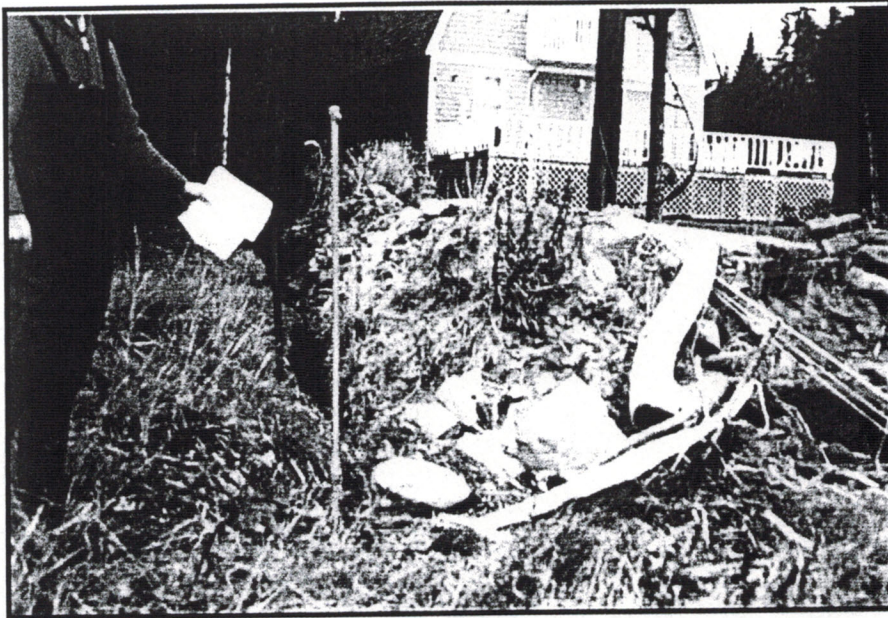
**Figure 27.** A man-made drainage structure in back of a house at site 43. Some erosion was observed.

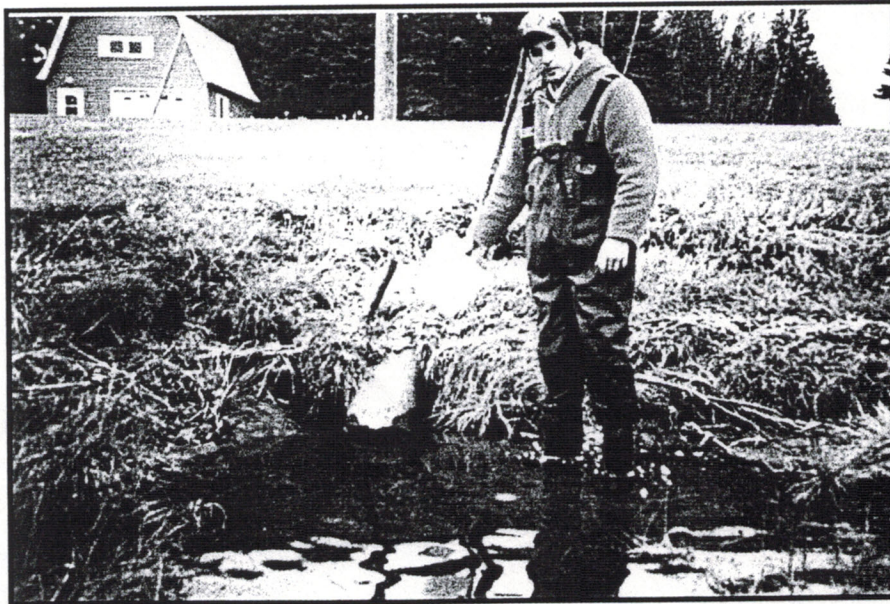
**Figure 28.** A cement culvert originating from a house's driveway ditch at site 44.

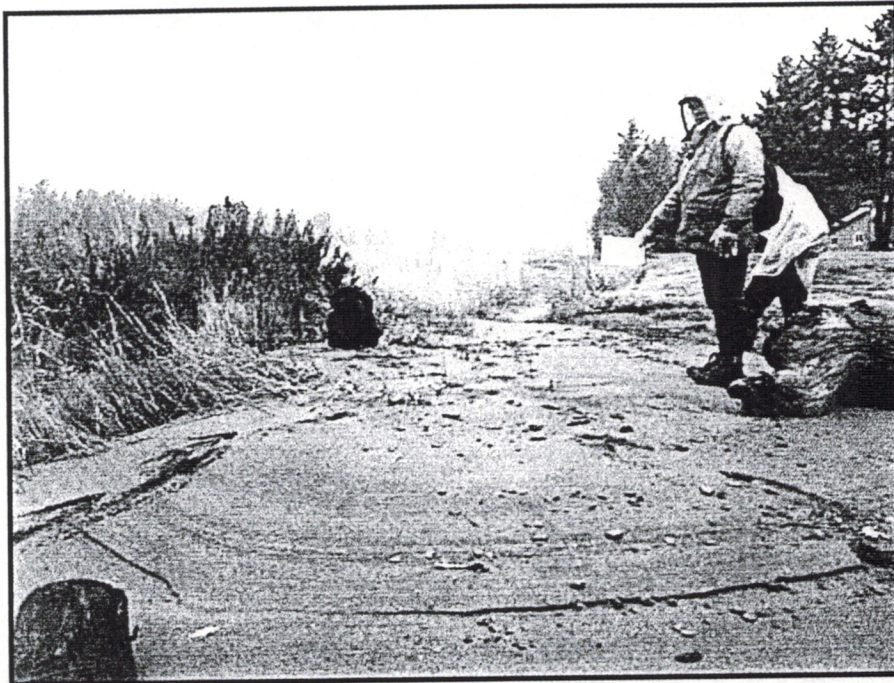
**Figure 29.** Serious sediment loading caused by a series of drainage ditches from a nearby farm at site 45.

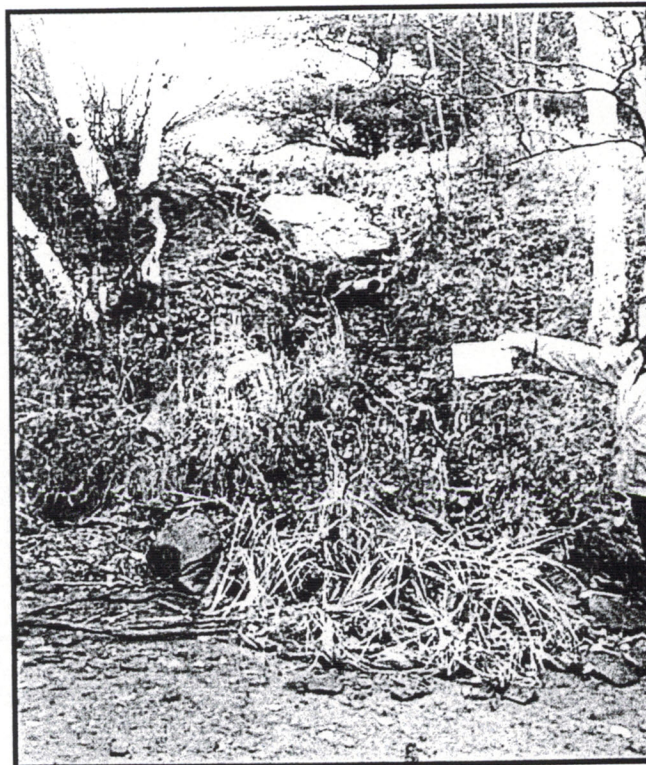
**Figure 30.** Small plastic pipe originating from a beige house at site 46. Water was flowing from pipe.

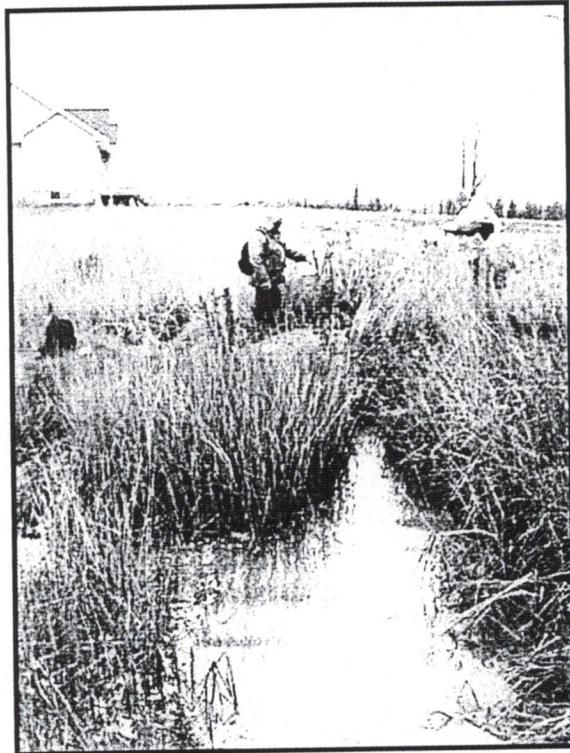
**Figure 31.** Serious sediment loading caused by a ditch leading from a nearby house at site 50.

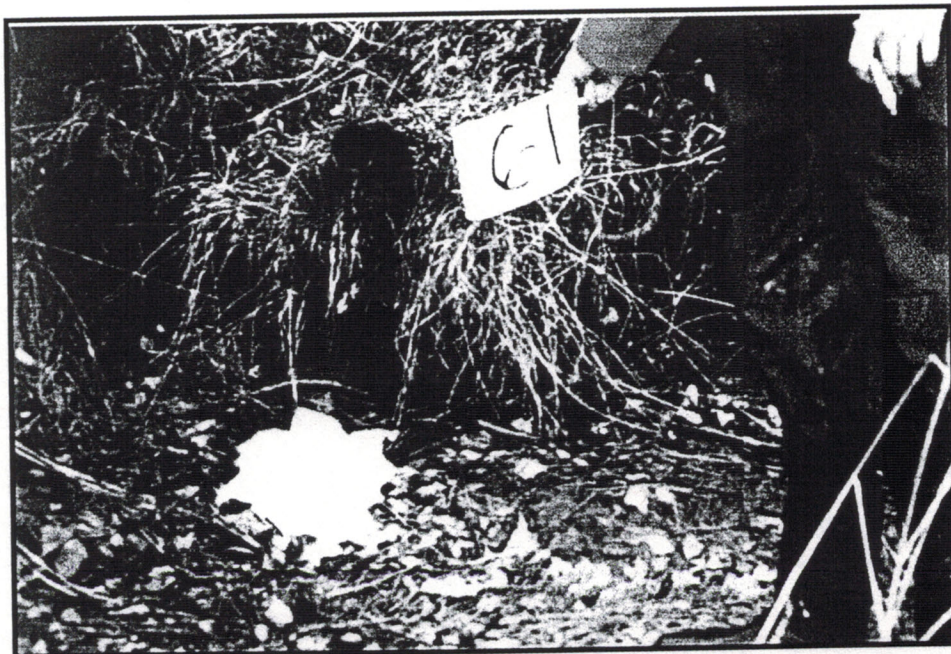
**Figure 32.** Soapy water observed flowing from a small plastic drainage pipe at site 61. The pipe originates from a nearby house.

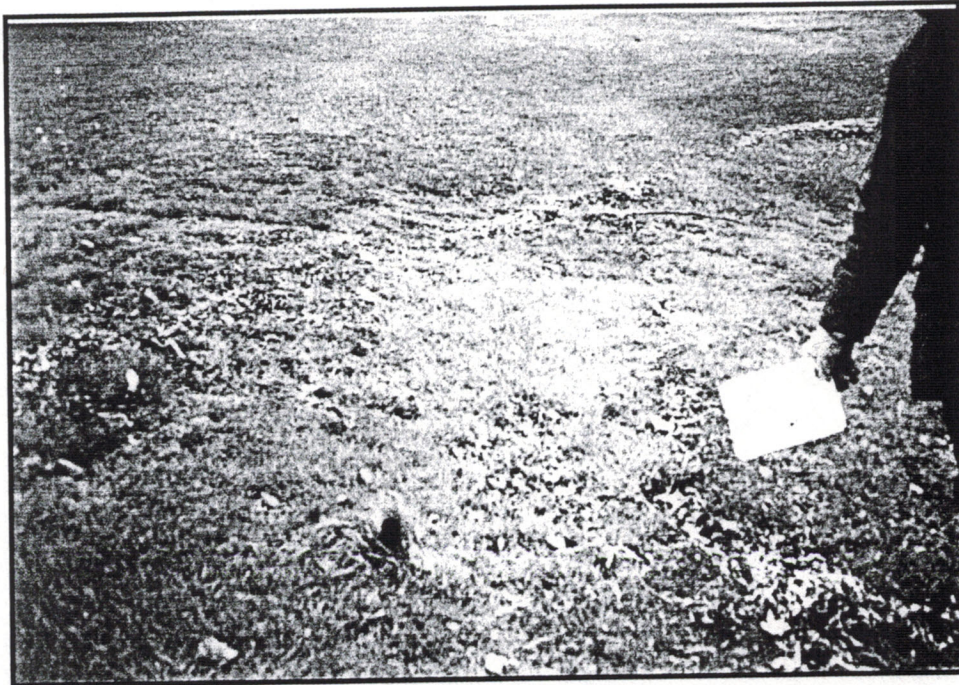
**Figure 33.** Two small plastic drainage pipes originating from behind a house at site 63. A pool is also located behind the house.

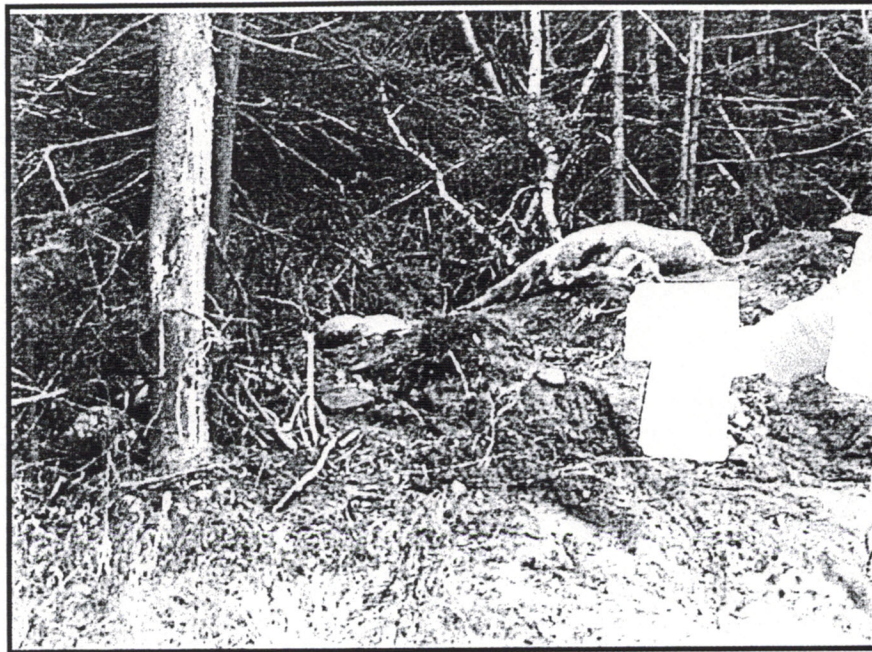
**Figure 1.** Dead hog carcasses litter the bank of Batesman brook at site 3.

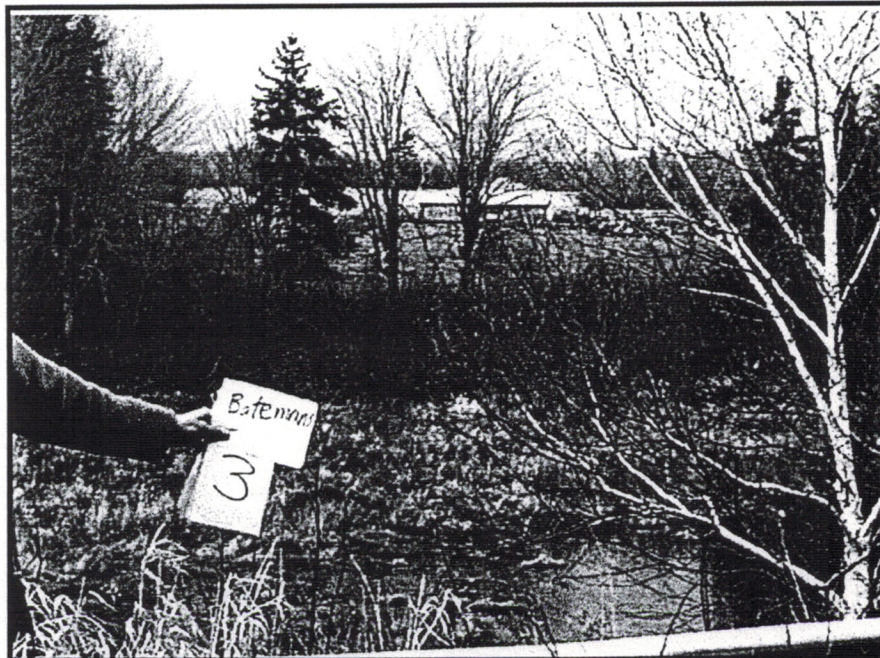
**Figure 2.** Hog and cattle farm approximately 125 meters from Batesman brook at site 3.

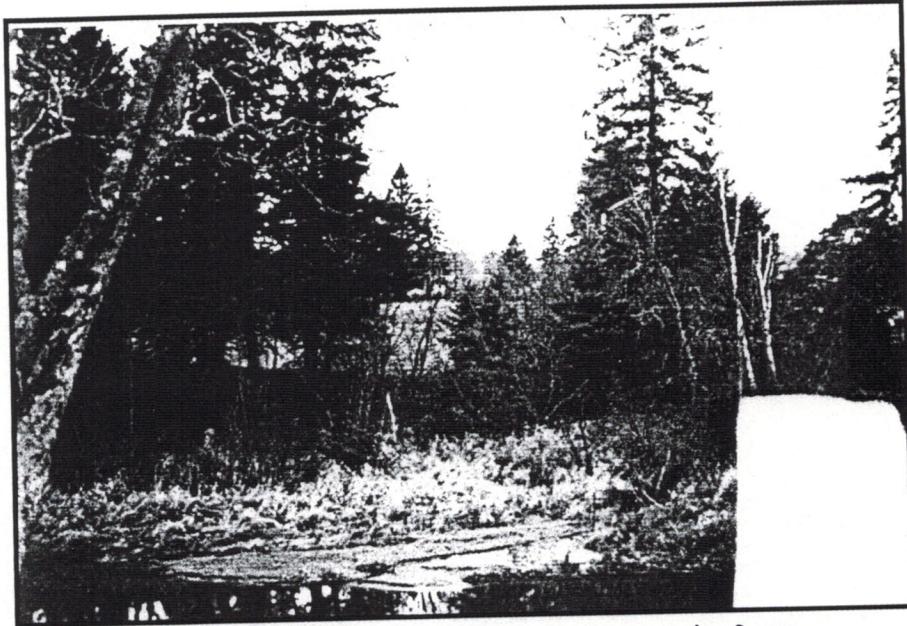
**Figure 3.** Erosion ditch near cattle and hog farm at site 3 on Batesman brook.

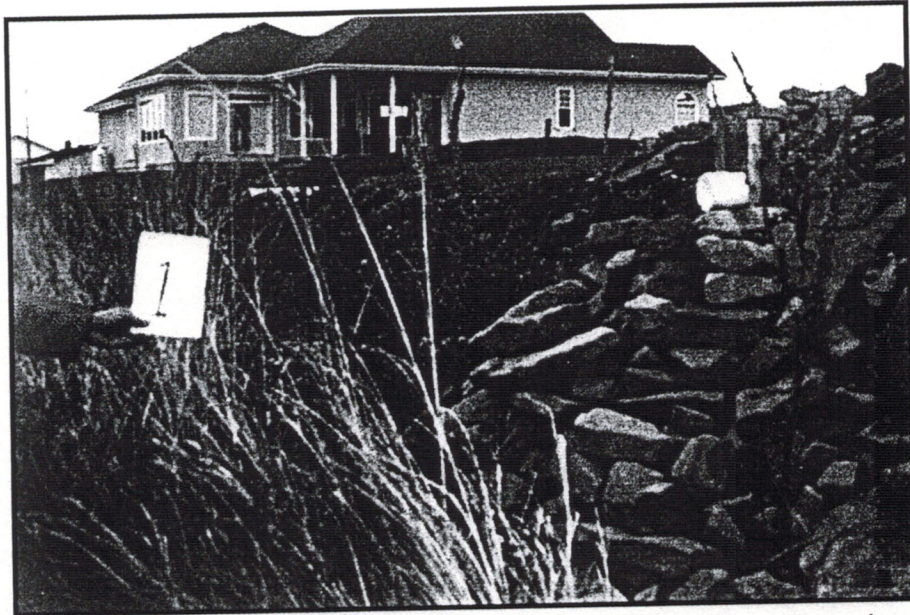
**Figure 1.** Two plastic drainage pipes originating from a house at site 1.

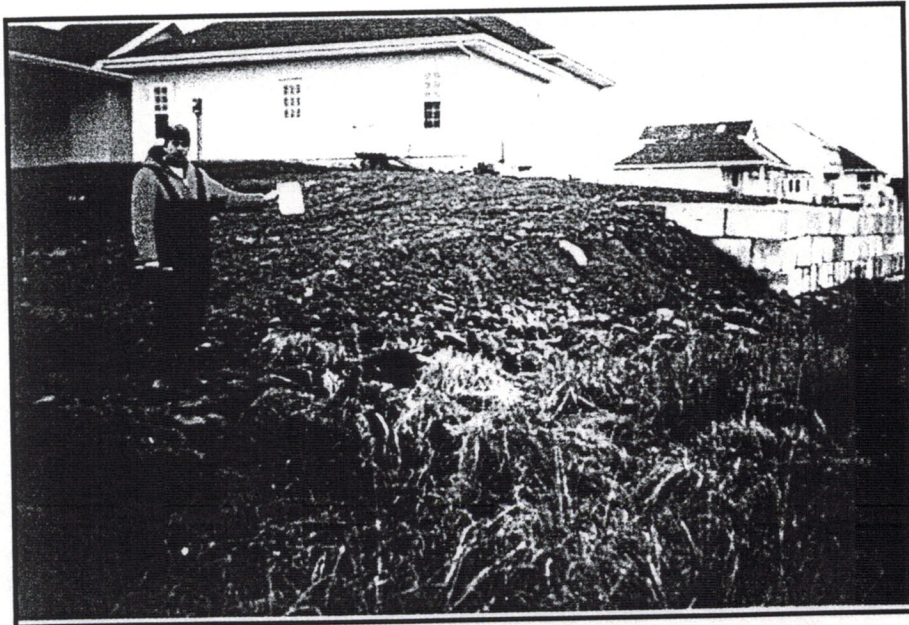
**Figure 2.** Concrete wall in front of house at site 2. There is approximately 30 meters of vegetation between the wall and the brook.

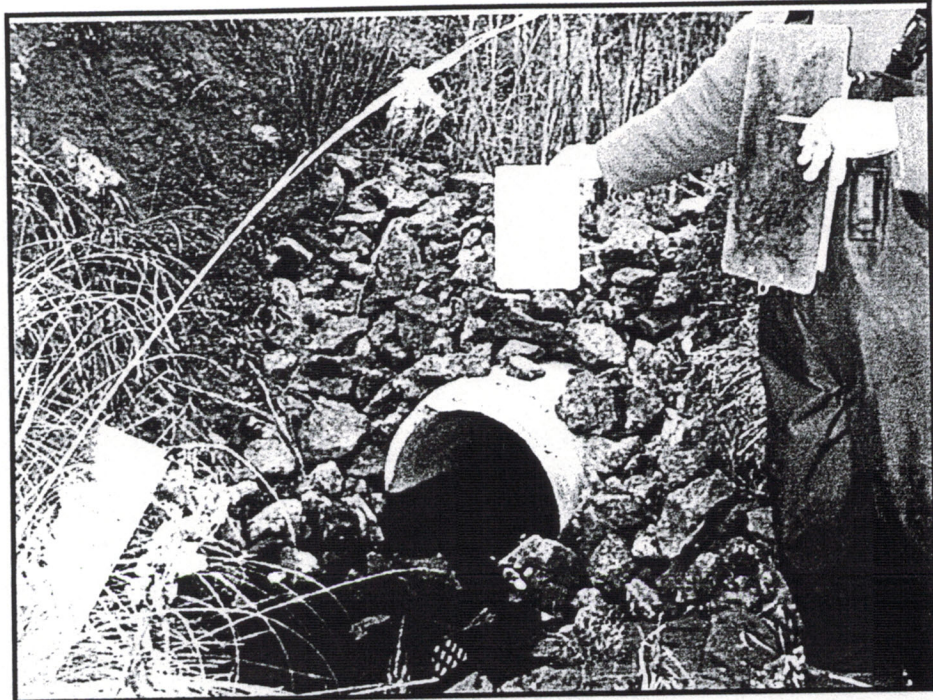
**Figure 3.** Cement culvert originating from Ditch Road at site 3.

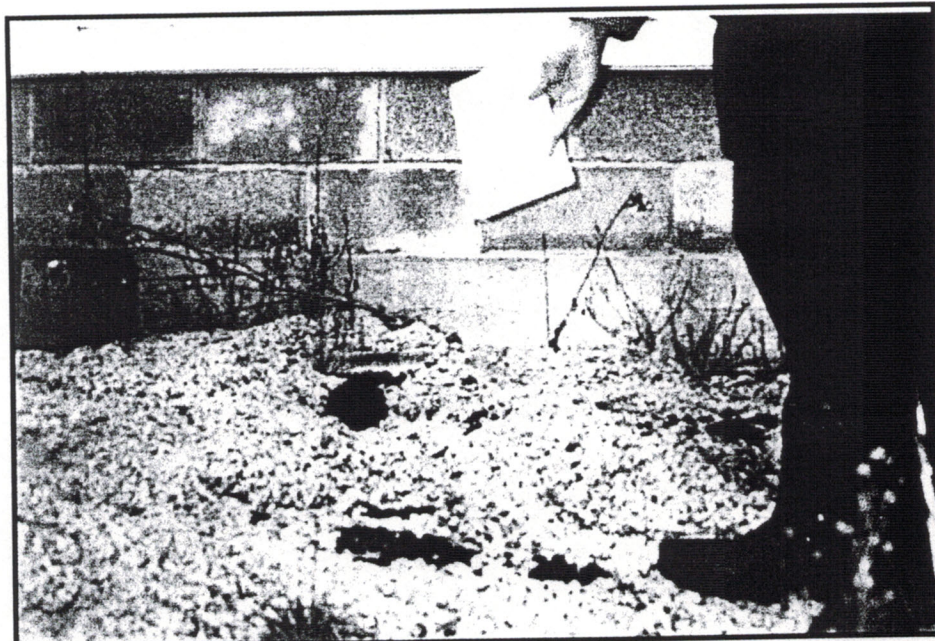
**Figure 4.** Plastic pipe originating from house at site 4.

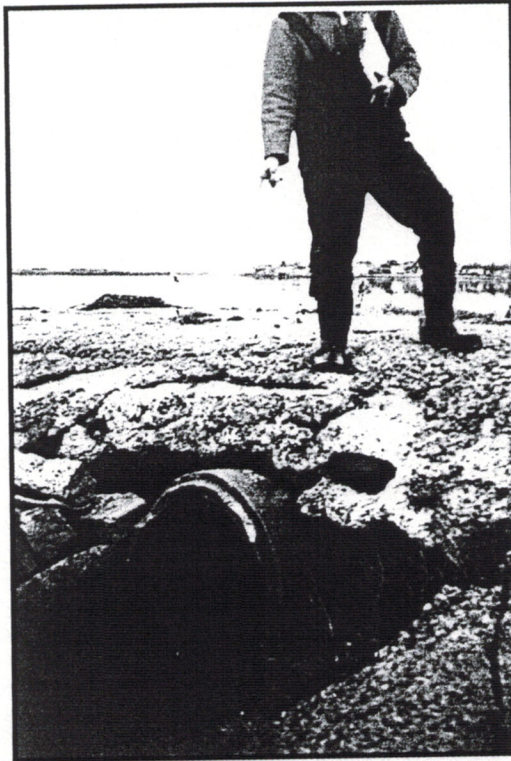
**Figure 5.** Cement culvert crossing Wayne's brook at site 5.

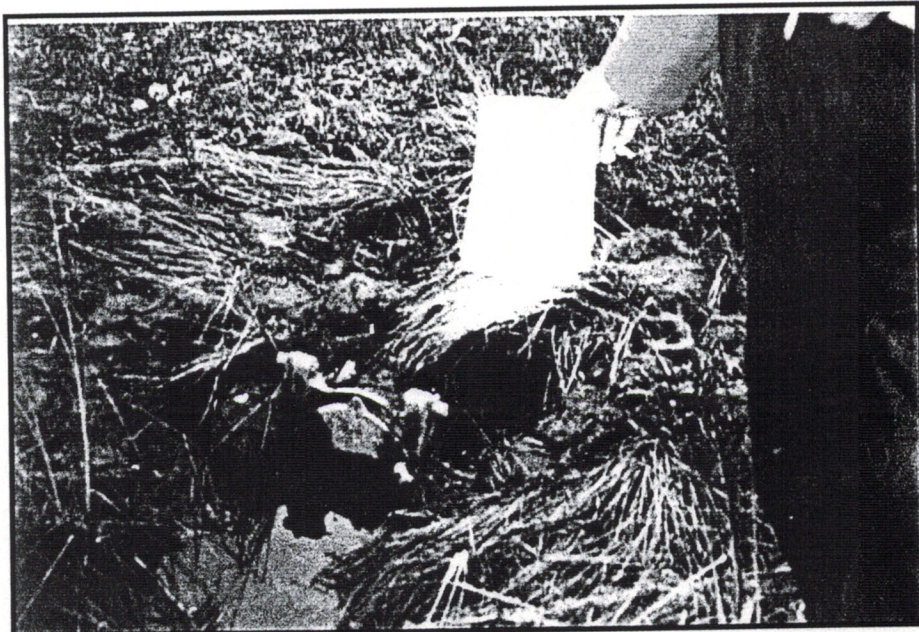
**Figure 6.** Metal storm drainage pipe originating from brick building at site 6.

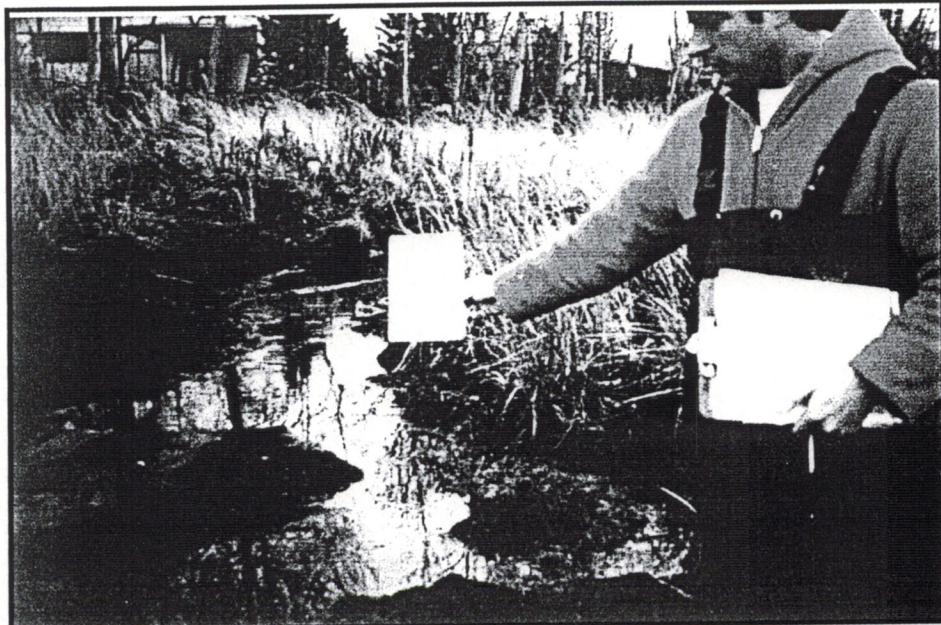
**Figure 7.** Small stream flowing to Shediac Bay.

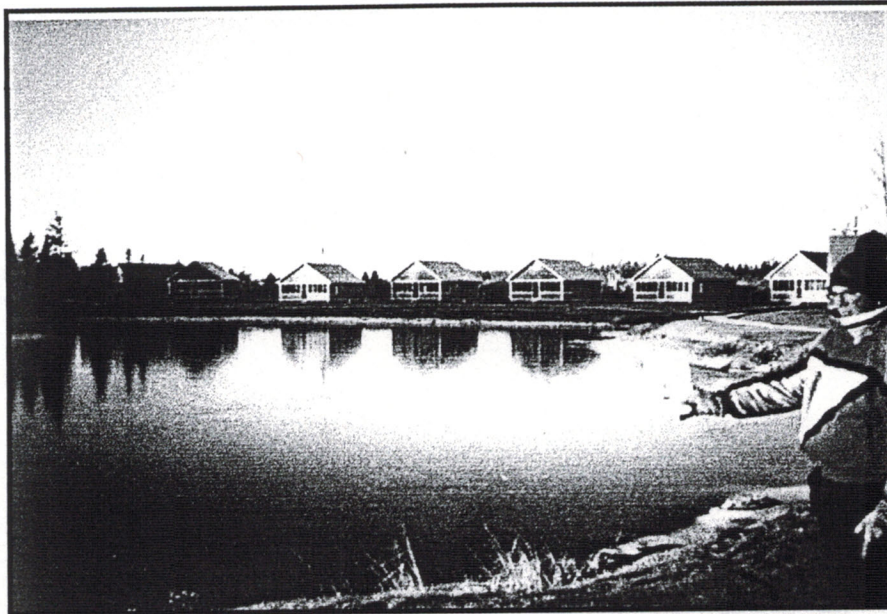
**Figure 1.** A stretch of cottages near the brook at the beginning of site 1.

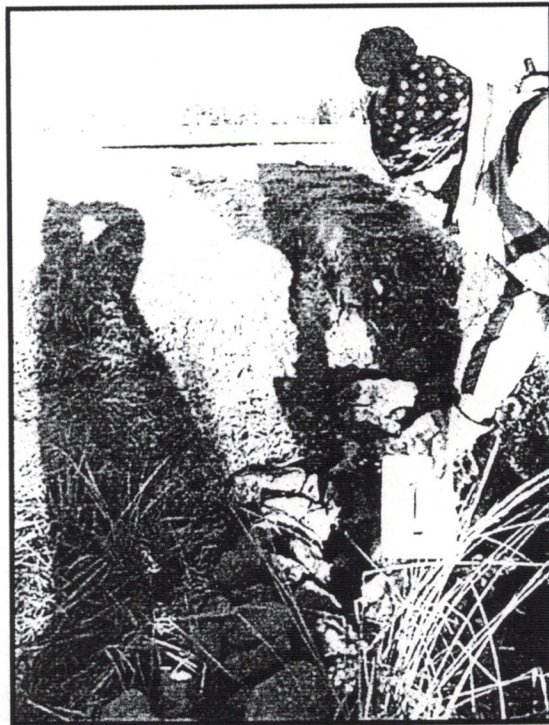
**Figure 2.** Plastic pipe running underneath rocks at the end of site 1.

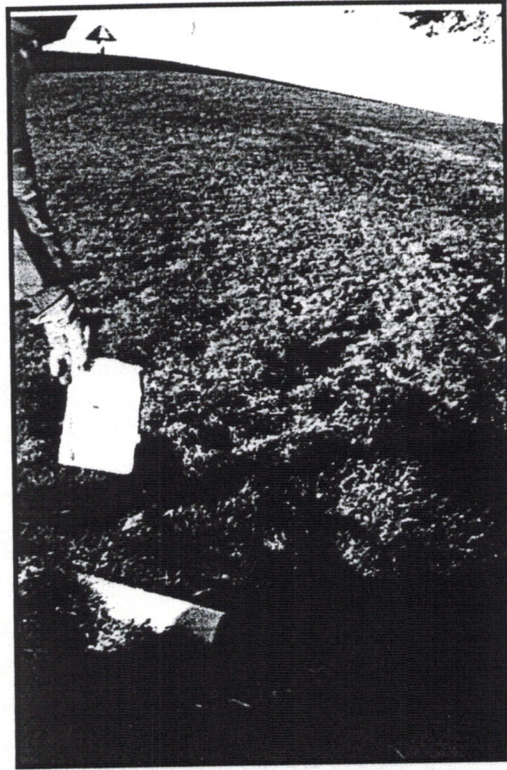
**Figure 3.** Plastic drainage pipe near house at site 3. Water is flowing into a ditch that leads to brook.

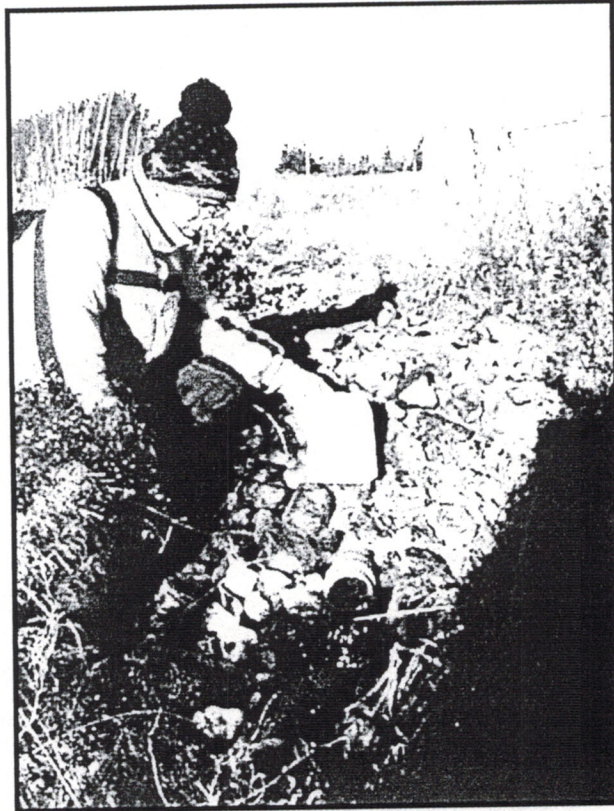
**Figure 5.** Plastic drainage pipe leading into a ditch that flows into the brook (site 5).
