# Riparian Habitat Health and Sedimentation Sources Assessment on the Scoudouc River

**New Brunswick Wildlife Trust Fund**

Dominique Audet, M.Sc. Biology  
Shediac Bay Watershed Association

January 2010

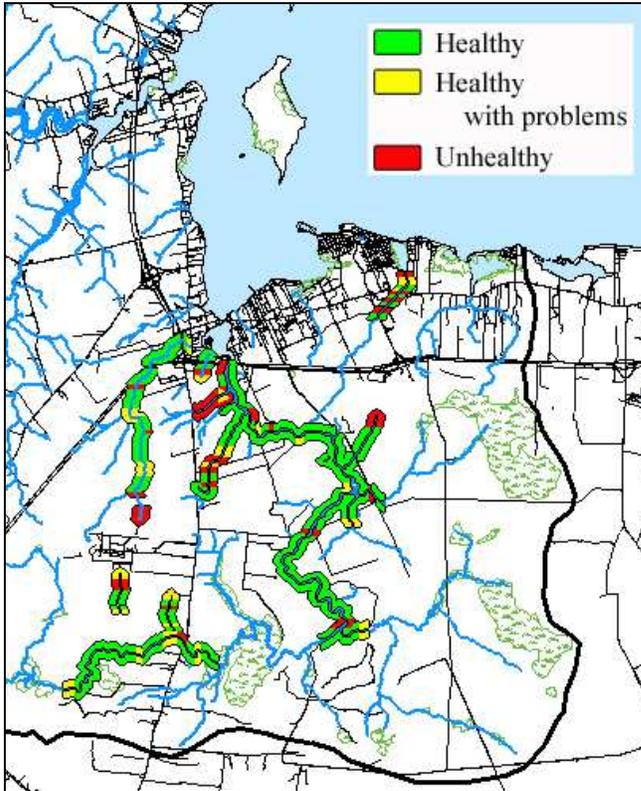
Figure 2. Riparian areas health classification following the 2008 Scoudouc River assessment.

A total of 38.8 km of shoreline and 1.16 km<sup>2</sup> of riparian zones were surveyed, covering the Scoudouc River and its tributaries as well as the Cornwall Brook. A total of 137 stream reaches were surveyed and 274 riparian zones were classified according to their health using the *Riparian Health Assessment tool* (Fig. 2). Results (Table 1) show that most riparian zones (63.5%) were classified as “Healthy” representing a distance of 30.0 km of shoreline. A total of 14.6% of riparian zones were classified as “Healthy with Problems”

and 17.5% of riparian zones were classified as “Unhealthy” covering 3.6 km and 4.7 km of shoreline, respectively.

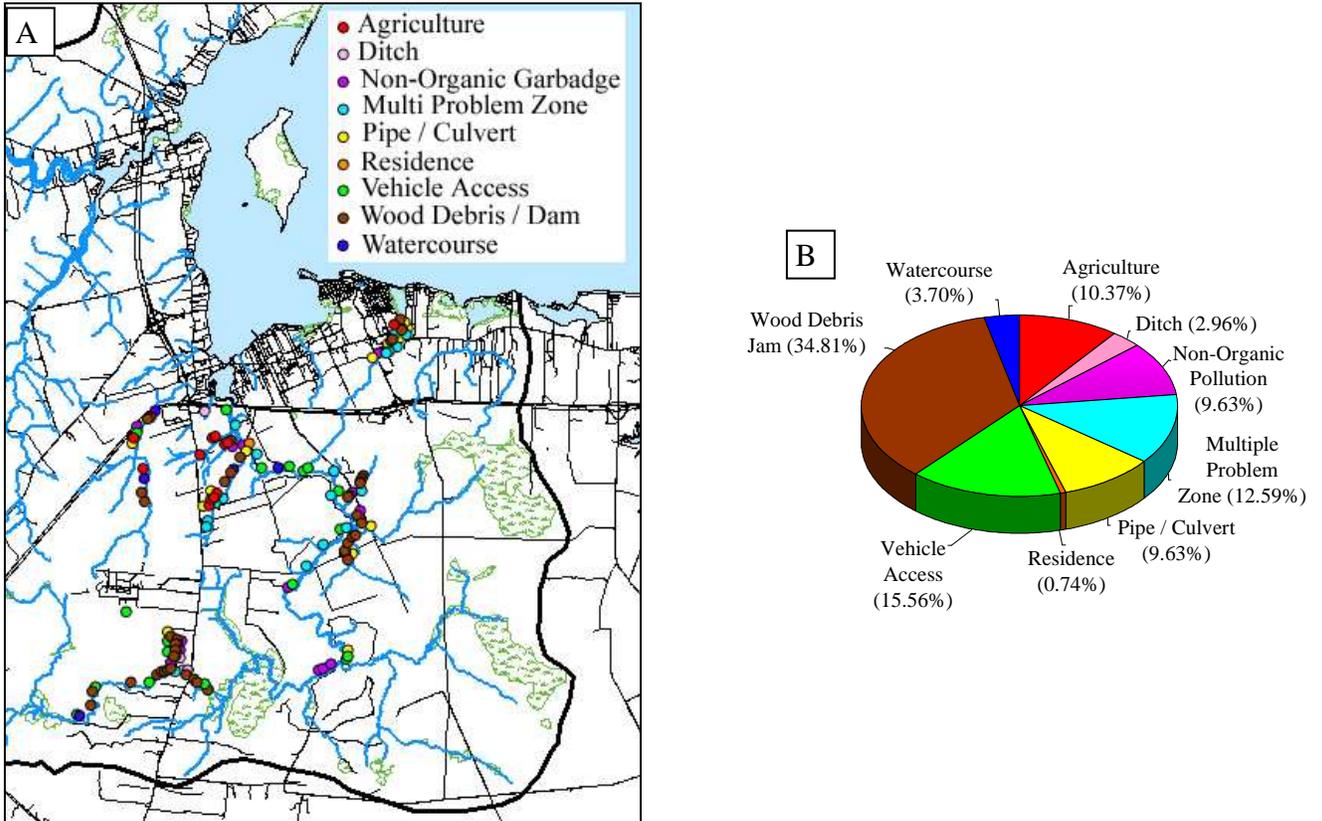
Figure 3. A) Pollution sources location and B) proportion per category as observed during the sanitary survey along the Scoudouc River performed in 2008.

During the Sanitary Survey, a total of 146 pollution and sedimentation sources were identified (Fig. 3). Most stream degradation occurrences were caused by wood debris jams (34.8%) causing stream profile alterations. Other significant problems included trail crossings creating riparian and stream bed damages as well as sedimentation intake.

Agriculture also appeared to be a source of sedimentation and organic pollution mainly in the Scoudouc and Cornwall Brook area. Among those pollution sources, 30 were considered as actual sedimentation sources and 22 could potentially contribute to sedimentation intake in the river.

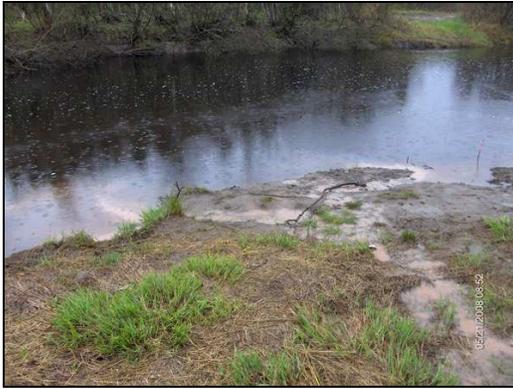
Damaged riparian zone on the Scoudouc River

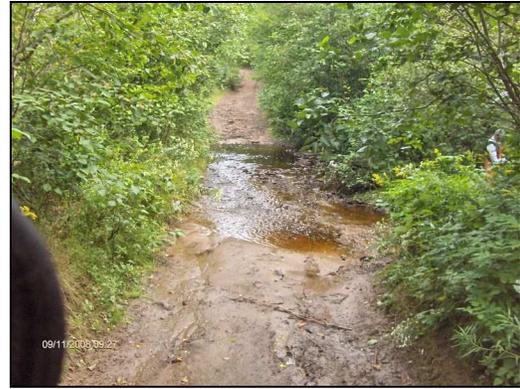
VTT crossing on the Scoudouc River

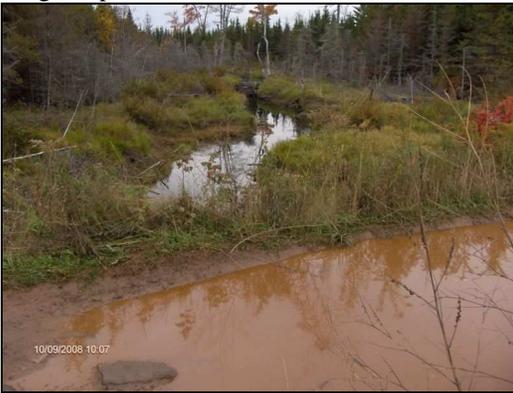
Damaged riparian zone on the Scoudouc River

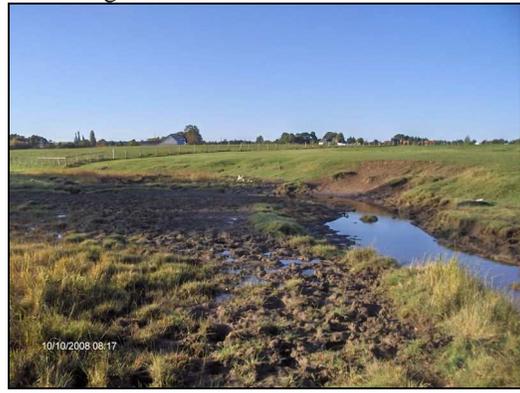
Damaged riparian zone and cattle access the Scoudouc River

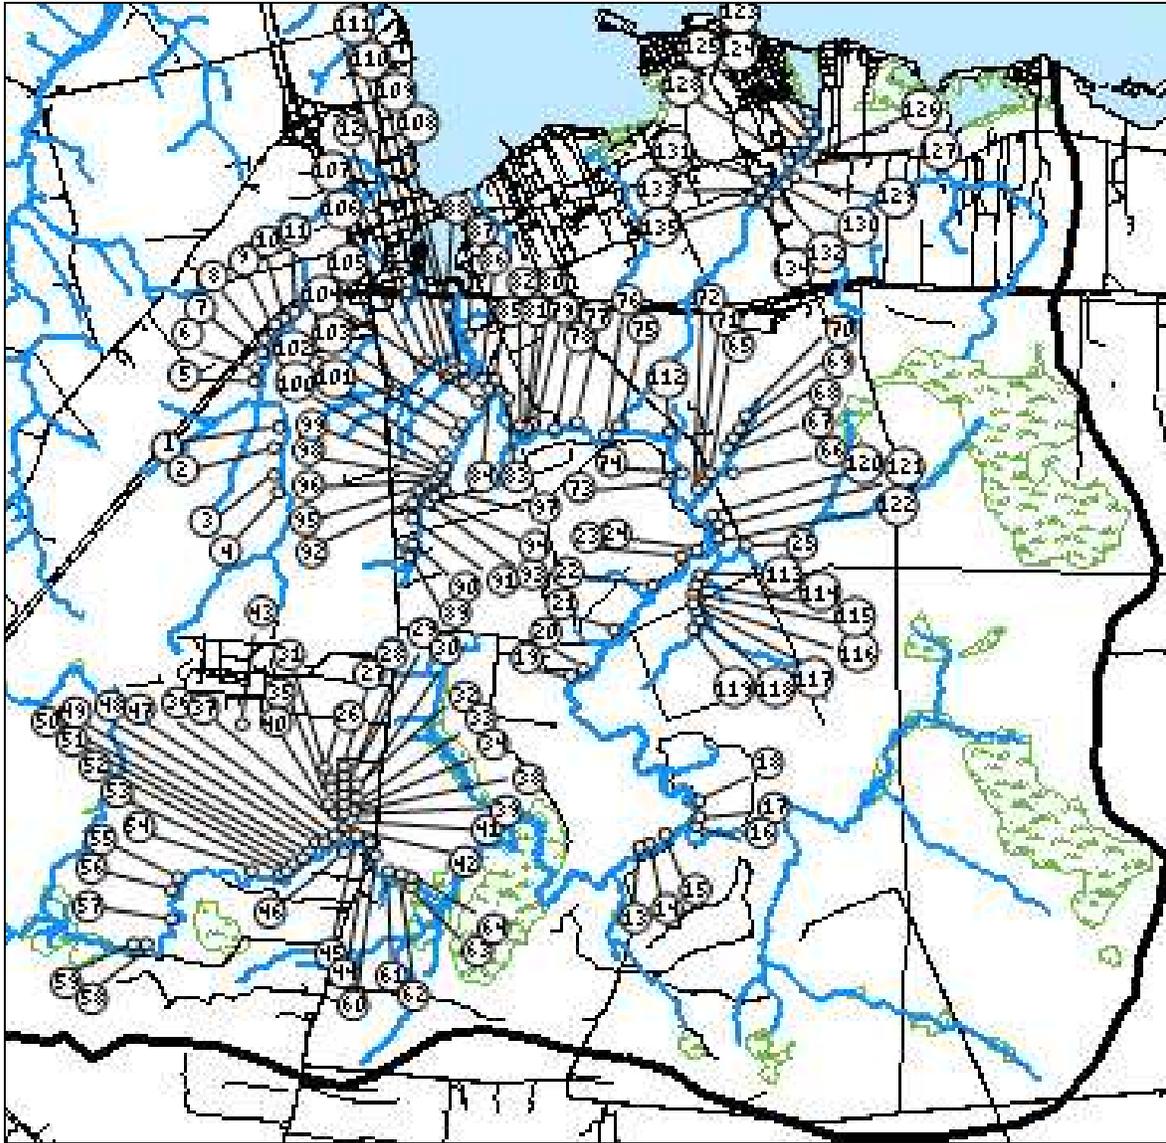
Figure 5. Pollution sources sites observed during the sanitary assessment along the Scoudouc River in 2008.

Point source #	Type	Status	Observation	Northing	Easting
1	AG	D	Cattles have access into the brook. The right bank is eroded and the vegetation is destroyed. The water is brownish due to the sedimentation. Heavy sedimentation in the stream.	46.19436	64.57960
2	WC	P	Man-made dam, looks like an old bridge with wooden structure on both bank sides. Membranes have been added into the stream to build what appears to be a dam (disintegrating structure)	46.19262	64.58012
3	W	P	Wood debris jam. There is sediment accumulation in the stream and in the debris jam. Little erosion on both sides of the bank.	46.18837	64.58018
4	W	P	Wood debris jam. There is sediment accumulation in the stream.	46.18467	64.57911
5	PC	P	A culvert/bridge appears to be too small for the reason that it has created a higher water velocity.	46.28490	64.58366
6	AG	D	Cattles have access to the stream. Both banks are eroded and the vegetation is destroyed. Water is brownish in color due to sedimentation. Heavy sedimentation in stream was observed.	46.20200	64.58247

7	VA	D	Tractor crossing. There is a trail with no riprap; however, rocks were added into the stream creating an elevated bed.	46.20343	64.58205
8	MP	P	Car parts and hay bale were observed in the stream.	46.20465	64.58162
9	W	D	A wood debris jam has created a pool as well as erosion on the right bank.	46.20568	64.57990
10	W	D	Wood debris jam. The debris has created a partial island.	46.20617	64.57882
11	WC	D	There are a lot of animal tracks on the right bank. The right bank is heavily eroded (appears to be natural erosion). It also seems to be a source of sedimentation.	46.20732	64.57730
12	DI	P	Sedimentation loads has been created from the drainage ditch which originates from the farm field.	46.20719	64.56080

13	MP	P	An old run down cabin is located on the right bank.	46.14683	64.51981
14	MP	P	An old dump site with visible scrap metal located on the right bank.	46.14779	64.51743
15	MP	P	An old dump with visible metal cans, bottles, etc.	46.14850	64.51588
16	VA	P	A small campsite with an ATV trail access on the left side of the bank.	46.14872	64.51305
17	VA	D	An ATV trail passes through the brook. Both banks are eroded and sedimentation is present. There is no Buffer zone.	46.14958	64.51353
18	PC	P	An old culvert washed out in brook.	46.15042	64.51321
19	MP	P	An old run down cabin located on the right bank.	46.16670	64.53049
20	VA	P	An ATV trail on the left bank. About 10m of buffer strip has been eroded.	46.16707	64.52950
21	MZ	D	Pipeline and ATV trails are crossing the river. There is a riprap on the left bank and erosion on the right bank.	46.17249	64.52401
		D	A pipeline crossing the river. The buffer zone has been altered on both sides (decreased in size).	46.17249	64.52401

22	MZ	D	A road is passing through the tributary as a result, sedimentation flows into the Scoudouc River. This would be a good place for a restoration.	46.17580	64.52013
		D	A road is passing though the tributary as a result, sedimentation flows into the Scoudouc River. This would be a good place for a restoration.	46.17580	64.52013
23	VA	D	A dirt road is next to the river. The road is eroded and sedimentation flows directly into the river.	46.18041	64.51428
24	MZ	D	An ATV trail is next to the river. Visible garbage near the river and sedimentation flows into river. This would be a good place for a restoration.	46.18054	64.51208
		D	An ATV trail follows the river to a camping site. The riparian zone is on the left side which is severely eroded. This would be a good place for a restoration.	46.18054	64.51208
25	PC	D	The water crosses the culvert. Both sides of the	46.18084	64.50461

banks are eroded (downstream of the culvert).		
26	PC	D	The culvert appears to be too small for the reason that it has created a higher water velocity at outflow.	46.15694	64.57251
27	W	D	A wood debris jam as well as heavy alder population is trapping the sedimentation. This would be a good place for a restoration.	46.15491	64.57197
28	W	D	A wood debris jam is trapping the sediments. This would be a good place for a restoration.	46.15463	64.57185
29	W	D	A wood debris jam is trapping the sediments. There is a sediment accumulation in the stream. This would be a good place for a restoration.	46.15424	64.57129
30	MP	P	An old dump site with visible scrap metals, cans, bottles, etc.	46.15422	64.57108
31	VA	D	There is a small bridge for an ATV access in the trail. Visible broken vehicle parts in the brook. The sediments flow into the stream.	46.15394	64.57063
32	W	D	A few logs in the brook are blocking the water velocity.	46.15358	64.57056

33	MP	P	An old dump site with visible cans, bottles, scrap metal, etc	46.15335	64.57054
34	W	D	A wood debris jam as well as heavy alder population in the brook is trapping the sediments.	46.15313	64.57072
35	VA	D	A dirt road crosses a bridge. There is a drainage ditch on both sides of the road. A clear cut lot is located at 20m from brook. There could be a severe sedimentation problem when there is heavy rain.	46.15280	64.57085
36	W	D	There is a wood debris jam in the brook trapping the sediments. There is a sediment accumulation in the stream. This would be a good place for a restoration.	46.15211	64.57079
37	W	D	There is a sediment accumulation in the brook due to the wood debris jam. This would be a good place for a restoration.	46.15199	64.57095
38	W	D	An old bridge with broken parts is blocking the water velocity.	46.15020	64.57051

39	W	D	Sedimentation is being trapped in the wood debris jam. There is a sediment accumulation in the stream. This would be a good place for a restoration.	46.14997	64.57054
40	DI	D	A ditch from an old excavating site flows directly into the brook. There could be a sedimentation problem when there is heavy rain.	46.14920	64.57053
41	W	D	A wood debris jam as well as a heavy alder population in the brook is trapping the sediments. This would be a good place for a restoration.	46.14879	64.57051
42	W	D	An old double culvert bridge. There are sediments accumulating from the dirt road when there is heavy rain.	46.14869	64.57035
43	VA	D	There is a small bridge for an ATV in the trail. This would contribute to a sedimentation problem when there is heavy rain.	46.16019	64.58464
44	DI	D	Beside of the road, there is a run-off from the drain that flows directly into river. This would contribute to a sedimentation problem when there is heavy rain.	46.14530	46.56470

45	DI	D	Beside of the road, there is a run-off from the drain that flows directly into river. This would contribute to a sedimentation problem when there is heavy rain.	46.14671	64.56597
46	W	D	There is a beaver dam that flooded both banks.	46.14707	64.56996
	W	D	There is a small animal access leading into the river. The buffer strip is damage on the right side.	46.14707	64.56996
47	MP	P	An old dump site with visible plastics, cans, etc.	46.14663	64.57081
48	W	P	A fallen tree in the river traps the debris.	46.14643	64.57161
49	W	P	A fallen tree in the river traps the debris.	46.14610	64.57206
50	W	P	A fallen tree in the river traps the debris.	46.14582	64.57244
51	W	D	An old beaver dam flooded both sides of the river.	46.14550	64.57404
52	W	D	A 20m old beaver dam is trapping wood debris.	46.14501	64.57551
53	VA	P	There is a camping site near the ATV trail. The left	46.14352	64.57742

bank is eroded. There is no buffer strip.		
54	W	D	A fallen tree in the river is blocking the water flow as well as trapping sediments.	46.14335	64.58385
55	VA	D	An ATV trail passes through the river. Both sides of bank are eroded. Sedimentation is present.	46.14332	64.59439
56	W	D	A fallen tree in the river is trapping wood debris. There is erosion on both sides of the river.	46.13795	64.59634
57	W	D	A wood debris jam is trapping sediments. There is a sediment accumulation in the stream. Both banks are eroded.	46.13665	64.59649
58	WC	D	There is a man-made dam where the banks are flooded. This slows the water velocity as well as trapping debris and sediments.	46.13438	64.59888
59	VA	D	An ATV trail passes through the river. Both banks are eroded and there is sedimentation in the stream.	46.13464	64.59962
60	W	P	Fisher bridge.	46.14530	64.56462
61	W	D	A fallen tree acts as natural dam. It has created a pool.	46.14367	64.56319

62	W	D	There is wood debris in the stream and trapping the sediments.	46.14279	64.56136
63	VA	P	Power line crossing. There is minimal buffer strip.	46.14388	64.55851
64	W	P	A beaver dam has created a pool which has slowed the water velocity.	46.14278	64.55663
65	MP	P	Visible polystyrene foam and logs are next to the brook. A dead porcupine was observed in the culvert.	46.18891	64.51030
66	MZ	D	An old dump site with mattresses and wooden materials on the left side of bank.	46.18907	64.51017
		D	The culvert has created a pool and a fragmentation of the fish habitat (the culvert is too high).	46.18907	64.51017
		D	Same culvert as previous (upstream) is blocked by debris which has created a large pool as a result it has slowed the water velocity.	46.18907	64.51017

67	W	D	A wood debris jam is trapping the sediments. This would contribute to a sedimentation problem when there is heavy rain.	46.19086	64.50840
68	W	D	Alders are trapping debris as well as sediments. There is a sediment accumulation in the stream.	46.19127	64.50812
69	W	D	A beaver dam has created a pool as a result, it has flooded both banks.	46.19169	64.50758
70	W	D	Two beaver dams and one hut have severely flooded both banks.	46.19222	64.50735
71	W	D	Fallen trees as well as wood debris have created a barrier. Both banks are eroded. There is a sediment accumulation in the stream.	46.18803	64.51118
72	W	D	Wood debris accumulation has created a barrier.	46.18758	64.51162
73	VA	P	There is an old trail at the end of the river. There is a possible source of sedimentation.	46.19031	64.51630
74	MZ	P	An old cemented culvert slowed the water velocity. There is a dirt road next to the river. There is a potential sedimentation problem that flows into the river when there is heavy rain.	46.18916	64.51810

D	An ATV trail passes through the river. There is no buffer strip.	46.18916	64.51810
75	VA	D	An ATV trail passes through the river. Both banks are eroded. There is a potential source of sedimentation.	46.19445	64.52506
76	VA	D	An ATV trail passes through the river. Both banks are eroded. There is a potential source of sedimentation.	46.19398	64.52656
77	VA	D	An ATV trail has eroded the left side of the bank. There is a visible camping site. This could contribute to a sedimentation problem when there is heavy rain.	46.19419	64.53149
78	WC	P	An old excavating site found in a small tributary. There is a potential source of sedimentation.	46.19518	64.53499
79	VA	P	There is a road that leads to a camping site near the river. There is a potential source of sedimentation.	46.19429	64.53598

80	VA	D	Found an old excavating site. This site could be used for recreational purposes or camping. There is no buffer strip.	46.19407	64.53716
81	VA	D	An ATV trail is leading to a camping area. The right bank is eroded. There is a potential source of sedimentation.	46.19333	64.54077
82	VA	D	A road is leading to an old excavating site. There is no buffer strip. There is a potential source of sedimentation.	46.19529	64.53429
83	MZ	D	A culvert is used for precipitation run-offs.	46.19865	64.54426
		D	There is a residential clear cut. The right bank is eroded. There is no buffer strip.	46.19865	64.54426
84	PC	D	There is a broken culvert. It is used for precipitation run-offs. The bank is collapsed. There is a potential source of sedimentation as well as contamination.	46.19988	64.54604
85	R	P	A residential clear cut. The right bank is eroded. There is a small wharf.	46.20016	64.54787
86	MP	D	There are columns from an old railway bridge.	46.20049	64.54853

87	MZ	D	An agricultural field next to the river (is on the left bank). There is minimal buffer strip. There is a potential source of sedimentation when there is heavy rain.	46.20510	64.55101
		P	The right bank is eroded near residential area.	46.20510	64.55101
88	VA	D	There are two bridges passing through the river. There is a riprap present. There is a run-off from the HWY-15 that flows directly into river	46.20914	64.55184
89	MZ	D	Cattles are having access to the stream. Both banks are eroded and the vegetation is destroyed. The water is brownish in color due to the sedimentation. There is heavy sedimentation in the stream.	46.17792 to 46.19042	64.55956 to 64.55795
		D	A culvert is blocking the water velocity. The water becomes stagnant. There is visible cow manure next to the water.	46.17792 to 46.19042	64.55956 to 64.55795

D	Cattles are having access to the stream. Both banks are eroded and the vegetation is destroyed. The water is brownish in color due to the sedimentation. There is heavy sedimentation in the stream.	46.17792 to 46.19042	64.55956 to 64.55795
90	MZ	D	There is a double culvert which has created a pool as a result it has slowed down the water velocity.	46.19042	64.55795
91	PC	D	An old broken culvert in the brook it has created a barrier as well as slowing the water velocity.	46.18173	64.55800
92	MZ	D	There is a dirt road next to the brook. There is a potential source of sedimentation when there is heavy rain.	46.18260	64.55772
		D	A culvert is trapping debris and sedimentation.	46.18260	64.55772
93	AG	D	Cows are having access to the brook. Both banks are eroded and the vegetation is destroyed. The water is brownish in color due to the sedimentation. There is heavy sedimentation in the stream.	46.18273	64.55784

94	AG	D	Cows are having access to the brook. Both banks are eroded and the vegetation is destroyed. The water is brownish in color due to the sedimentation. There is heavy sedimentation in the stream.	46.18398	64.55770
95	PC	D	There is a potential source of sedimentation near the culvert (coming from the road) when there is heavy rain.	46.18549	64.55812
96	AG	D	Cows are having access to the brook. Both banks are eroded and the vegetation is destroyed. There is heavy sedimentation in the stream.	46.19664	64.55720
97	AG	D	Cows are having access to the brook. Both banks are eroded and the vegetation is destroyed. The water is brownish in color due to the sedimentation. There is heavy sedimentation in the stream.	46.18634	64.55576
98	MZ	D	A dirt road is passing through the stream. There is a potential source of sedimentation when there is heavy rain.	46.18732	64.55551
		D	An old bridge with debris is slowing the water velocity.	46.18732	64.55551

99	AG	D	Cows are having access to the brook. Both banks are eroded and the vegetation is destroyed. The water is brownish in color due to the sedimentation. There is heavy sedimentation in the stream.	46.18722	64.55526
100	AG	D	Cows are having access to the brook. Both banks are eroded and the vegetation is destroyed. The water is brownish in color due to the sedimentation. There is heavy sedimentation in the stream.	46.18819	64.55411
101	W	D	An old beaver dam is slowing the water velocity.	46.19055	64.55239
102	W	D	A wood debris jam is blocking the water velocity as well as trapping the sediments. This would be a good place for a restoration.	46.19271	64.55095
103	WC	D	An old brook bed is dry. There is a potential sedimentation source.	46.19358	64.55064
104	W	P	A wood debris jam is blocking the water velocity as well as trapping sediments. This would be a good place for a restoration.	46.19730	64.54739

105	AG	D	Cows are having access to the brook. Both banks are eroded and the vegetation is destroyed. The water is brownish in color due to the sedimentation. There is heavy sedimentation in the stream.	46.19817	64.56216
106	AG	D	Cows are having access to the brook. Both banks are eroded and the vegetation is destroyed. The water is brownish in color due to the sedimentation. There is heavy sedimentation in the stream.	46.20089	64.55700
107	AG	D	Cows are having access to the brook. Both banks are eroded and the vegetation is destroyed. The water is brownish in color due to the sedimentation. There is heavy sedimentation in the stream.	46.20187	64.55534
108	W	P	A wood debris jam is slowing the water velocity as well as trapping sedimentation.	46.20051	64.55114
109	MP	P	There is garbage as well as wooden material on the right bank.	46.20036	64.55157
110	AG	D	Cows are having access to the brook. Both banks are eroded and the vegetation is destroyed. The water is brownish in color due to the sedimentation. There is heavy sedimentation in the stream.	46.20010	64.55185

111	AG	D	Cows are having access to the brook. Both banks are eroded and the vegetation is destroyed. The water is brownish in color due to the sedimentation. There is heavy sedimentation in the stream.	46.19964	64.55352
112	MZ	D	A blocked culvert is slowing the water velocity.	46.19459	64.51601
		D	There is garbage on both sides of the culvert and it is slowing the water velocity.	46.19459	64.51601
		D	A dirt road could potentially be a sedimentation source when there is heavy rain.	46.19459	64.51601
113	W	P	A wood debris jam is slowing the water velocity. There is a sediment accumulation in the stream as well as in wood debris (trapped). This could be a good restoration site.	46.17808	64.51122
114	W	P	A wood debris jam is slowing the water velocity. There is a sediment accumulation in the stream as well as in wood debris (trapped). This could be a good restoration site.	46.17784	64.51212
115	W	P	A wood debris jam is slowing the water velocity. There is a sediment accumulation in the stream as well as in wood debris (trapped). This could be a good restoration site.	46.17686	64.51212

116	W	P	A wood debris jam is slowing the water velocity. There is a sediment accumulation in the stream as well as in wood debris (trapped). This could be a good restoration site.	46.17585	64.51197
117	W	D	An old beaver dam has created a large pool. As well as slowing the water velocity.	46.17576	64.51260
118	PC	D	The banks are lightly eroded near the old culvert. A dirt road could potentially be a source of sedimentation when there is heavy rain.	46.17553	64.51205
119	W	D	An old beaver dam is blocking the water velocity and has created a pool.	46.17423	64.51099
120	MP	P	Tires in the brook.	46.18419	64.50786
121	W	P	A wood debris jam has created a natural dam. This could be a good restoration site.	46.18259	64.50936

122	W	P	A wood debris jam has created a dam. There is sediments accumulation in the stream as well as in the wood debris. This could be a good restoration site	46.18132	64.51011
123	AG	D	Cows are having access to the brook. Both banks are eroded and the vegetation is destroyed. The water is brownish in color due to the sedimentation. There is heavy sedimentation in the stream.	46.23057	64.49484
124	PC	P	An old culvert has created a pool. Cows have access into brook. Both banks are eroded. The water is brownish in color due to the sedimentation. There is heavy sedimentation in the stream.	46.22962	64.49465
125	PC	P	An old culvert in the stream. There is sedimentation in the stream as well as next to the culvert.	46.22796	64.49410
126	MZ	D	A double culvert and a bridge are responsible for slowing the water velocity and by creating a pool.	46.22741	64.49491
		D	A double culvert and a bridge are slowing the water velocity.	46.22741	64.49491

127	MZ	D	A bridge is slowing the water velocity. A Heavy alder population is present.	46.22719	64.49527
		D	A culvert is slowing the water velocity. A heavy alder population is present.	46.22719	64.49527
128	PC	D	There is water coming out of from a pipe (coming from a shack). The source is unknown.	46.22746	64.49535
129	MZ	P	A bridge is slowing the water velocity.	64.22658	64.49651
		P	There is a potential sedimentation source from the road when there is heavy rain.	64.22658	64.49651
		D	A culvert used for precipitation run-off that flows directly into the stream. There are broken pieces of asphalt that could potentially be a source of contamination.	64.22658	64.49651
130	W	D	A residential bridge where both banks are eroded.	64.22638	64.49695
131	PC	P	There is water coming from a pipe next to a residential area.	46.22563	64.49767

132	MZ	D	There is garbage such as tires and metals in the stream. There is also trapped sedimentation.	46.22442	64.49885
		D	Wood debris has created a barrier.	46.22442	64.49885
133	MZ	D	Two pipes could potentially be contaminated with precipitation run-off. The precipitation run-off flows directly into the stream	46.22316	64.50081
		D	A double culvert is blocking the water passage.	46.22316	64.50081
134	MP	D	An old dumping zone (cars) has diverted the brook by forming an island. There is heavy sedimentation in the stream.	46.22179	64.56275
135	PC	D	Old pierced culvert. The water is flowing under the mouth of the culvert.	46.22080	64.56327
