**RESTORATION PROJECT
CORNWALL BROOK
- 2006 -**

Cornwall Brook

**Prepared by:
Mathieu Leblanc, Field Technician
Shediac Bay Watershed Association
And
Dominique Audet M.Sc., Coordinator
Shediac Bay Watershed Association**

January 2007

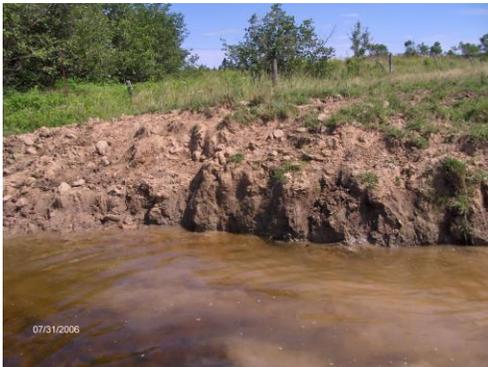
The major problems that we encountered were bank erosion caused by cattle access (see figure 4) resulting in important siltation problems downstream, overabundant alders along the banks, in-stream debris (see figure 5) and excessive amount of algae in some areas (see figure 6).

Figure 4: Cattle access

Phase 2 of the restoration project, which we hope will start during the 2007 field season, will have many aspects and will be more hands on. First off, we will be doing a clearing of overabundant alders and in-stream debris in order for the stream to naturally flush out sediments and give us a better look at its actual state. There after we will be strategically placing deflector tree to address the siltation problem and restore the pool/riffle pattern. We would also like to limit or prevent the cattle to access the stream by fencing off a section of the stream. Finally, we would also like to create a tractor crossing in order to minimize its impact of the stream bottom and on the banks.

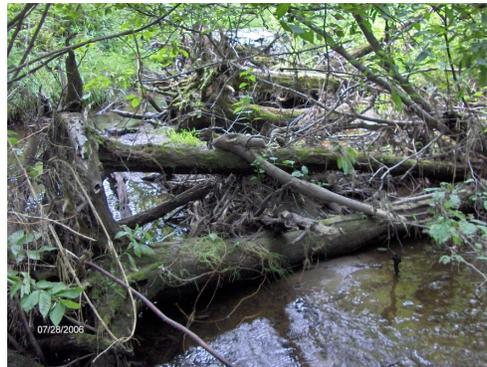
Figure 5: Wood debris

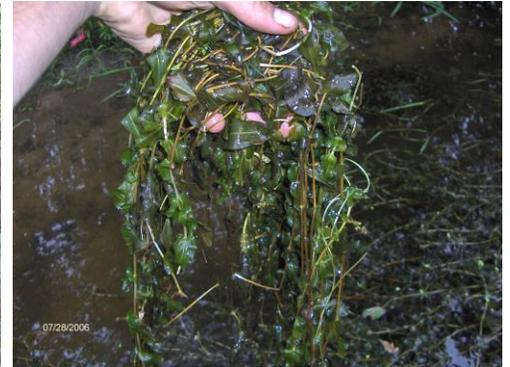
Figure 6: Excessive algae bloom
