**Shediac Bay Watershed Association
Association du bassin versant de la baie de Shediac**

**Fiscal Year 2006-2007
Année fiscale 2006-2007**

November 8, 2007

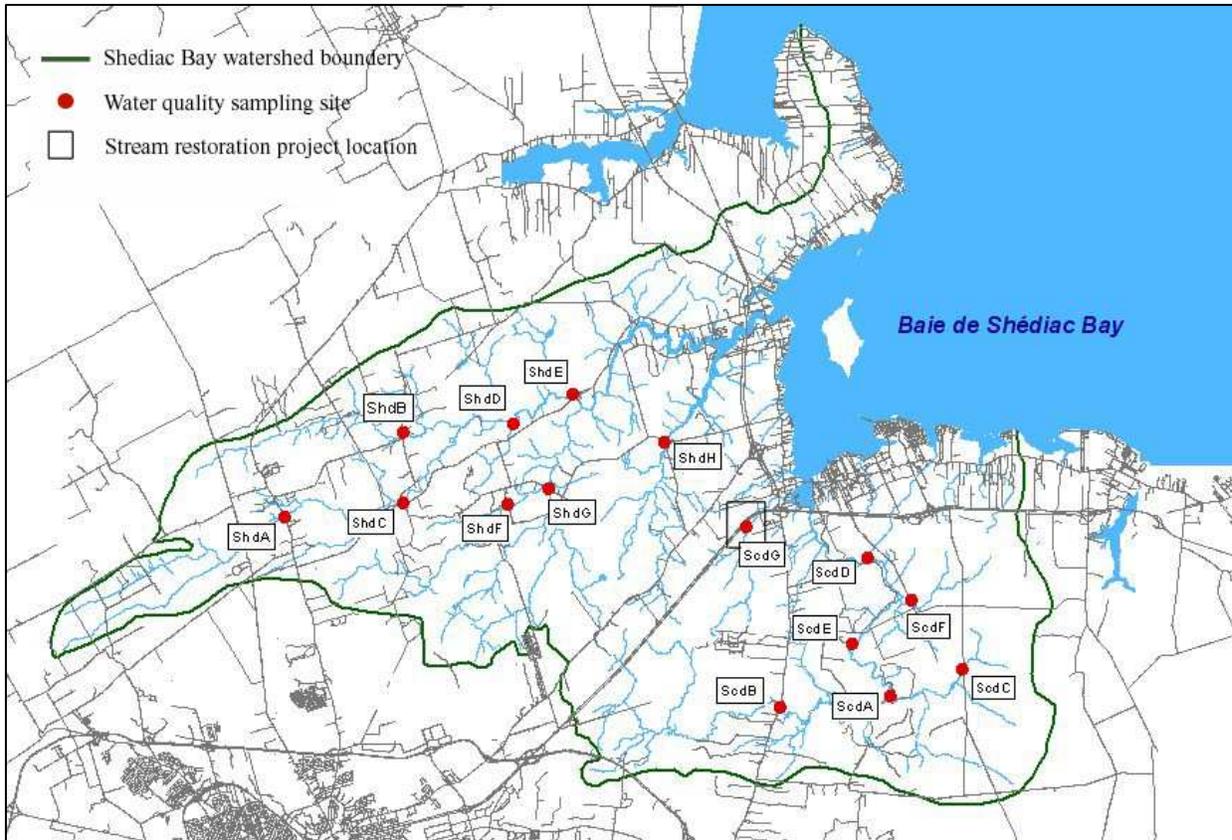
Figure 1. Map of Shediac Bay watershed including water quality sampling site and stream restoration locations

The Shediac Bay Watershed covers 400 km² of land area and stretches along 36 km of coastline, from Cap Bîmet to Cap de Cocagne (Fig. 1). The Shediac and the Scoudouc rivers are characterized by dendritic patterns of small tributaries covering a watershed of 201.8 and 143.3 km², respectively. The Shediac River is composed of two major water arms. The northern water arm is created by the convergence of the McQuade Brook, the Weisner and the Calhoon Brooks.

The stream habitat survey was performed in a section of the Cornwall Brook (Fig. 1) part of the Scoudouc River system. The stream habitat survey was performed using the protocol set-out by the New Brunswick department of Environment and the Federal Department of Fisheries and Oceans. A total of 34 reaches of 50 m each for a total distance of 1.7 km were analysed from July 25th to August 11th. During the survey, physico-chemical and morphological parameters were recorded at each stream reach. Riparian bank characteristics and potential pollution point sources were also identified.

Water quality testing was conducted between July 6th and November 2nd. Sampling sessions were conducted on a monthly basis at 15 different sites (Fig. 1). However, few sampling sites were no accessible during certain period of the year.

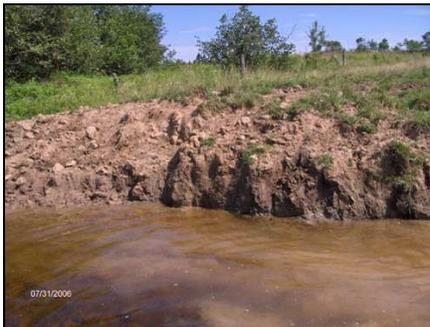
Figure 2. Cattle access in Cornwall Brook

The major ecosystem stressors encountered were bank erosion caused by cattle access (Fig. 2) creating important siltation loading downstream, overabundant alder growth along the banks, in-stream wood debris jams (Fig. 3) and excessive amount of aquatic plants (Fig. 4).

During phase 1 of the restoration project, a total of 12 wood debris jams were strategically and partially cleared to allow fish passage and to prevent further blockage. During phase 2 of the restoration project, tree deflectors will be strategically installed to address the siltation problem and to restore the pool/riffle pattern. The introduction of tree deflectors will help flush out silt deposits and allow the redistribution of the silt against the stream banks. This project will also involve restoring the damaged riparian zones and developing a solution with the farmers in order to resolve the problems caused by cattle.

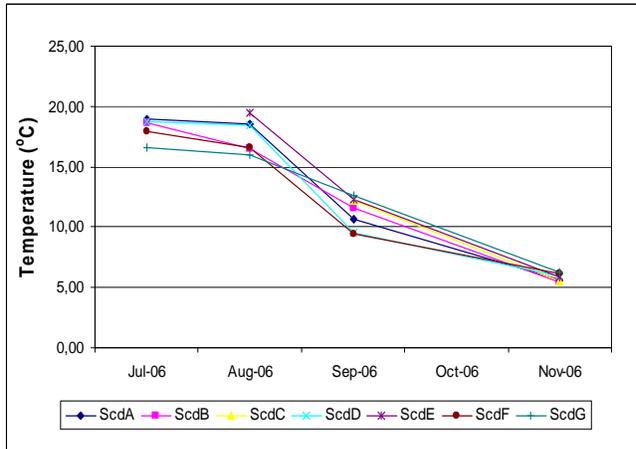
Figure 5. Water temperatures for the Scoudouc River

The overall water temperature in the watershed was 13.5 °C which are acceptable values. The overall mean for both rivers was 12.61 °C for the Scoudouc River (Fig. 5) and 14.21 °C for the Shediac River (Fig. 6). The highest temperature recorded was 20.5 °C at site ShdD on July 6th and the lowest temperature recorded was 5.47 °C at site ScdB on November 2nd. There was no past available data to compare evolution of water quality.

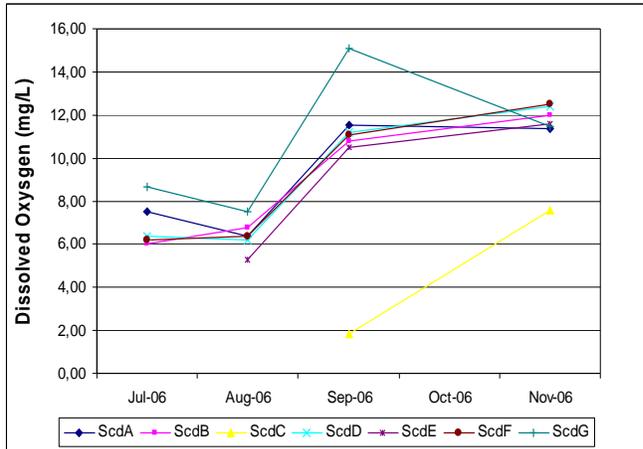
Figure 7. DO levels for the Scoudouc River

The overall DO mean for all the sites was 9.2 mg/l, and the overall mean using only the data obtained with the new YSI, is 11.26 mg/l. From 1999 to 2002 the overall mean was 12.93 mg/l and no significant change over time was observed. The overall mean for the Scoudouc River (Fig. 7) was 8.96 mg/l (10.77mg/l for new YSI only) and 9.39 mg/l for the Shediac River (Fig. 8) (11.68mg/l for new YSI only). The highest level recorded was 15.09 mg/l at site ScdG on September 28th and the lowest level recorded was 1.86 mg/l at site ScdC on September 28th. Furthermore, only three samples were below 6 mg/l. They were ScdC at 1.86 mg/l on September 28th, ScdE at 5.3 mg/l on August 10th and finally ShdH at 5.81 mg/l on July 6th.

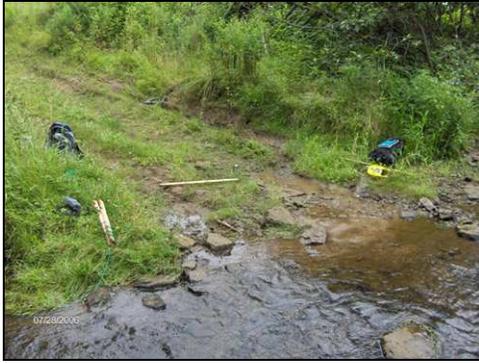
During the monitoring period, areas of concern were identified. Bank erosion issues were observed at various locations in both Shediac and Scoudouc river systems (Fig. 9, 10). Improper culverts were also identified to cause habitat fragmentation (Fig. 11). Riparian zone without buffer zone are also present in the watershed in residential areas (Fig. 12).

Figure 9. ScdG Tractor access

The conductivity measurements support the fact that sedimentation loading and agricultural runoff could be a problem at site ScdG, where values are of highly over the recommended levels (0.309 $\mu\text{S}/\text{cm}$).

As for the potential problems and pollution sources, the major concerns for the SBWA were sedimentation loading in the Scoudouc River tributary (caused by cattle and tractor and ATV crossings), barrier culverts, and eroding banks. Most problems resulted from poor practices and will be addressed by the SBWA during the next few years.

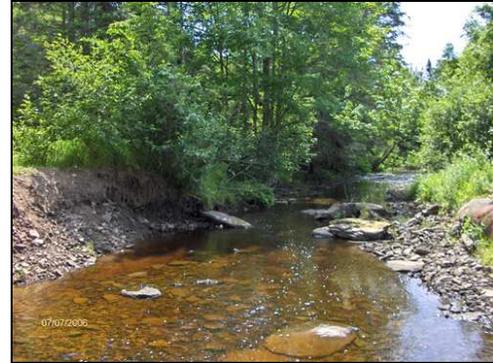
Figure 10. ScdA ATV crossing (eroding bank on left side)

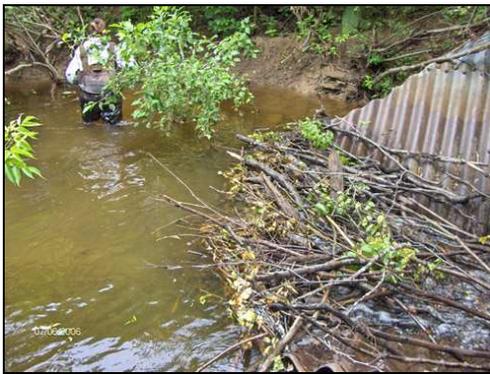
Figure 11. ShdB Blocked culvert

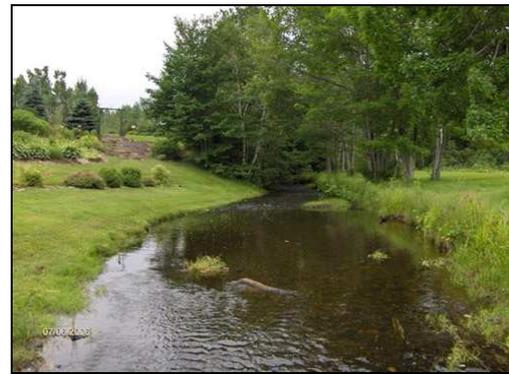
Figure 12. ShdF Altered shoreline

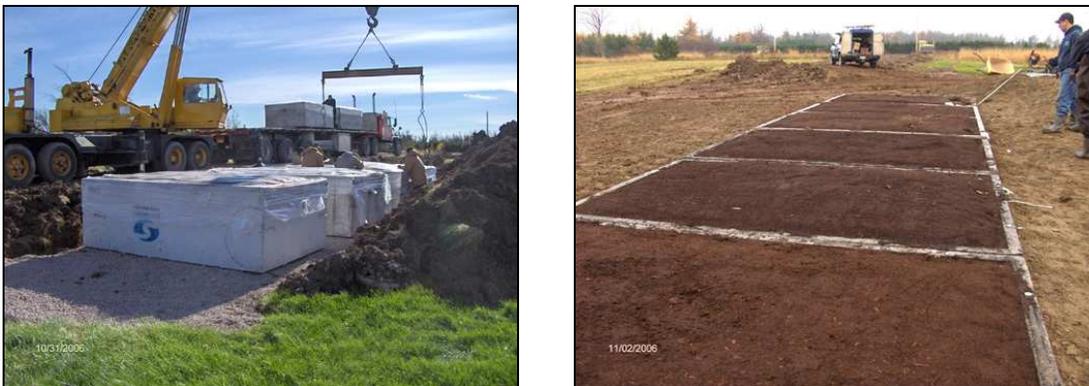
The peat moss filtering system installed in Scoudouc in October 2006 was the third of its kind in New Brunswick (Fig. 13). The technology is however much more developed in Nova Scotia where hundreds of these systems are in activity.

Figure 13. Installation of a peat system drainage field at the senior residence in Scoudouc, NB

The installation of a regular septic bed and the replacement of the actual sewage treatment system were not considerable solutions for the problematic site. Among several suggestions to rapidly remediate the situation, it was proposed to install a septic system connected to peat moss cells acting as draining fields. This system is very compact and can accommodate large households or small institutions. The peat moss filtering system is very advantageous for those who have soil type or space issues. Extensive water quality testing revealed that these types of systems are very efficient and therefore acceptable for residential use.

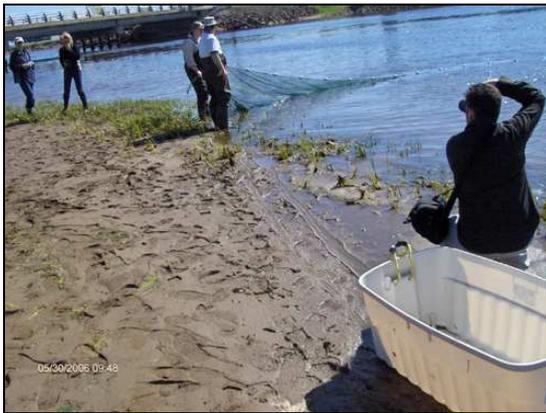
Figure 14. DFO Community Aquatic Monitoring Program performed during the 2006 season (CAMP)

Again this year, we were able to monitor the water quality within the Shediac Bay Watershed by partnering with the Department of Fisheries and Oceans on the Community Aquatic Monitoring Program (CAMP) from May to October of 2006. This is our fourth year of involvement in this project. This is a long-term monitoring program aiming to study ecosystem evolution and changes over time. This ecosystem assessment tool is still in the development stage and could be established in the future years.

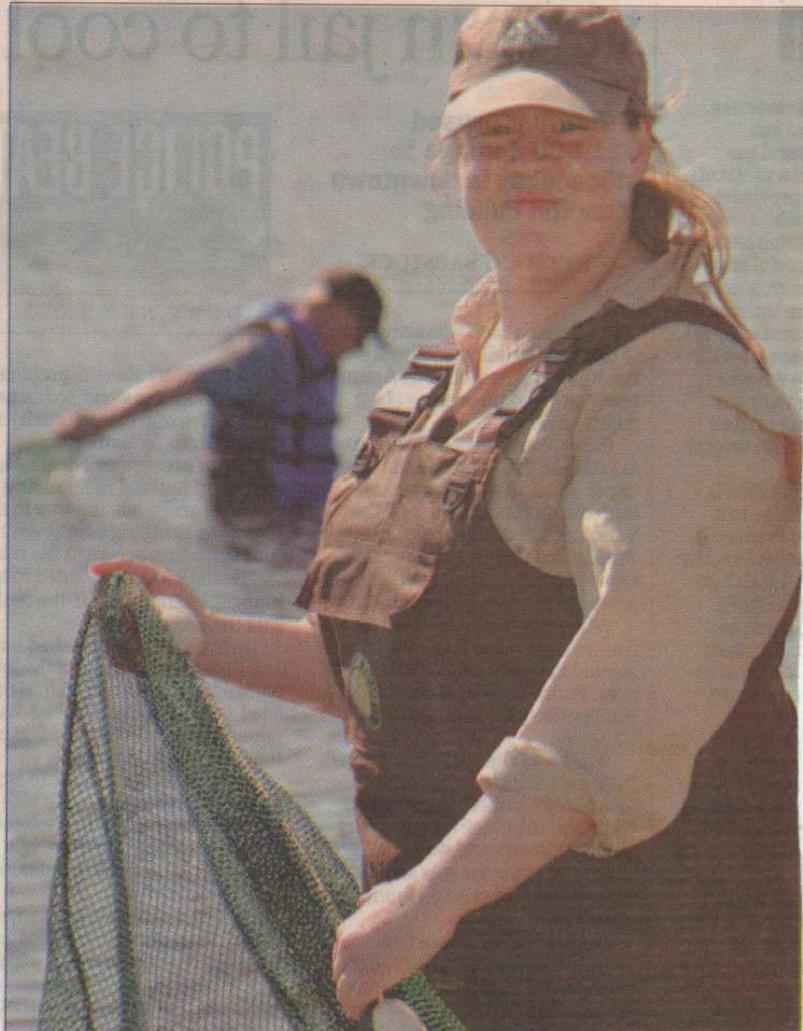
Dominique Audet, executive director of the Shediac Bay Watershed Association, and Jim Weldon (background), DFO Community Aquatic Monitoring Program co-ordinator, place a net in the Scoudouc River in Shediac yesterday where they were sampling water and sea life.
