Water Quality Remediation and Public Outreach

Final Report

The Shediac Bay Watershed Association Inc.
Julien Bourgeois

March 1, 2011

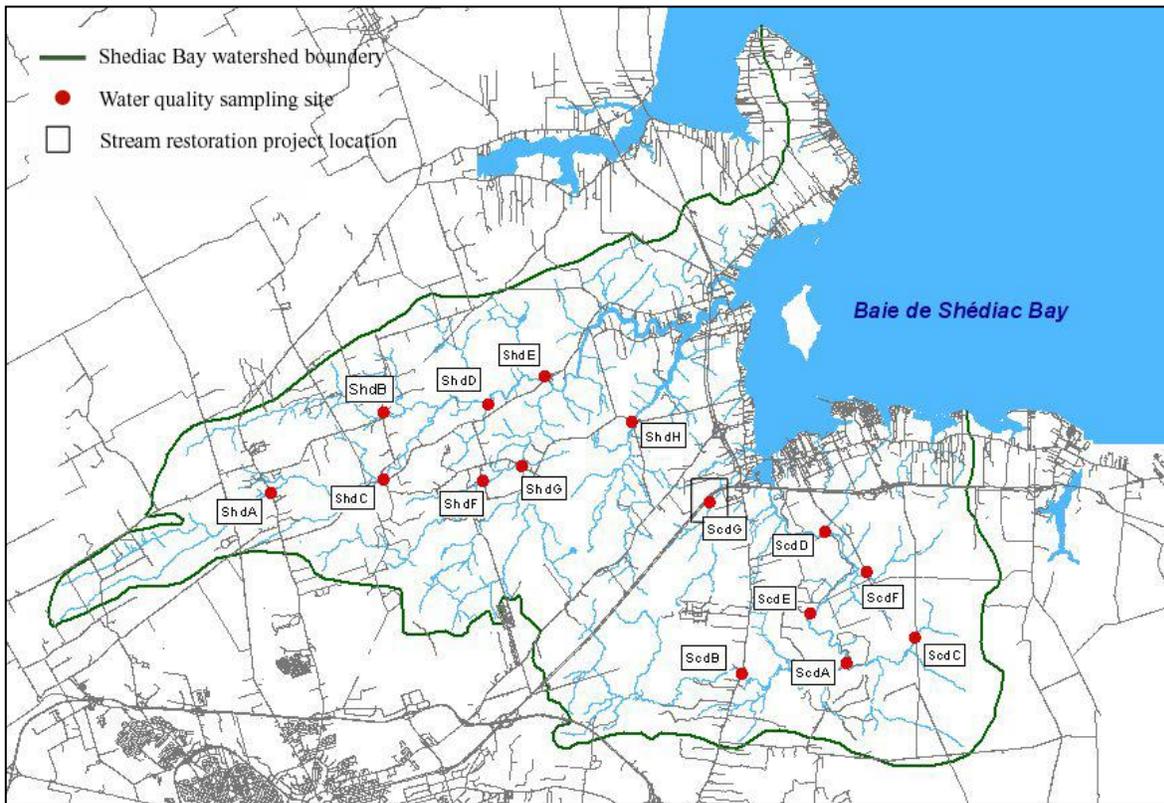
Figure 1. Map of Shediac Bay watershed including water quality sampling site and stream restoration locations

The Shediac Bay Watershed covers 400 km² of land area and stretches along 36 km of coastline, from Cap Bîmet to Cap de Cocagne (Fig. 1). The Shediac Bay Watershed is composed of two major river systems emptying into Shediac Bay: the Shediac River and the Scoudouc River. The Shediac and the Scoudouc rivers are characterized by dendritic patterns of small tributaries covering a watershed of 201.8 and 143.3 km², respectively. The Shediac River is composed of two major water arms. The northern water arm is created by the convergence of the McQuade Brook, the Weisner and the Calhoon Brooks. The southern large water arm of the Shediac River is the continuation of the Batemans Brook. Water velocity in both rivers is weak due to the gentle regional elevation. The watershed boundaries stretch into both Kent and Westmorland County and cross into both the Shediac and Moncton Parish. The Watershed region consists of a population of approximately 15,000 people.

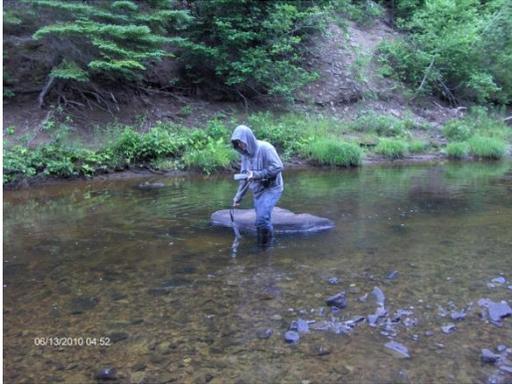
Figure 2. Water quality sampling using the YSI600 in the Shediac River in 2010.

Basic water quality parameters (DO, temperature, pH, and conductivity) were measured using a water-condition instrument YSI QS600 (Fig. 4). Nitrate-nitrogen concentrations was measured a LaMotte Smart II Colorimeter. This instrument measures the amount of light that travels through a reacted sample and converts the measurement to a digital reading as mg/l. As for the Total coliform and *E.coli* values, the IDEXX Quanti-tray\2000 was used. This is a semi-automated quantification method based on the standard methods Most Probable Number (MPN) model. The Quanti-Tray sealer automatically distributes the samples/reagent mixture into separate wells. After incubation, the number of positive wells is converted to an MPN using a

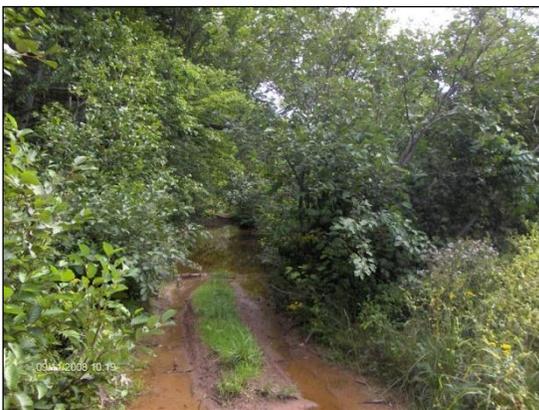
Figure 6. Scoudouc River Tractor access

During the monitoring period, areas of concern were identified. Bank erosion issues were observed at various locations in both Shediac and Scoudouc river systems. Riparian zone without buffer zone are also present in the watershed in residential areas.

As for the potential problems and pollution sources, the major concerns for the SBWA were sedimentation loading in the Scoudouc River tributary (caused by cattle and tractor access), barrier culverts and eroding banks. Most problems resulted from poor practices and will be addressed by the SBWA during the next few years.

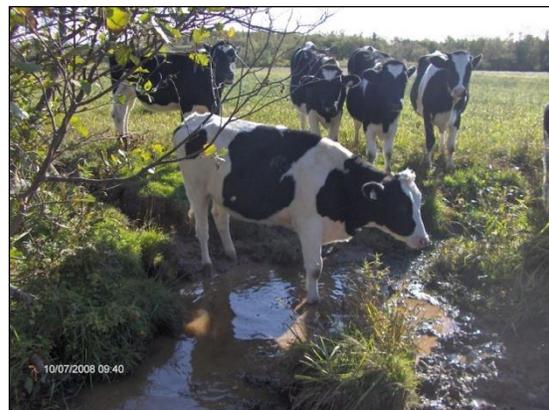
Figure 7. Scoudouc River Cattle access

E. coli concentrations are elevated where cattle appears to have access to the stream, in cottage areas or where erosion issues were noted. Stream water level is at his lowest in July at the ScdB site which is situated near the Fisher Bridge, the lagoon runoffs could contribute to increasing E. coli counts in the Scoudouc River.

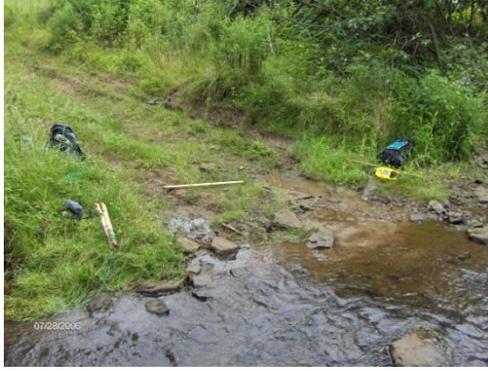
Figure 8. Tractor access(Scd g)

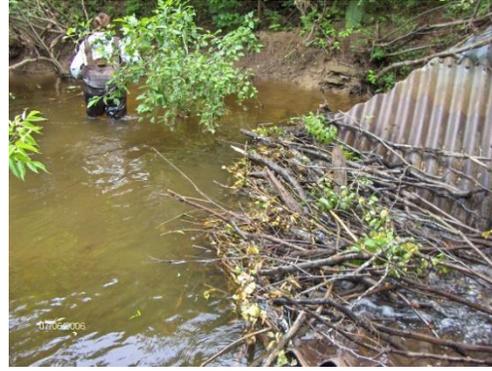
Figure 9. Blocked culvert (shd b)
