# **Environmental Evaluation of Shediac Bay Phase 1**

## **Final Report**

**The Shediac Bay Watershed Association Inc.**

**March 1, 2017**

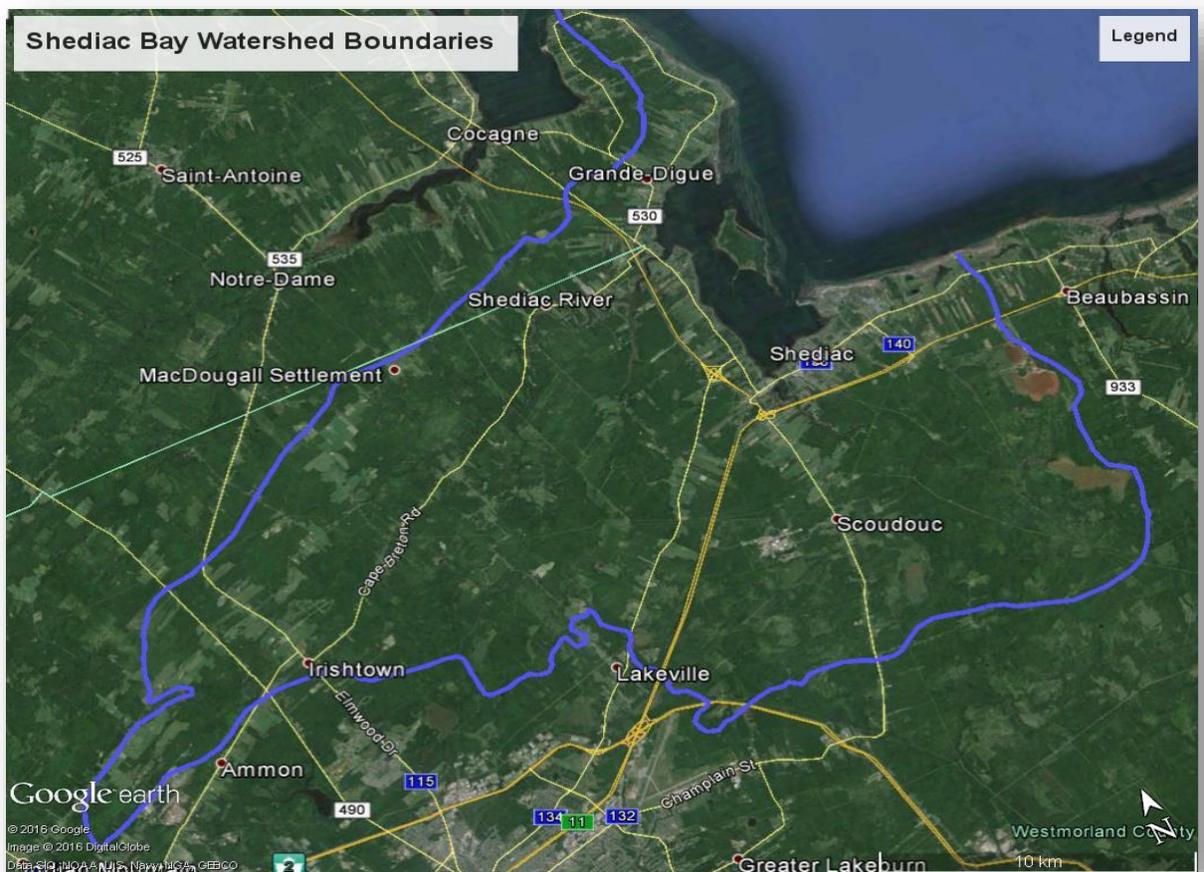
Map of Shediac Bay watershed boundaries

The Shediac Bay Watershed covers 420 km<sup>2</sup> of land area and stretches along 36 km of coastline, from Cap Bimet to Cap de Cocagne (Fig. 1). The Shediac Bay Watershed is composed of two major river systems emptying into Shediac Bay: the Shediac River and the Scoudouc River. The Shediac and the Scoudouc Rivers are characterized by small tributaries covering a watersheds of 201.8 and 143.3 km<sup>2</sup>, respectively. The Shediac River is composed of two major water arms. The northern water arm is created by the convergence of the McQuade Brook, the Weisner and the Calhoun Brook. The southern water arm of the Shediac River is the continuation of the Batemans Brook. Water velocity in both rivers is generally weak due to the gentle regional elevation. The watershed boundaries stretch into both Kent and Westmorland County and cross into both the Shediac and Moncton Parish.

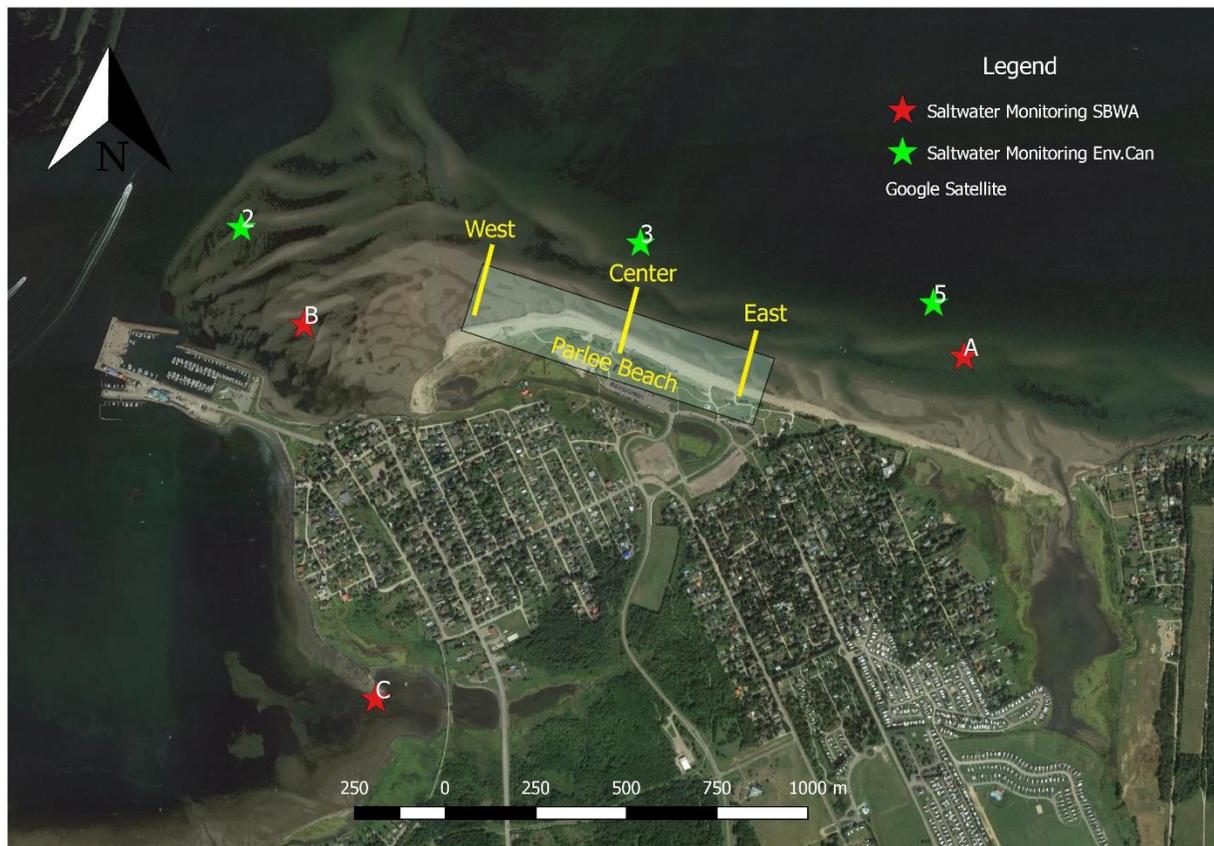
### Approximate site locations for sampling in the Pointe-du-Chêne area

Three sites were monitored in the Pointe-du-Chêne area by the SBWA. Two sites are situated at the limits of Parlee Beach. The SBWA chose to place two points at the limit of the beach to be able to add their data to the sampling already done by the staff at Parlee Beach. The third site is situated in South Cove. Environment Canada has some sampling sites all along the bay. The data in the tables looks at points near our sampling sites.

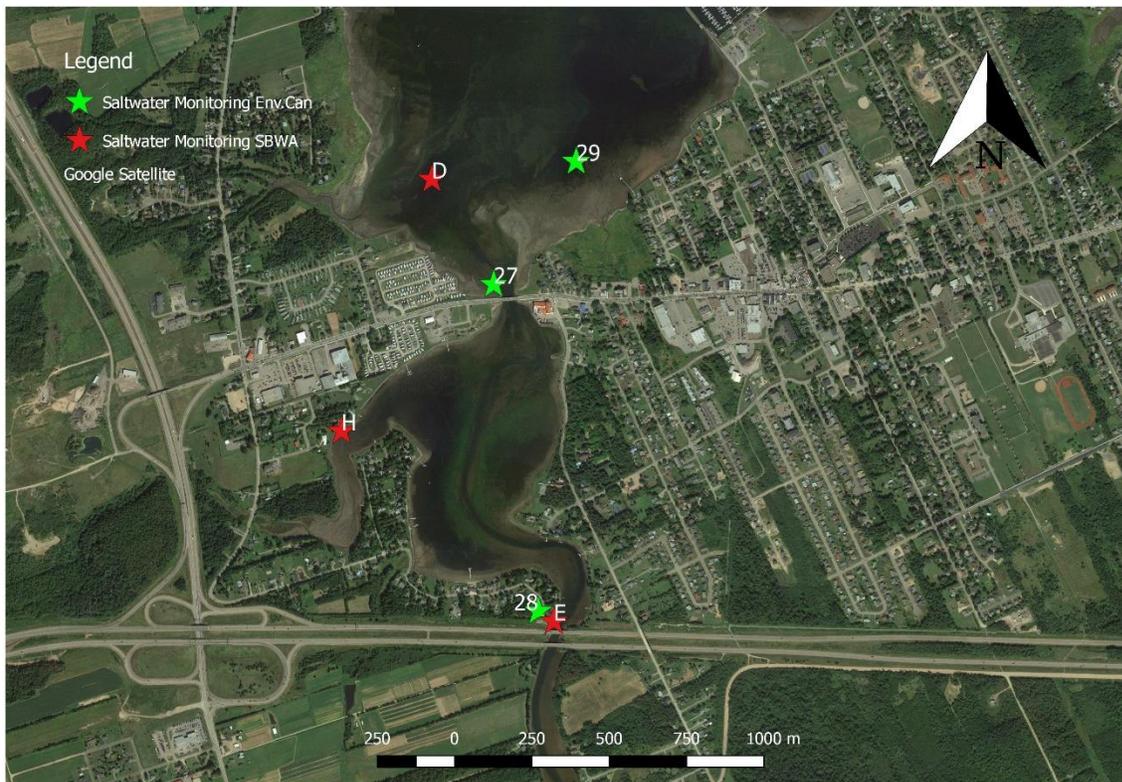
### Approximate locations of samples taken in the Scoudouc River area

Samples were taken in different locations at the mouth of the Scoudouc river.

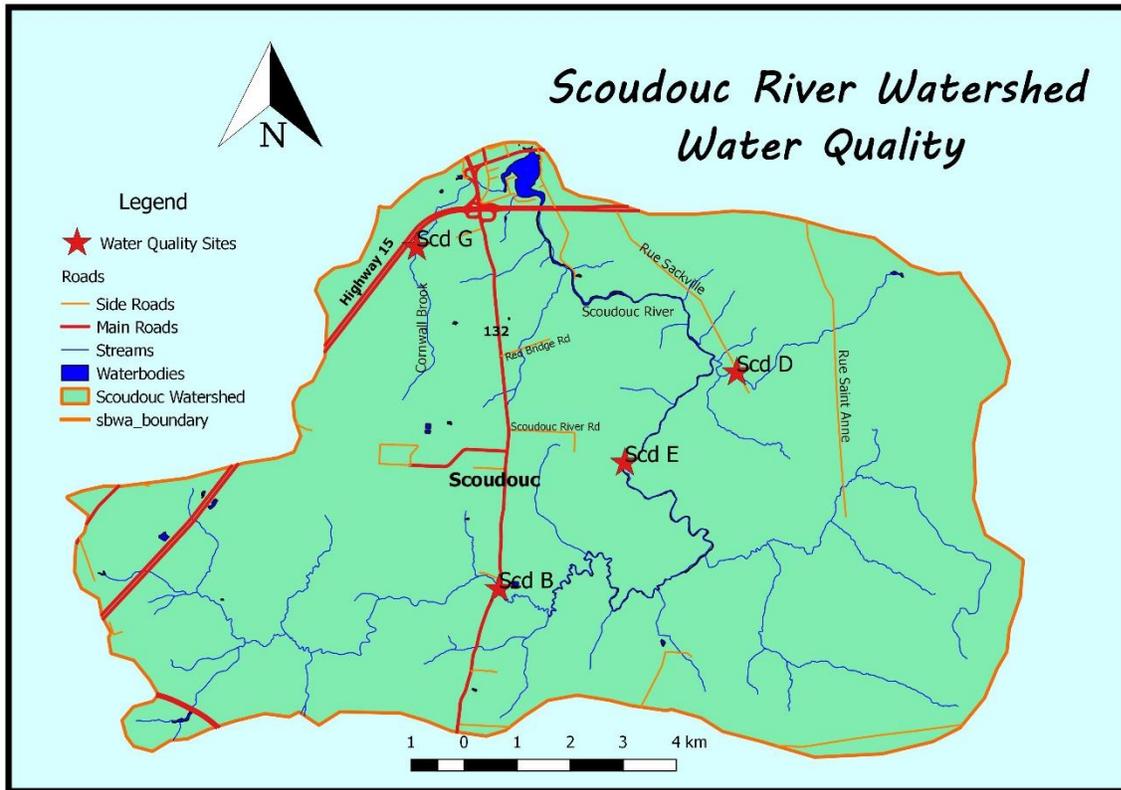
Scoudouc river water quality monitoring sites

The Shediac Bay Watershed Association has been monitoring E.coli in the freshwater of the Scoudouc river. Four sites have been monitored for water quality from 2000-2016.

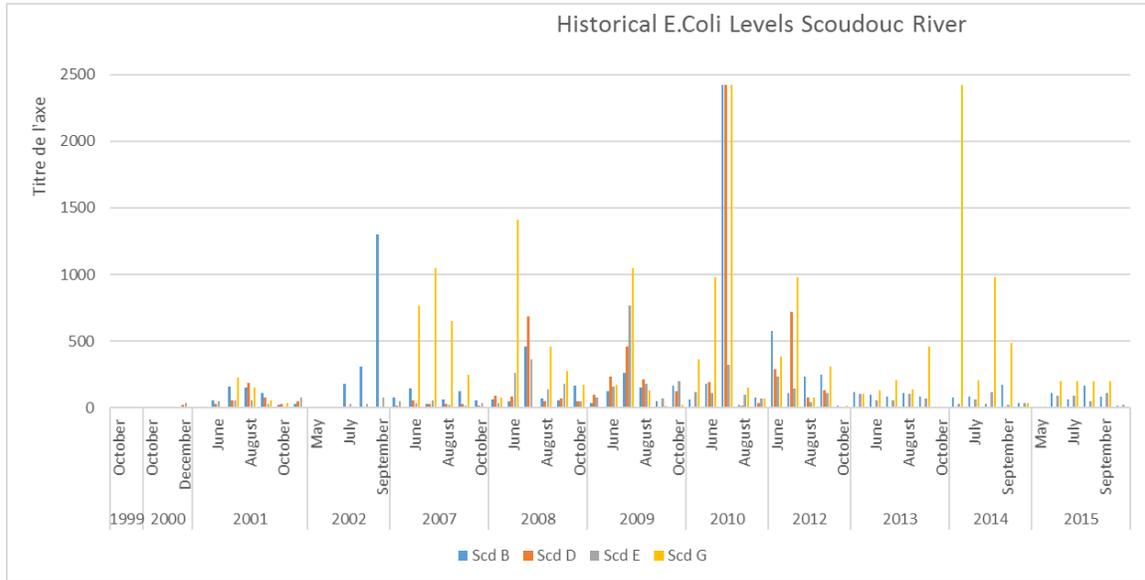
When we look at E.coli numbers for the Scoudouc rivers, all the sites experience high E.coli counts at some point. The highest results are during the summer. The following charts shows all results from monitoring in 2000-01 and from 2007-15. A guideline of under 200 MPN/100 ml for a class A river was developed for the NB water classification program and is used by the SBWA.

There was a heavy rainfall before the sampling of July 2010 that increased the numbers on all sites.

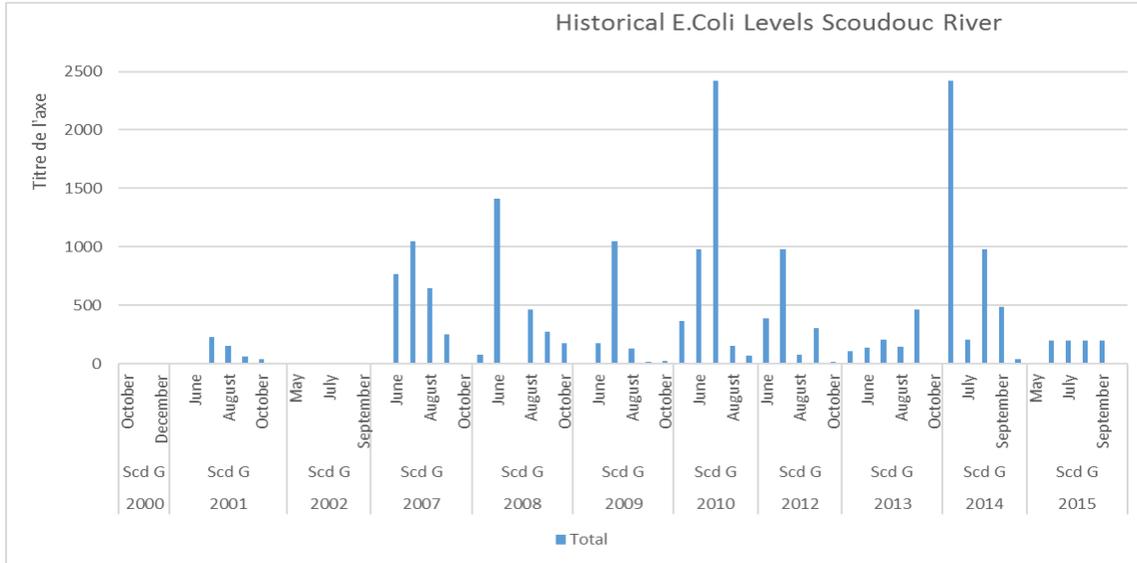
### 2.3.1 Cornwall Brook (Site Scd G)

The site situated in the Cornwall Brook is in a small tributary that exit near the mouth of the Scoudouc river. It crosses an agricultural zone. This site is the one with the most contamination from E.coli.

A project has been proposed for 2017 to replant a streamside buffer zone on fields that border the Cornwall Brook. Some restoration activities have also been done in the past in this area.

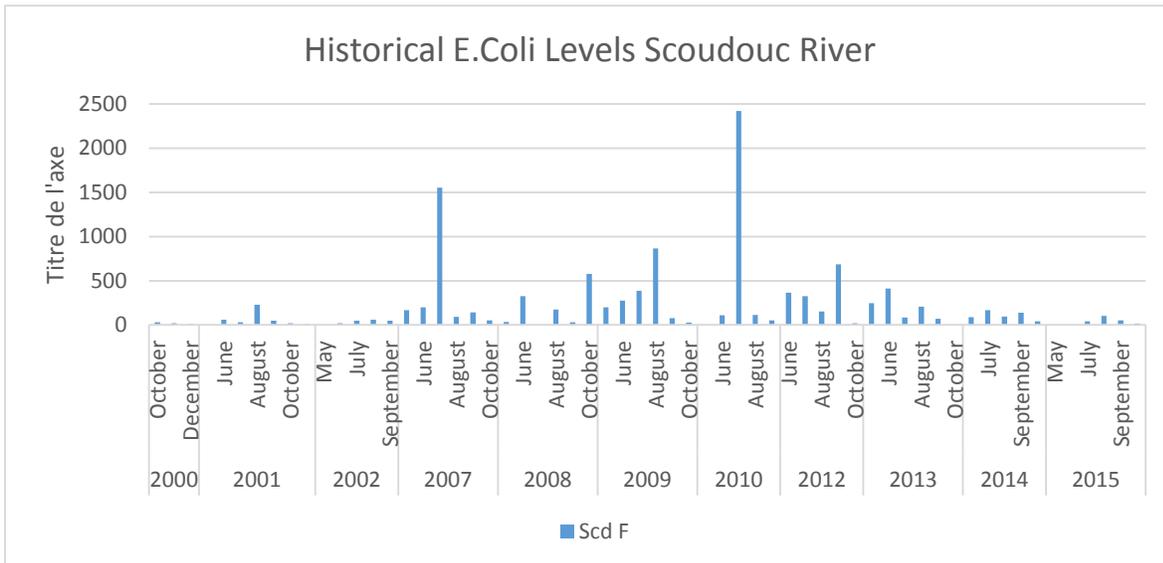
### 2.3.2 Pellerin Road (Site Scd F)

The next site is situated above agricultural zones in a wooded area accessed by taking Pellerin Road. The highest counts of E.coli occurred after the rain event in July of 2010.

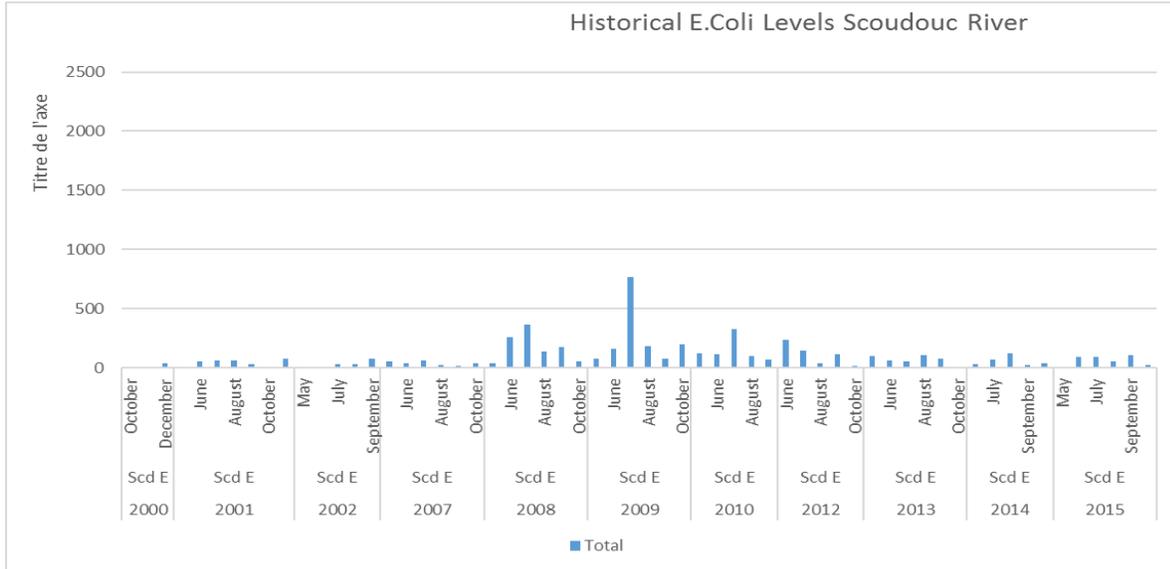
### 2.3.3 Scoudouc River off Scoudouc River Road (Scd E)

The next site is further upstream and accessed off Scoudouc River Road. The area is mostly wooded and has lower levels of bacterial contamination compared to the other sites. This site is downstream of the Greater Shediac Sewage Commission's waste water treatment lagoons. The discharge pipe of the lagoons is located approximately 11.5 km upstream.

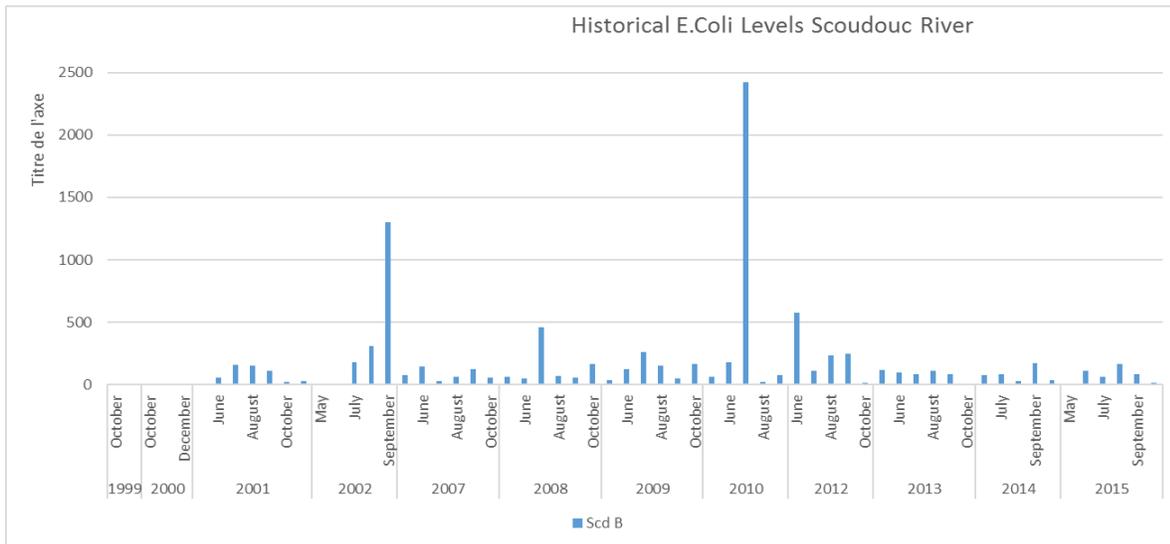
### 2.3.4 Scoudouc River Main Branch at Route 134 ( Site Scd B)

The site is where the main branch of the Scoudouc River crosses Route 134. It's situated in a residential zone. The counts are generally low, but has high counts on some occasions. The higher counts are after heavy rainfalls in July 2010 and June 2012. No notes on weather was taken in 2002.

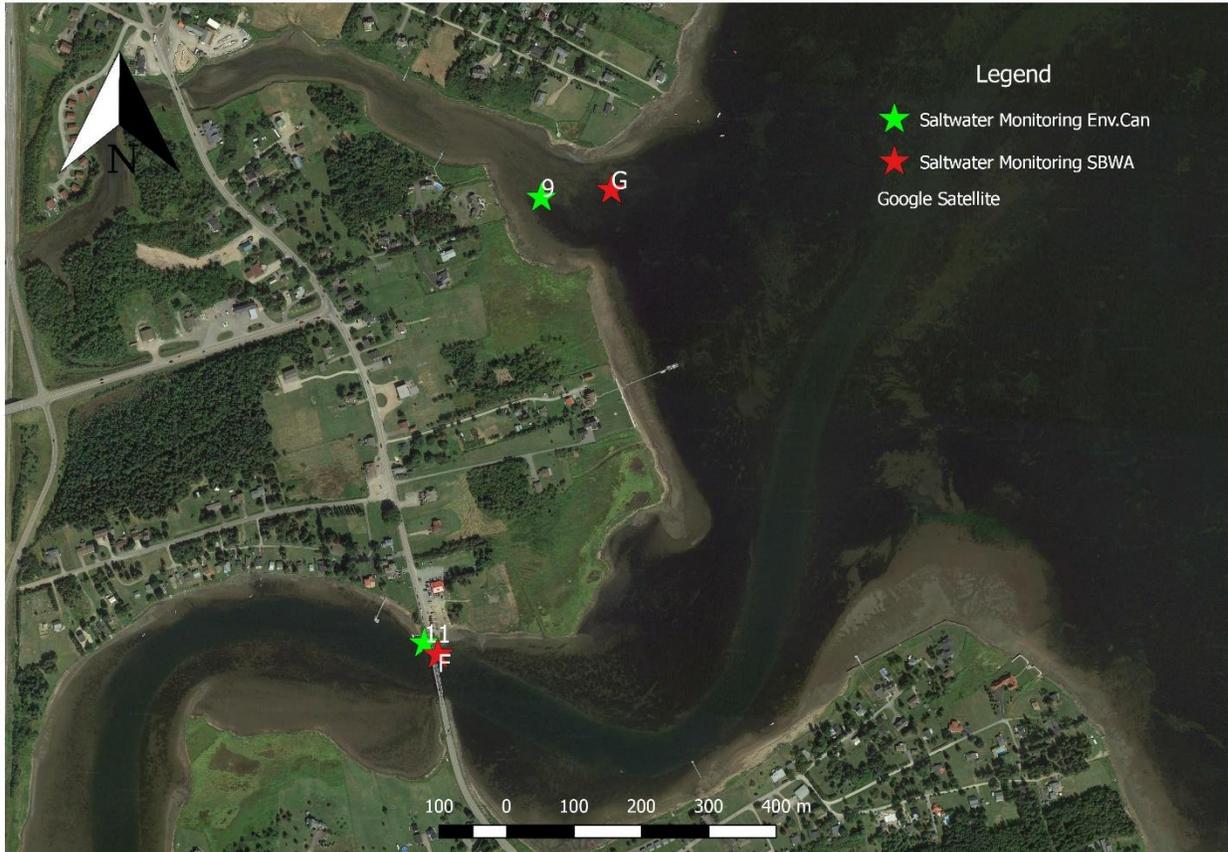
**Approximate locations of sampling sites in the Shediac River Area**

Two sites were chosen in the Shediac Bridge area for the study. One is located at the mouth of the Shediac River and the second is situated at the mouth of Albert Gallant brook.

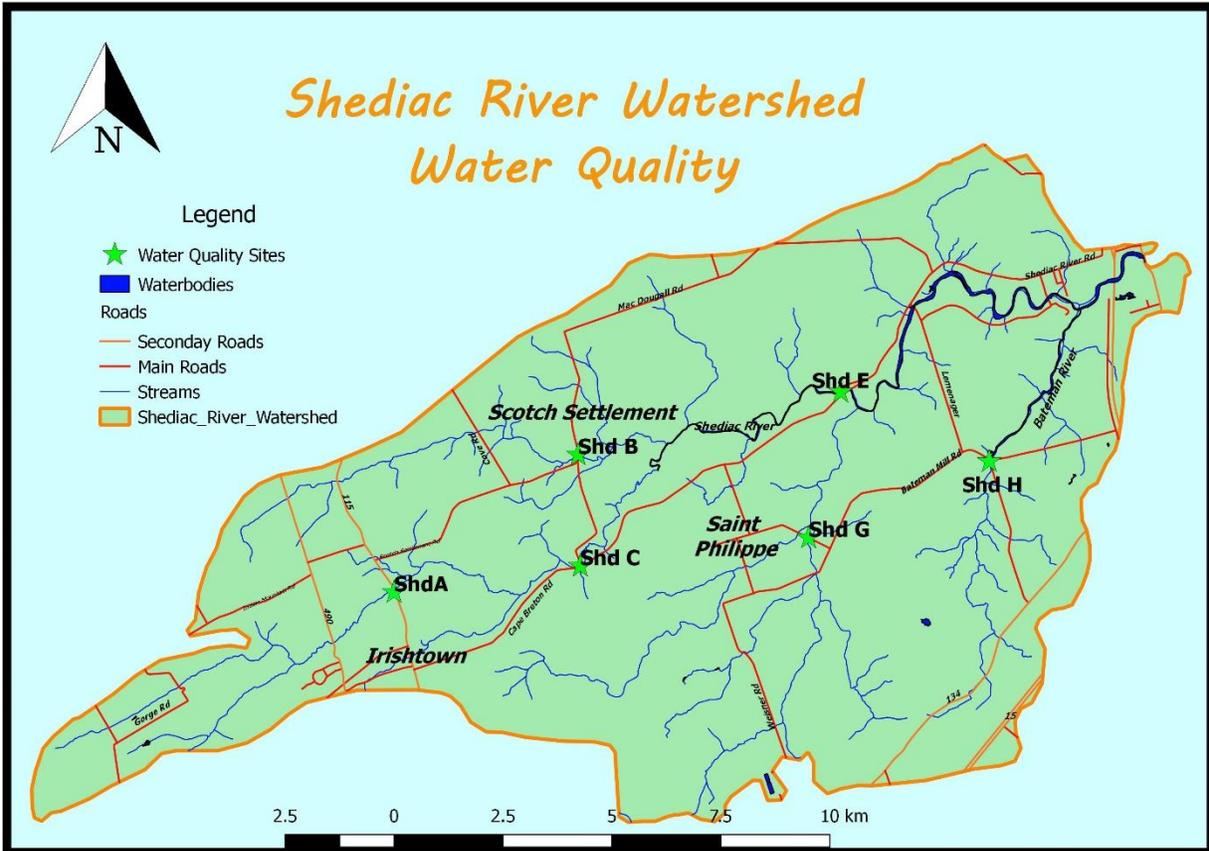
Shediac River Monitoring sites

The Shediac Bay Watershed Association has been monitoring E.coli in the freshwater of the Shediac river from 2000-2016. Seven sites have been monitored. The guideline developed for the water classification program for a class A river is under 200 MPN/100 ml.

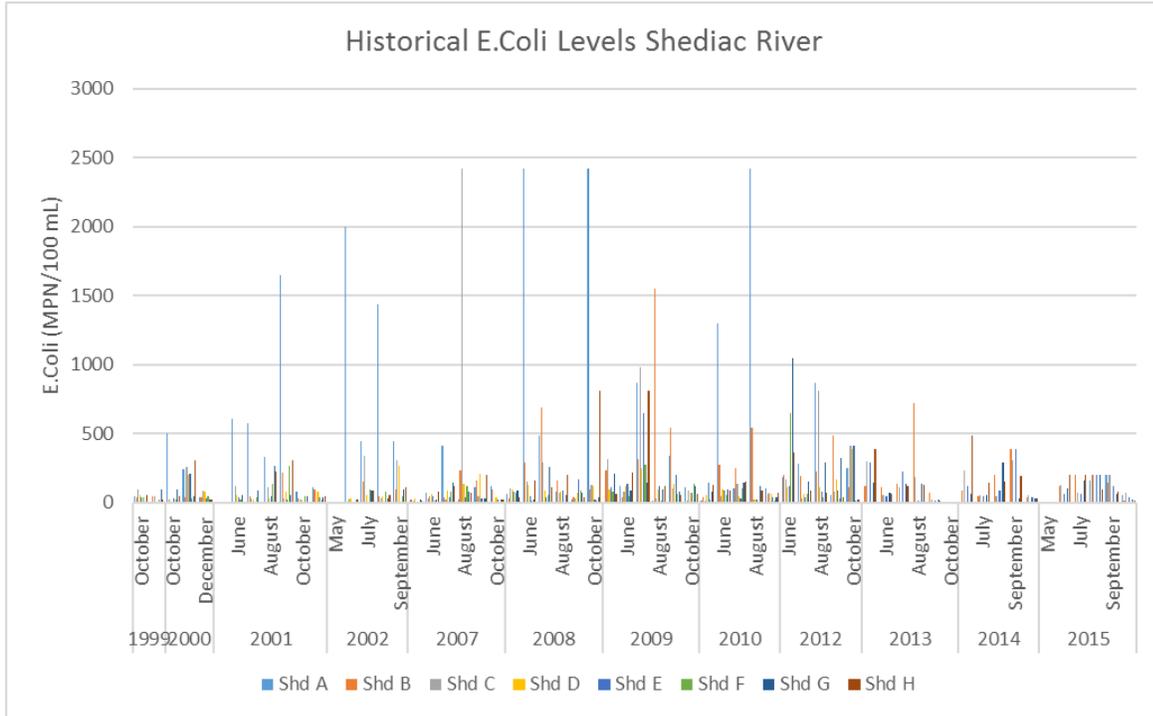
When we look at E.coli numbers for the Shediac rivers, all the sites experience high E.coli counts at some point.. The following charts shows all results from monitoring in 2000-01 and from 2007-15.

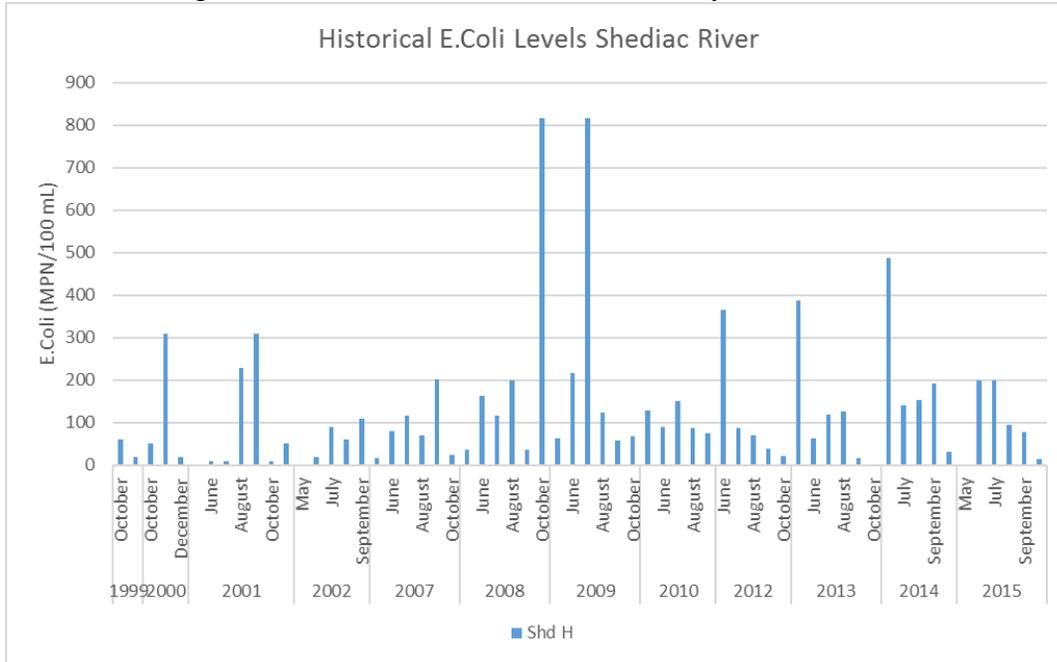
### 2.5.1 Bateman Mill – Site Shd H

Shd H is taken at the point where saltwater begins off the Bateman mills brook. The river crosses some agricultural lands and is also influenced by beaver dams.

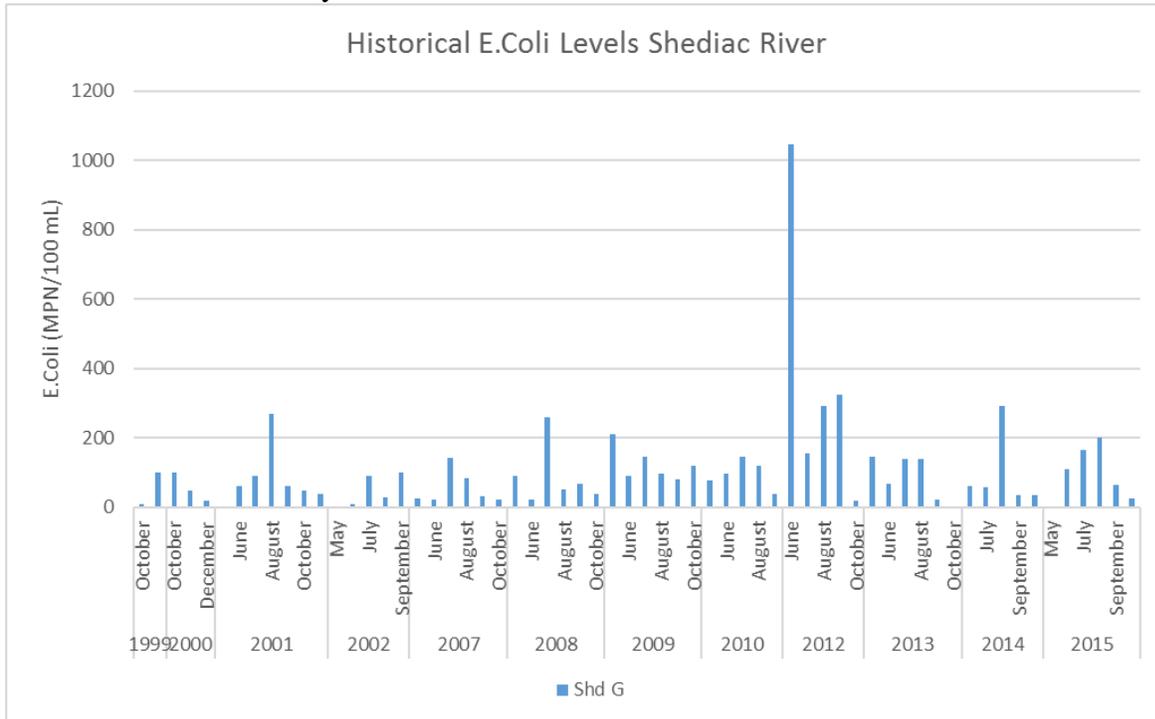
### 2.5.2 Weisner Brook – Site Shd G

The site for the Weisner Brook is located in Saint Philippe. The brook crosses agricultural lands and is influenced by beaver dams.

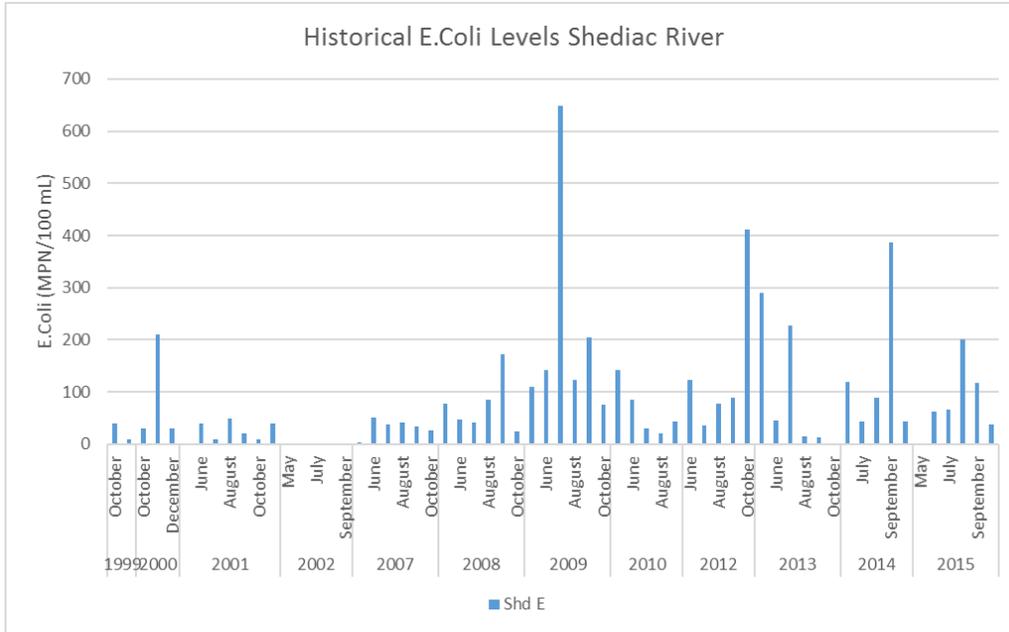
### 2.5.3 Main Branch Shediac River – Shd E

There's a site where the main branch of the Shediac river crosses the Shediac River road. The area is mostly forest lands.

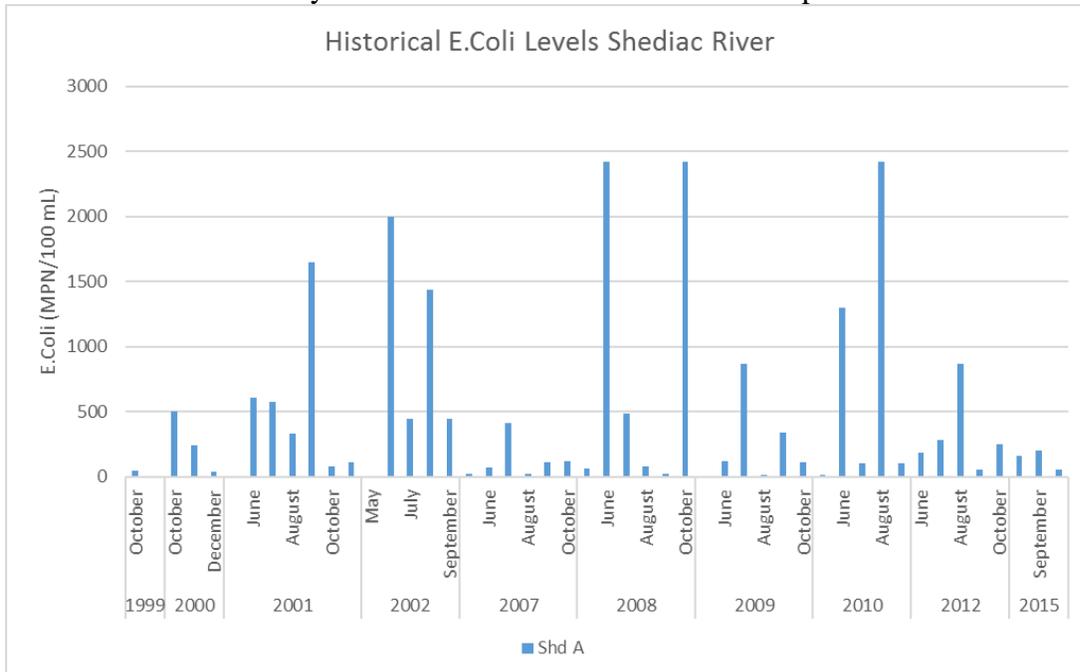
### 2.5.6 Irishtown – Shd A

The site is located in the upper reaches of the watershed in Irishtown of route 115. The area had the highest readings of E.coli in the watershed. This is an active farming area. There has been some restoration done by the SBWA but more could be accomplished to limit run off from fields.

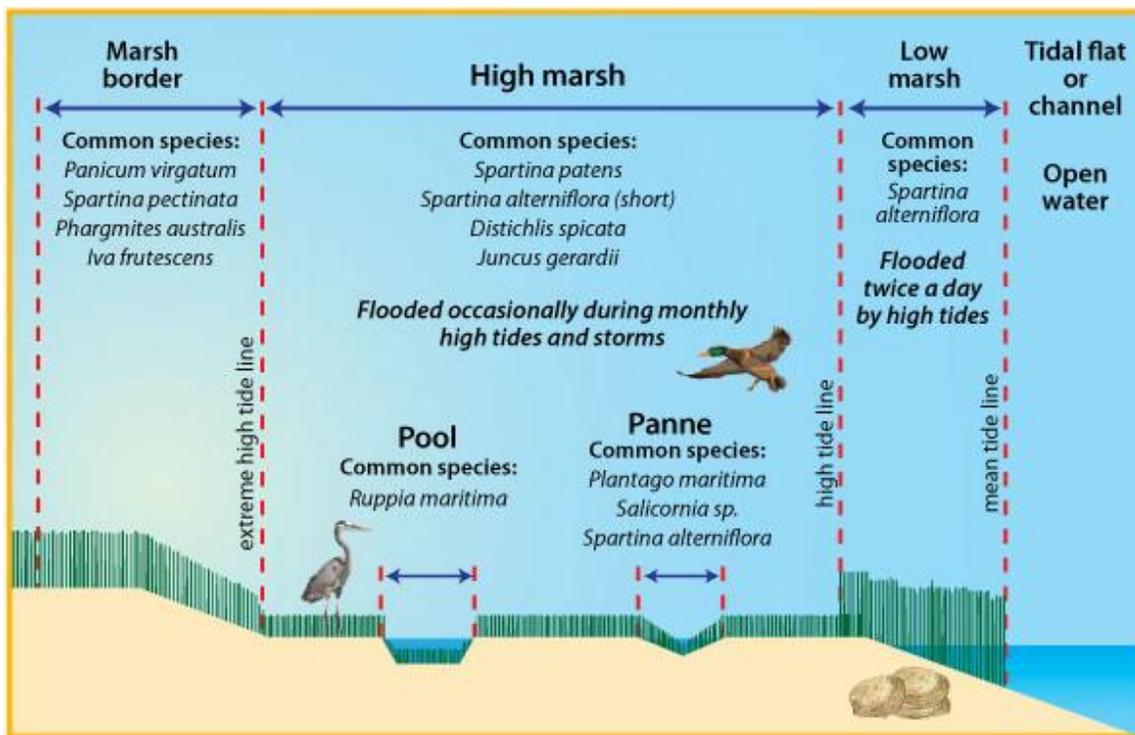
The following illustration list the common plant communities found in the different zones of salt marshes. The *Spartina* genus is particularly indicative of the marsh zones.

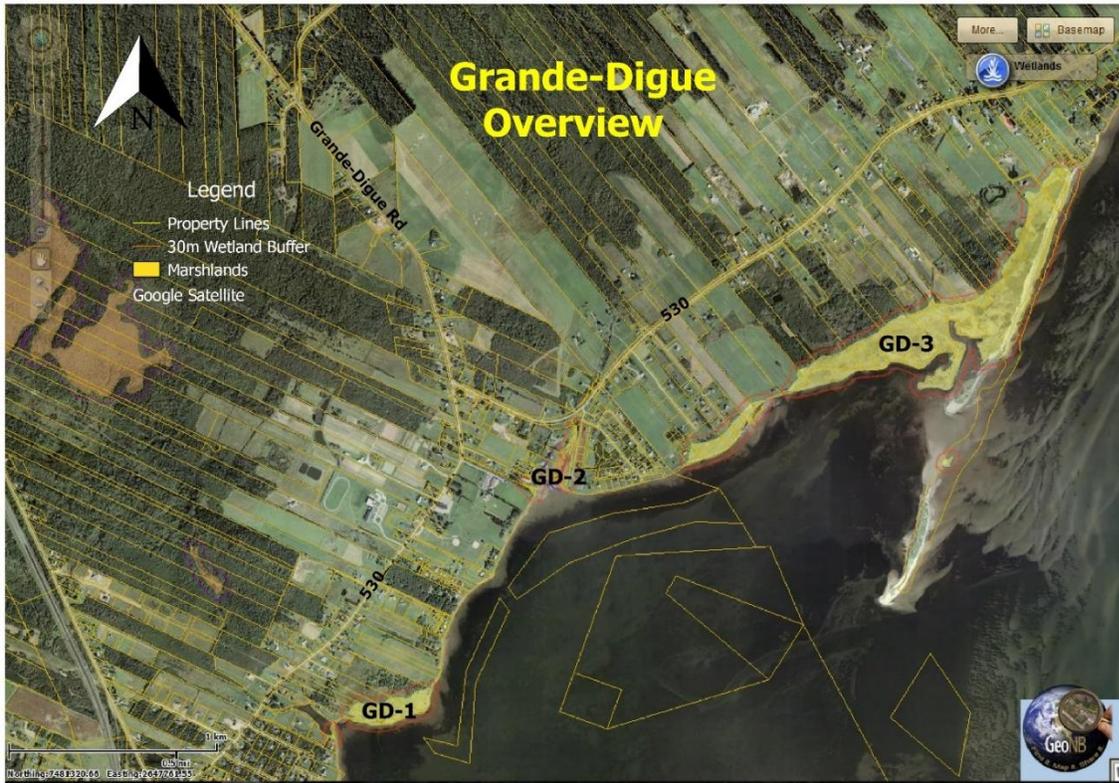
### 3.1 *Grande Digue Area*

Three marshes were surveyed in the Grande-Digue area.

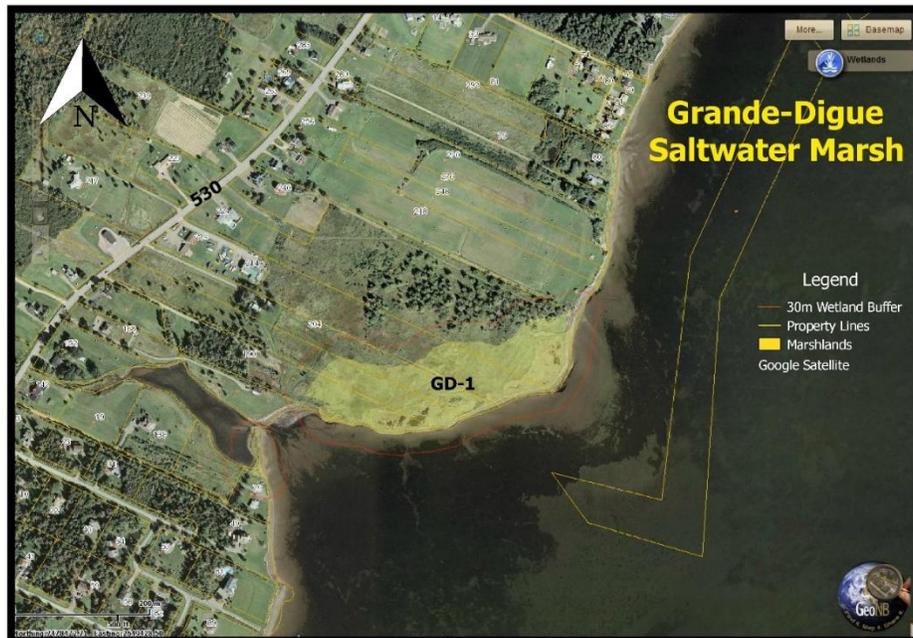
### 3.1.1 Grande-Digue -1

GD-1: Area 37,316 sq/m  
Perimeter 964m

This saltwater marsh is located a few kilometres north of the Shediac Bridge.

The surrounding area is dominated by shrubs and field species. The main shrubs found are meadow sweet and cranberries. 5 species of field plants were identified. The marsh border has 7 species dominated by *Spartina pectinate*. The presence of Narrow-leaved cat-tail indicates areas that have mostly freshwater influx. The high marsh zone has 4 species dominated by *Spartina patens* and *distichlis spicata*. The lower marsh zones also have 4 species dominated by *Spartina alterniflora*. Sapphire greens were found in small quantities.

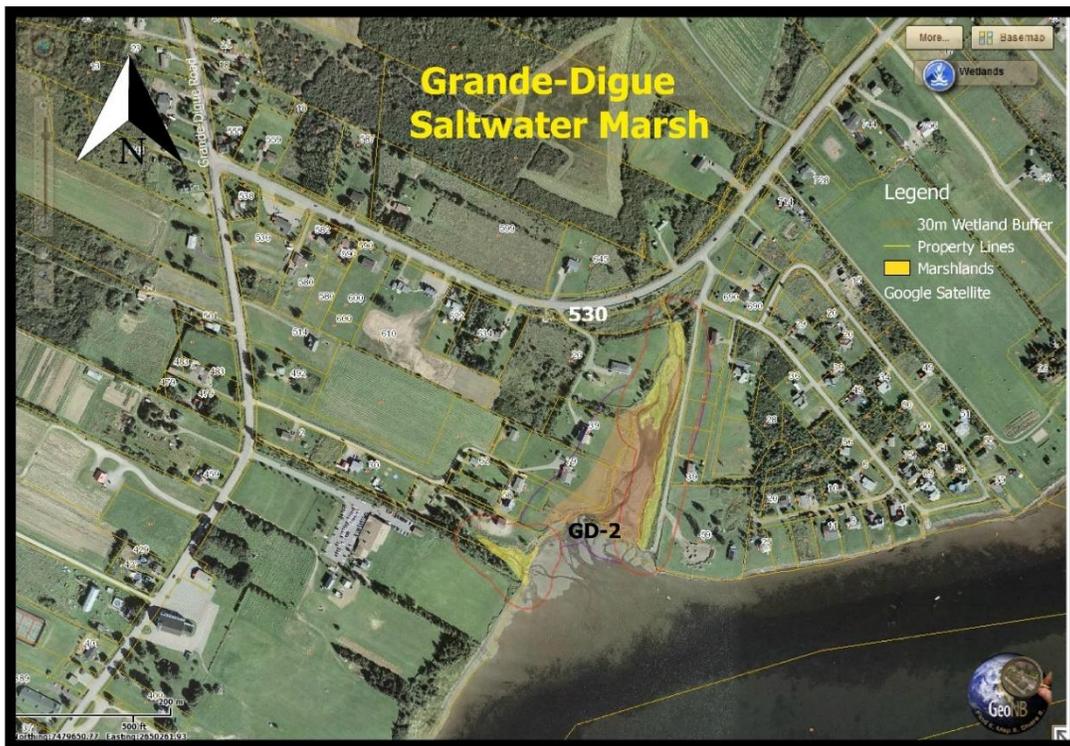
### 3.1.2 Grande-Digue -2

GD-2: Area 10,708 sq/m  
Perimeter 626m

This saltwater marsh is located behind the community centre Notre Centre off Route 530. The total area identified by GeoNB is 10708 sq/m but the actual size is much smaller.

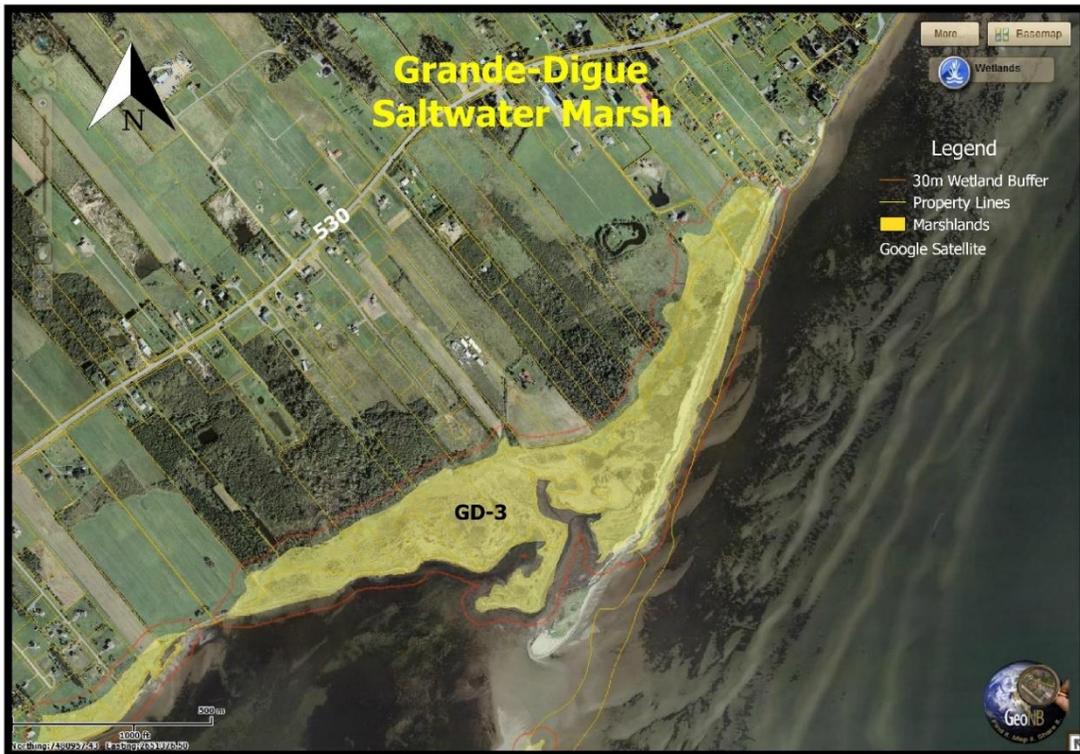
### 3.1.3 Grande-Digue -3

GD-3: Area 365,316 sq/m  
Perimeter 4,650m

This saltwater marsh is located off route 530 approximately 3 km for the village centre.

The three main areas of concern are the northern end where the most residential properties are found, near the middle where the fields are cultivated and finally near the southern edge, where large fields are found adjacent to the marsh. Some drainage ditches are present in the marsh.

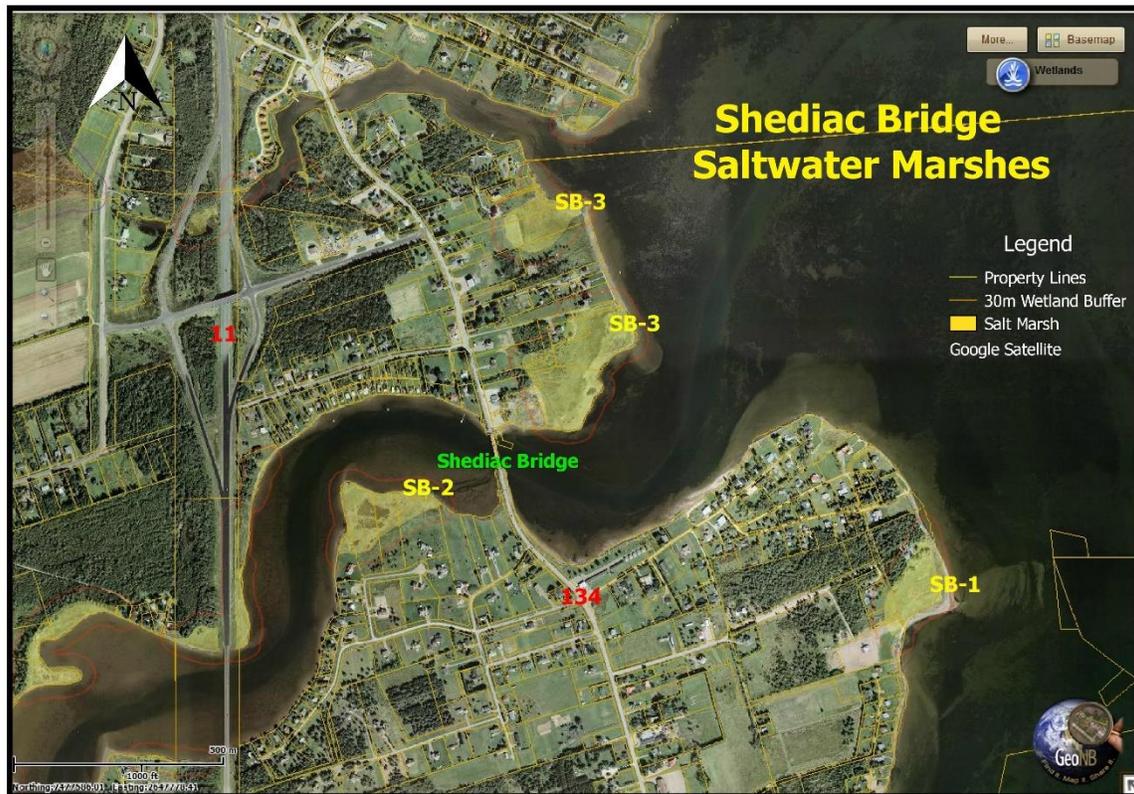
## 3.2 Shediac Bridge area

Three marshes were surveyed in the Shediac Bridge area. These saltwater marshes are located in Shediac Bridge near the bridge of route 134.

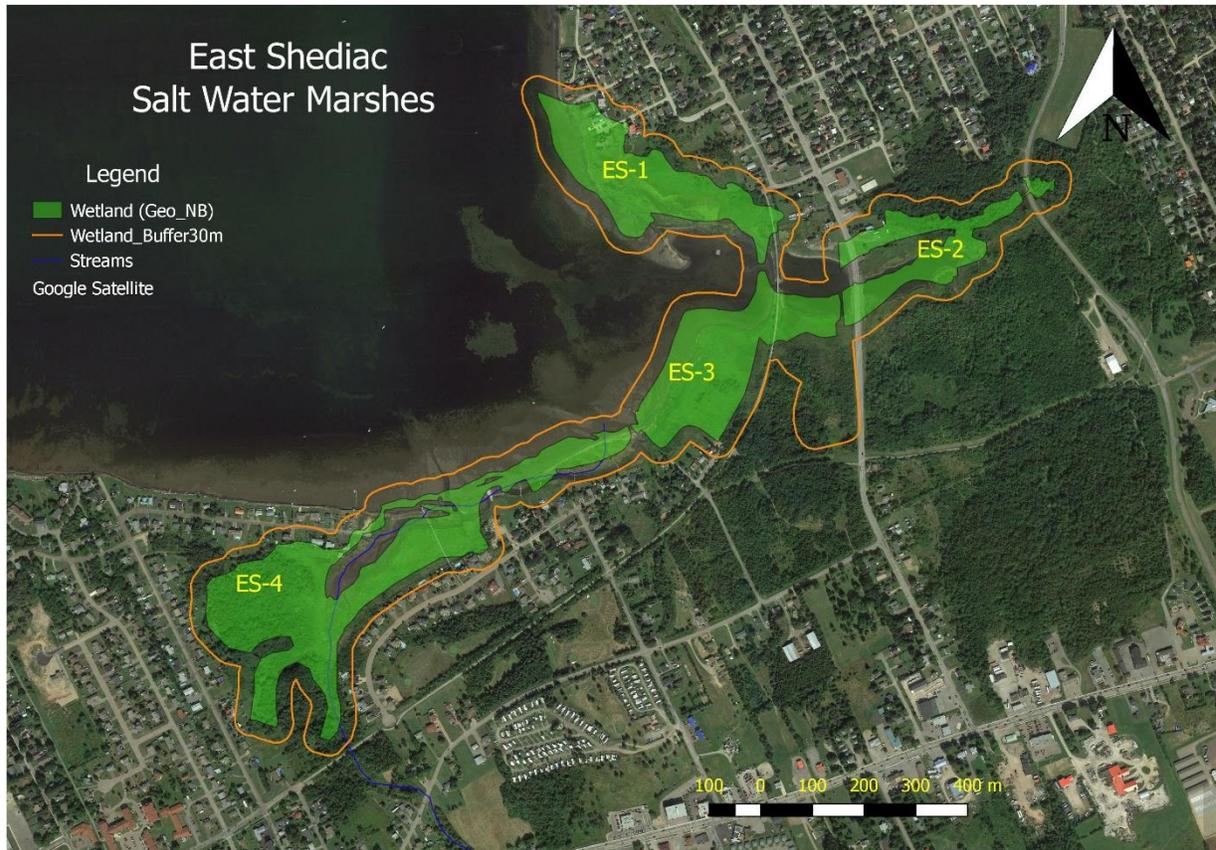
One marsh was surveyed in South Cove.

ES-1 : Area 43,452 sq/m Perimeter 1,448m	ES-2: Area 32,170 sq/m Perimeter 1,552m
ES-3: Area 52,692 sq/m Perimeter 1,198m	ES-4: Area 118,330m Perimeter 2,485m

In total, the area consists of 246,644 sq/m, with a perimeter of 6,683m.

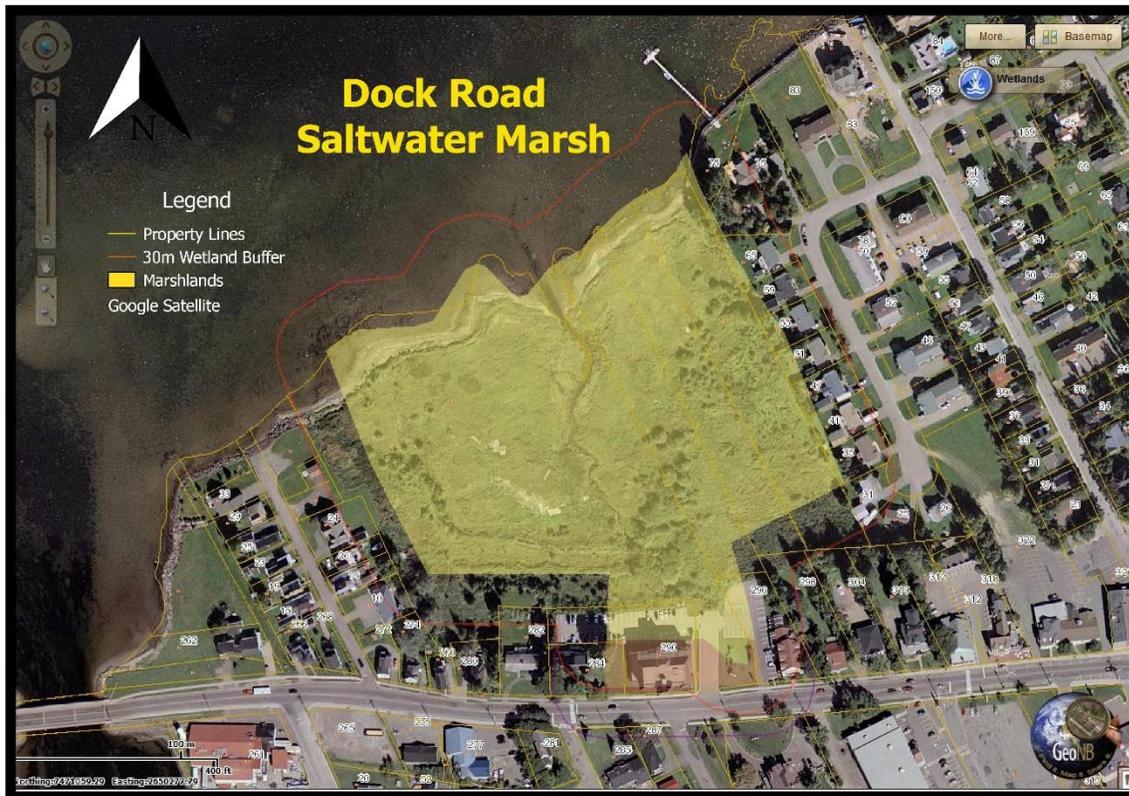
### 3.4.1 Dock Road – Behind Town Hall

DR: Area 46,545 sq/m  
Perimeter 886m

The marsh was surveyed on July 13<sup>th</sup>. This marsh is mainly dominated by shrubs and plants from the upper marsh zone such as *Spartina pectinate*. The high and lower marsh zones are present but have less diversity of plants than other marshes surveyed (3 each). However, there's a good variety of marsh border plants including some species that are associated with freshwater.

Some berms are present is cutting the high marsh zone. Lots of wood debris and an old dock can be found.

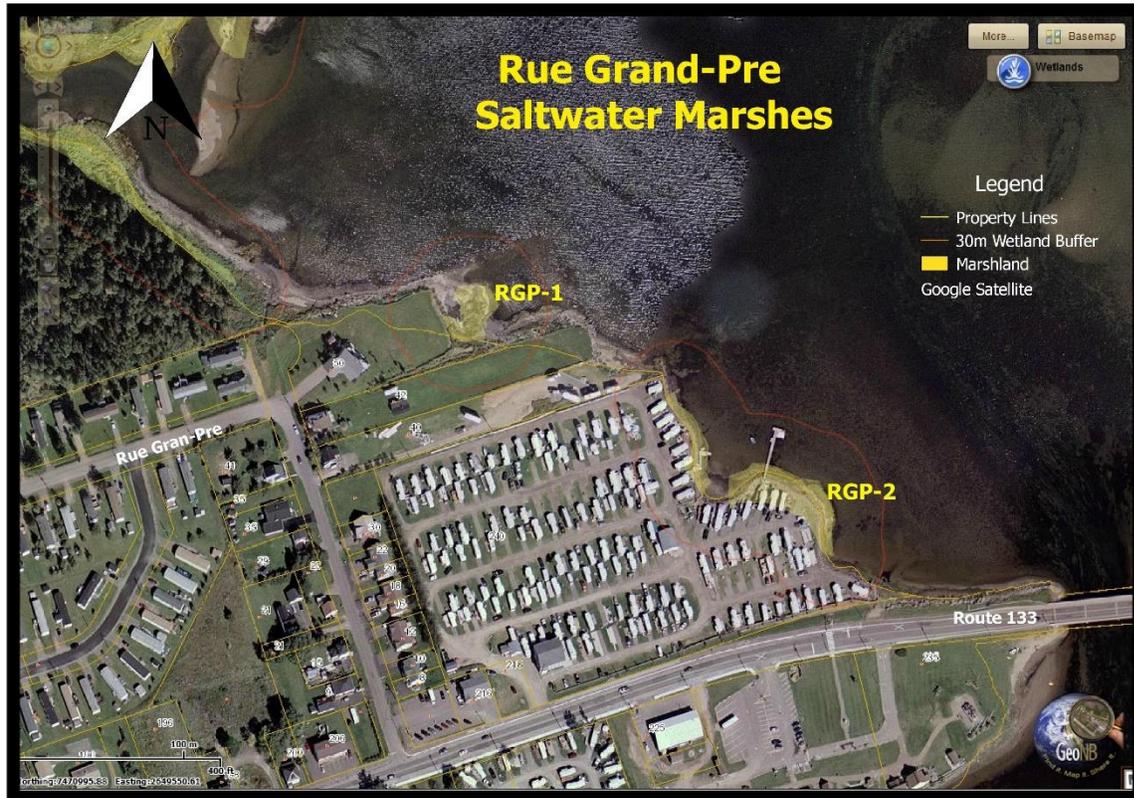
### 3.4.2 Rue Grand Pré Camping at Entrance of Town

RGB-1: Area 2,412 sq/m  
Perimeter 396 m

RGB-2: Area 1,874 sq/m  
Perimeter 192 m

This salt water marsh is located behind a campground. The wetland looks to have lost most of its functionality and integrity and has undergone a large amount of degradation and alteration. There's still presence of marsh plants from the three zones. The marsh border is infilled with rocks used as a breakwater for the campground.
