# **Environmental Evaluation of Shediac Bay Phase 1**

## **Final Report**

**The Shediac Bay Watershed Association Inc.**

**March 1, 2017**

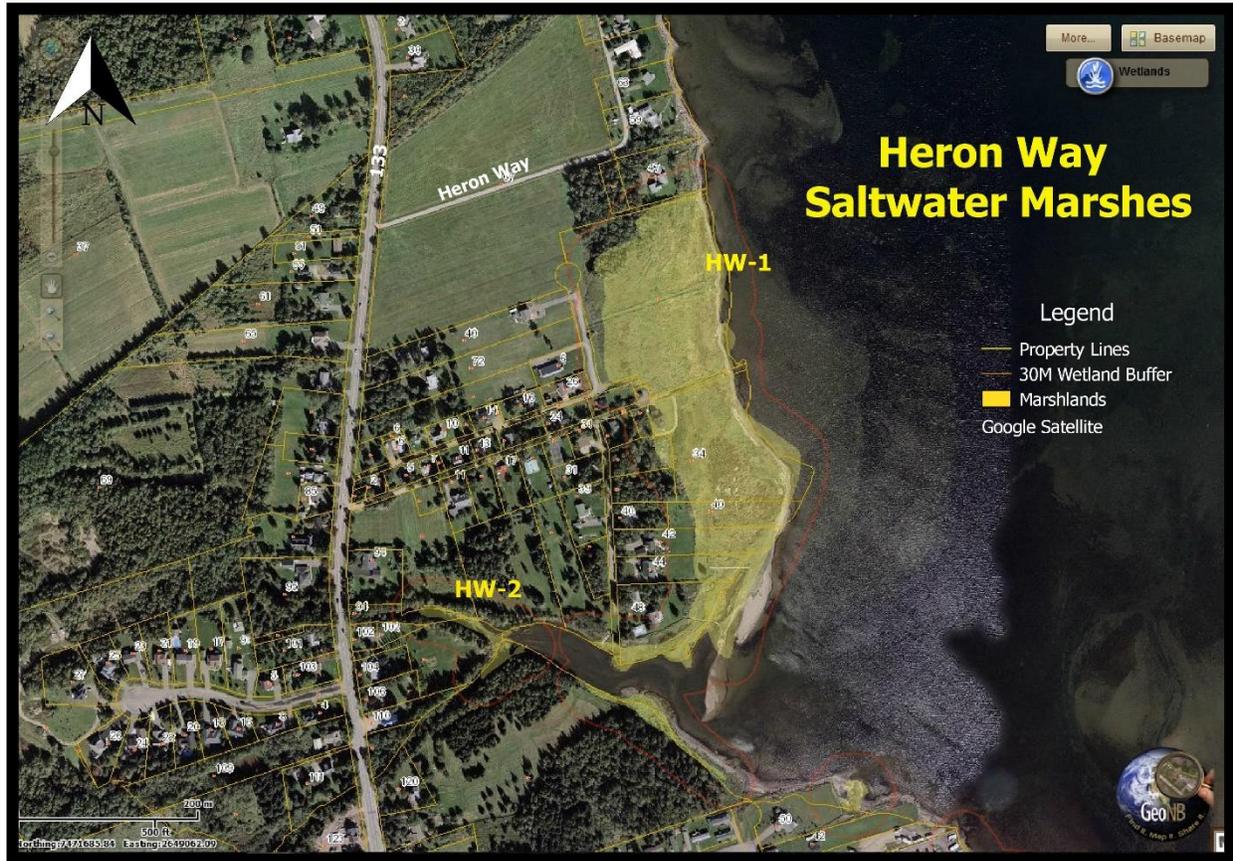
### 3.4.3 Heron Way

HW-1: Area 64,130 sq/m  
Perimeter 1,816 m

HW-2: Area 4,020 sq/m  
Perimeter 364 m

These salt-water marshes are located east of route 133. A large amount of the local private properties are found within the 30m proposed buffer.

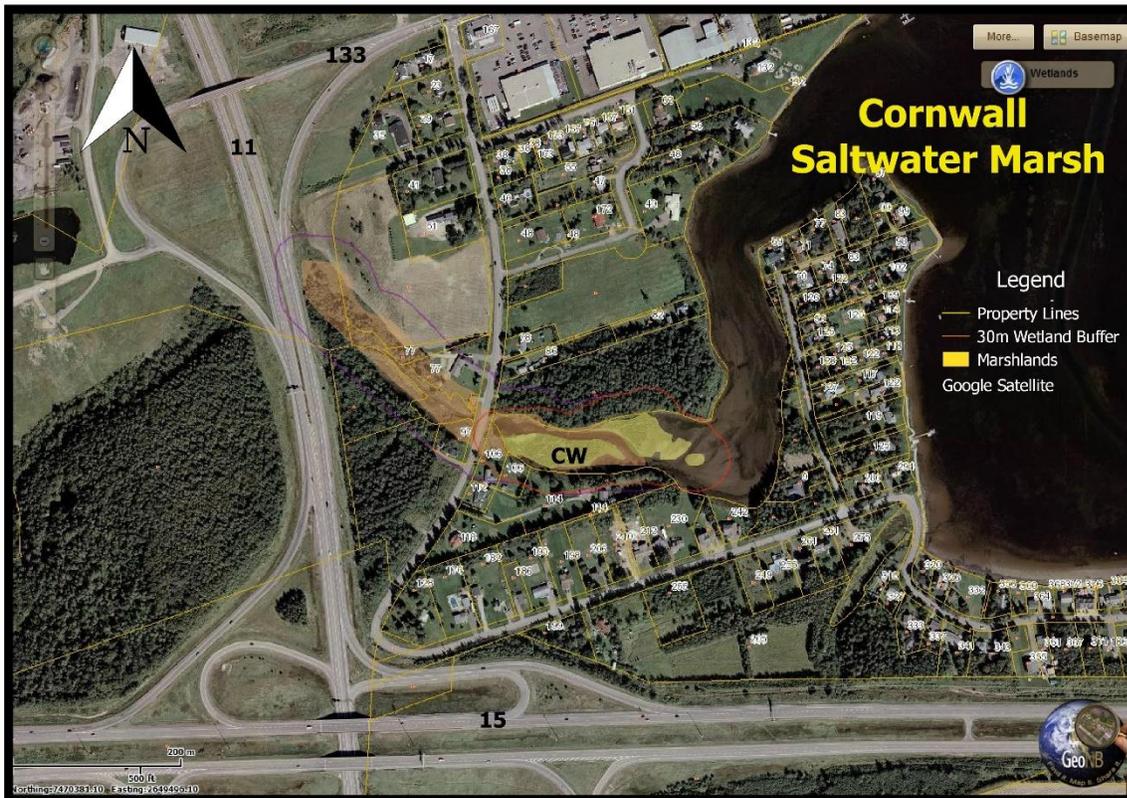
### 3.4.4 Cornwall brook

CW: Area 24,600 sq/m  
Perimeter 1,338m

This saltwater marsh is located east of highway 11 and north of highway 15. Only a few of the local private properties are found within the 30m proposed buffer, the majority of the length of the wetland is covered in trees.

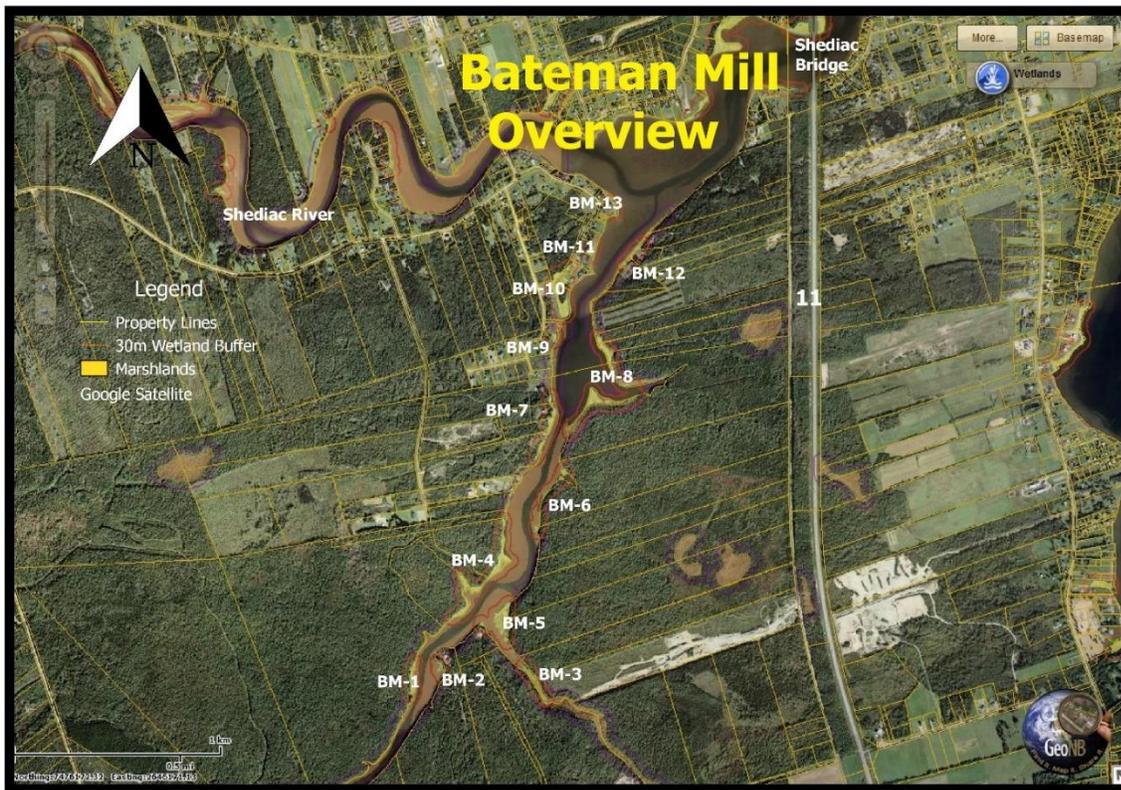
### 3.5 Bateman Mills area

The salt marshes along Bateman Mill's were surveyed by canoe on September 7<sup>th</sup>. Staff accessed the bigger marshes for investigation and observed the smaller marshes from the canoe.

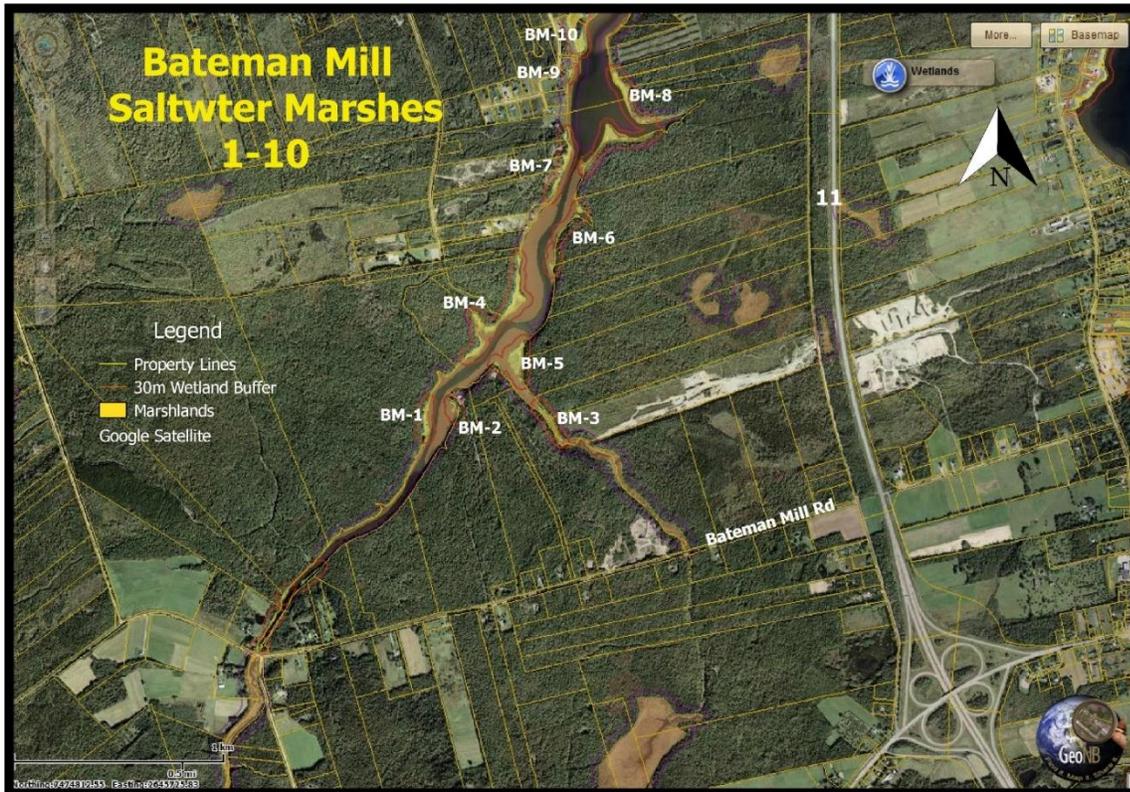
### 3.5.1 Bateman Mill marshes 1-10

This series of wetlands, 1 through 10, higher up the river, are surrounded by forested land. Local residential lots have been very respectful of the sensitive marsh sites and have kept a considerable distance from them. The only potential degradation in this area, that could impede in the health of these systems, is located to the south east off the number 11 highway, what seems to be a large gravel pit which could have the possibility of an increase in turbidity, erosion or sedimentation from the runoff. This is the biggest area of concern in this location.

The larger wetlands had the three marsh zones present. Some of the smaller ones were comprised of the lower marsh and marsh border. The marsh BM-05 had the presence of a berm that eliminated part of the marsh border.

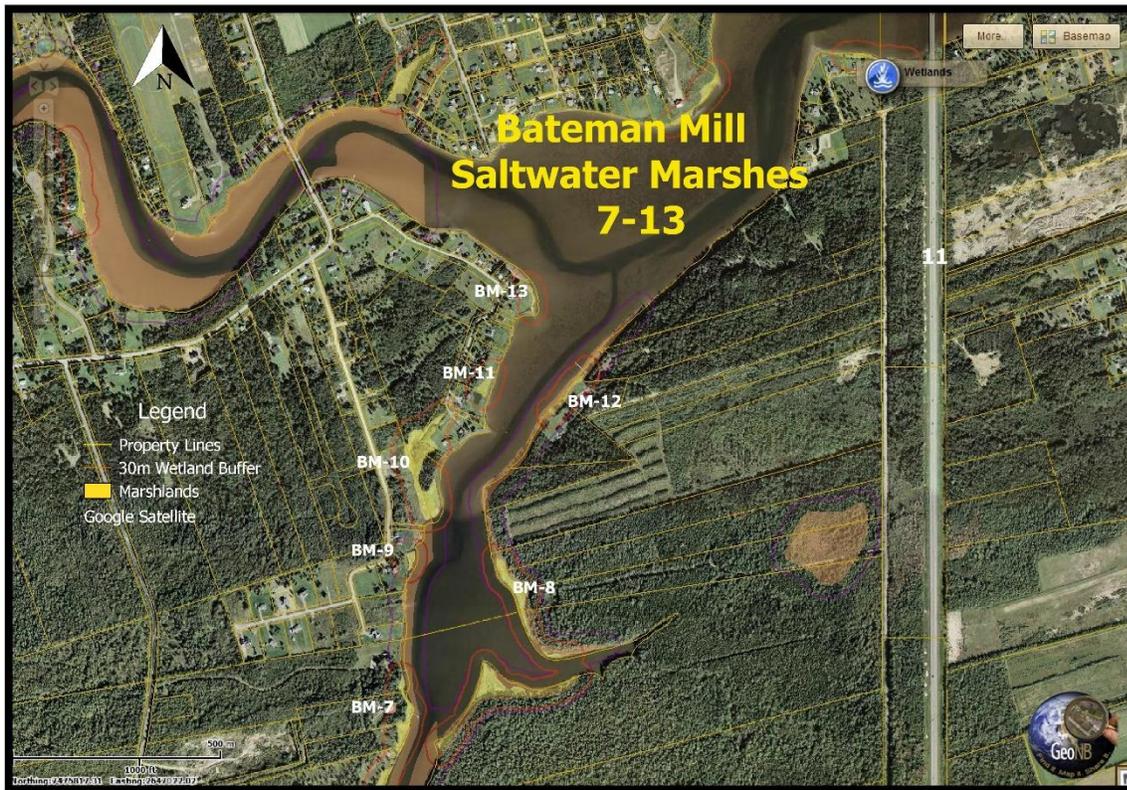
### 3.5.2 Bateman Mill marshes 7-13

This series of small saltwater marshes are found along the end of the Bateman Mill Stream where it connects to the Shediac River near the Shediac Bridge. Development has occurred near wetland 9 through 13, the remaining marshes are more isolated and seem to have kept their functionality and integrity over the years. Yet, many developers and residential lot owners sometime seem to take little notice of these smaller marshes and could be subject to more development in the future. Many of these wetlands can be reached via roads or possibly boat. There exists some minor industrial activity in proximity to the river, and could be a possible source of pollution and erosion.
