**RESTORATION PROJECT
CORNWALL BROOK
- 2006 -**

Cornwall Brook

**Prepared by:
Mathieu Leblanc, Field Technician
Shediac Bay Watershed Association
And
Dominique Audet M.Sc., Coordinator
Shediac Bay Watershed Association**

January 2007

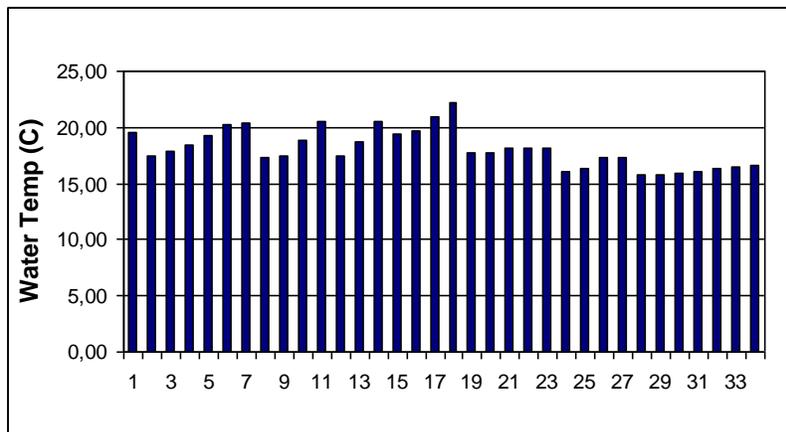
Figure 1: Average water temperatures for each reach

The water temperatures for all reaches (Figure 1) went from 15.80 $^{\circ}\text{C}$ to 22.26 $^{\circ}\text{C}$ with an overall average of 18.33 $^{\circ}\text{C}$.

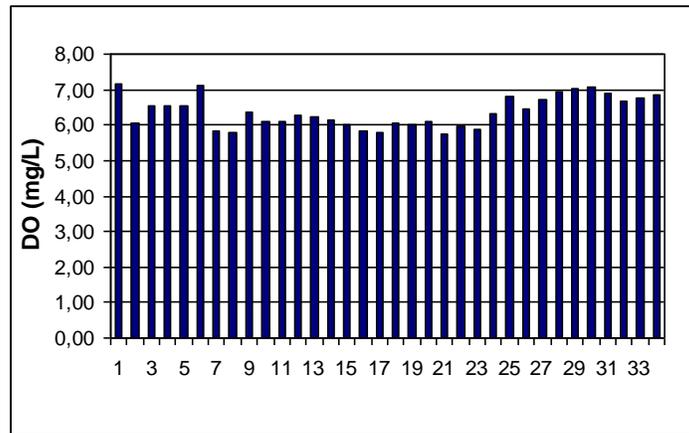
Figure 2: DO levels for each reach

The DO levels (Figure 2) went from 5.75 mg/L to 7.18 mg/L with an overall average of 6.37 mg/L. There were 7 reaches that fell below 6 mg/L but none fell below 5 mg/L.

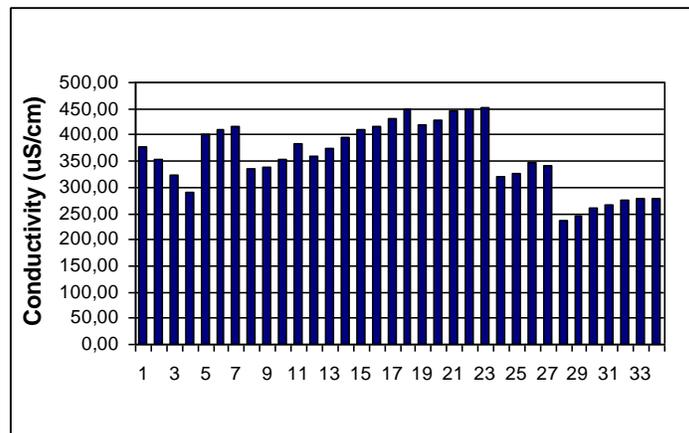
Figure 3: Conductivity levels for each reach

The conductivity levels (Figure 3) went from 236.57 uS/cm to 450.60 uS/cm with an overall average of 358.41 uS/cm.
