**APPENDIX B**

## Scoudouc River

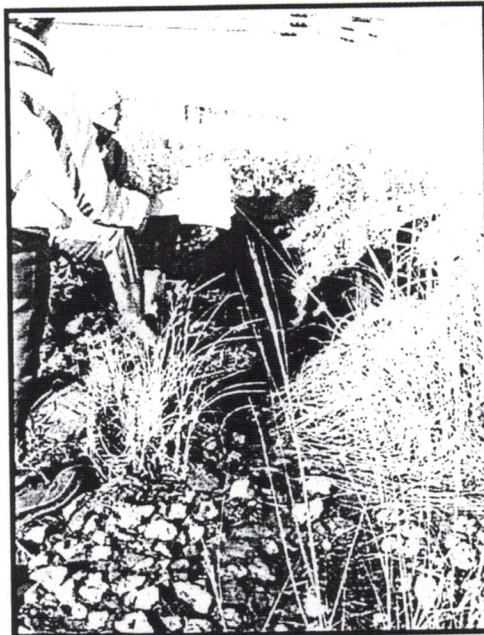
**Figure 4.** Cement culvert at site 4, which may be a source of sediment and runoff.
