**Shoreline Sanitary Surveys of Shediac, Scoudouc, Batemans, Wayne
Road and Albert-Gallant watersheds**

Final Report - February 2000

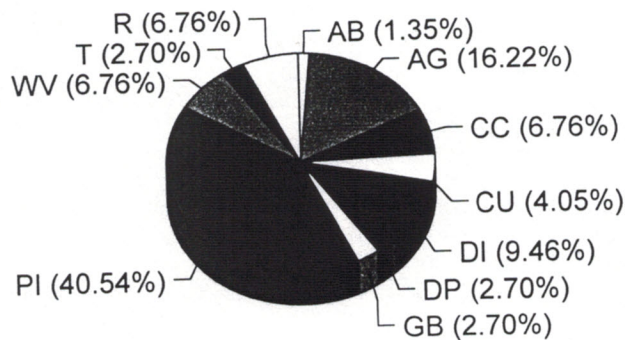
Figure 2. A pie chart showing the relative occurrence of different types of potential pollution sources along the Shediac river. The survey was conducted by the Southeastern Anglers Association in November 1999.

A 28 km stretch of the Shediac river was surveyed for any possible source of pollution that could affect water quality. Agricultural lands and pipes were the most numerous possible pollution sources seen on this river stretch. Three farm lands were contributing to heavy sediment loads. Near the other farms, only small amounts of sediment were observed in the watercourse. Ten pipes, considered suspicious, were flowing during time of inspection. The banks were eroding and erosion ditches were visible along two clear cuts. Two piles of garbage were also discovered along this stream. No leaching was evident. One junkyard, containing 11 derelict vehicles, was contributing to small amounts of sediment. No other leaching was visible. Culvert, ditches, trails and residences were also located near the river banks in certain areas. No serious problems were observed from the latter. All potential impacts to the river's water quality are summarized in Figure 2.

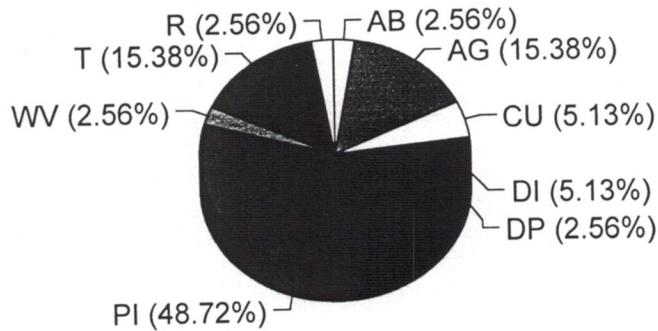
Figure 3. A pie chart showing the relative occurrence of different types of potential pollution sources along the Scoudouc river. The survey was conducted by the Southeastern Anglers Association in November 1999.

The sanitary survey was carried out along an eight-kilometre stretch of the Scoudouc river. The most commonly encountered possible pollution source types were from pipes, trails and agriculture (farms). Although pipes accounted for most of the possible pollution sources (39.5%), other types such as river crossings, trails, erosion ditches near farms and an open pit pose much more of a threat to the river's water quality. All potential impacts to the river's water quality are summarized in Figure 3.

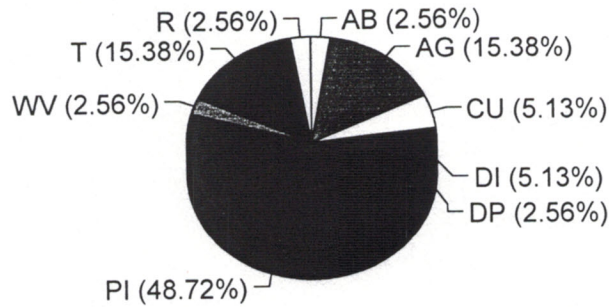
Figure 4. A pie chart showing the relative occurrence of different types of potential pollution sources along Batemans brook. The survey was conducted by the Southeastern Anglers Association in November 1999.

The sanitary survey was carried out along an six-kilometre stretch of Batemans brook. A variety of potential pollution sources were encountered along this short stretch. These included plastic drainage pipes from houses, a cattle and hog farm. One site was particularly polluted; four hog carcasses were strewn along the side of a lagoon near the stream (≈ 125 m). All potential impacts to the river's water quality are summarized in Figure 4.

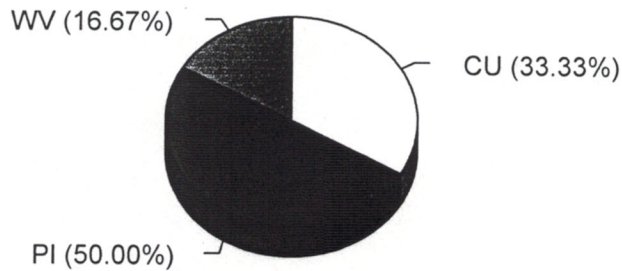
Figure 5. A pie chart showing the relative occurrence of different types of potential pollution sources along Wayne road brook. The survey was conducted by the Southeastern Anglers Association in November 1999.

The sanitary survey was carried out along an one-kilometre stretch of Wayne road brook. The most commonly encountered possible pollution source types were drainage pipes and two culverts. The potential impact of these pollution sources seems to be minimal. All potential impacts to the river's water quality are summarized in Figure 5.

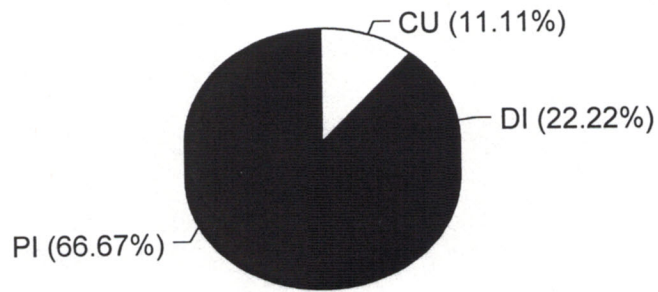
Figure 6. A pie chart showing the relative occurrence of different types of potential pollution sources along Albert-Gallant brook. The survey was conducted by the Southeastern Anglers Association in November 1999.

The sanitary survey was carried out along an one-kilometre stretch of Albert-Gallant brook. The most commonly encountered possible pollution source types were from drainage pipes, one culvert and two small drainage ditches. The potential impact of these pollution sources seems to be minimal. All potential impacts to the river's water quality are summarized in Figure 6.
